# **XTREME** **EXCAVATORS**

## **CAT 6060** **Inspection Report**

**Machine Make:** CAT  
**Machine Model:** 6060  
**Serial Number:**  
**Customer:** Whitehaven Coal  
**Site:** Blackwater  
**Hours:** 58,117

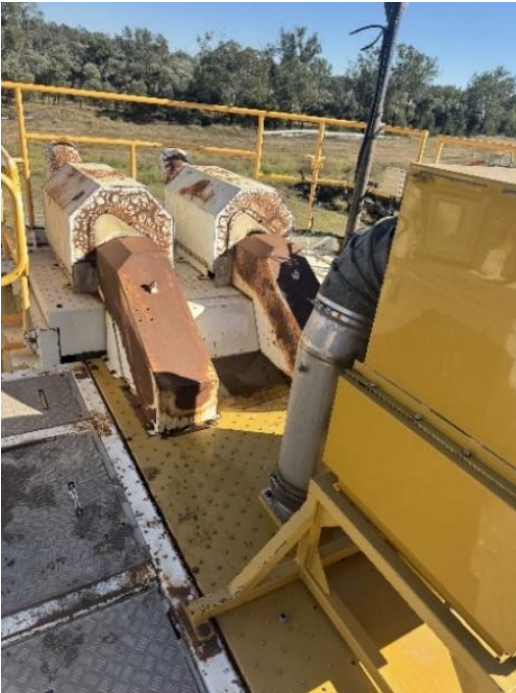
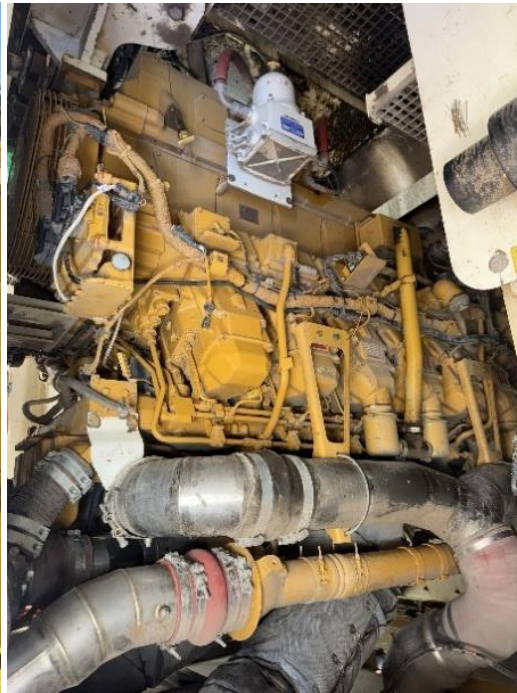
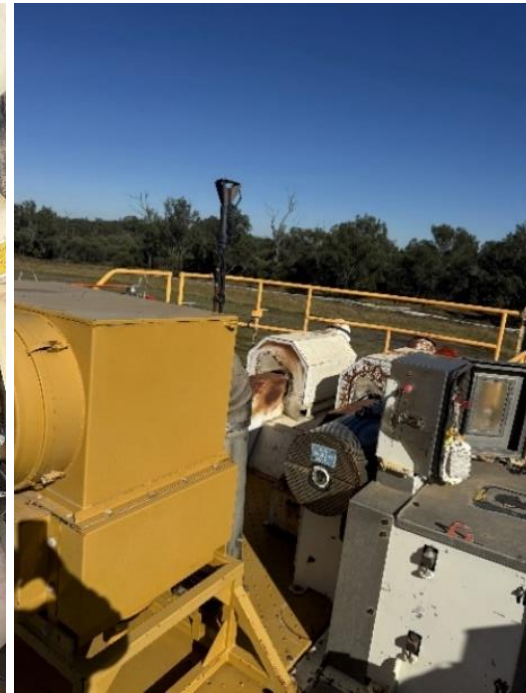
| Description | L/H | R/H |
|---|---|---|
| Intake Piping / Clamps | Intake piping and clamps in ok condition. A number of aftercooler clamps missing from hoses. Aftercooler has visible build up near cores in middle. Airboxes look to be in ok condition at time of inspection. | Intake piping and clamps in ok condition. A number of aftercooler clamps missing from hoses. Airboxes look to be in ok condition at time of inspection. |
| General Condition | LH Fuel Tank leaking, fish plated on bottom for repair. Engine missing A/C compressor guard. Electrical harnesses and sensors look ok at time of inspection. | RH Fuel Tank leaking, fish plated on bottom for repair. Electrical harnesses and sensors look ok at time of inspection. X15 box in good condition, 150amp fuse removed. |

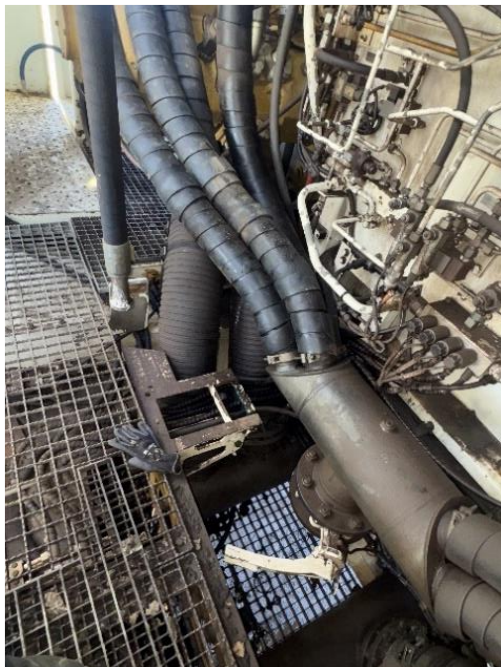
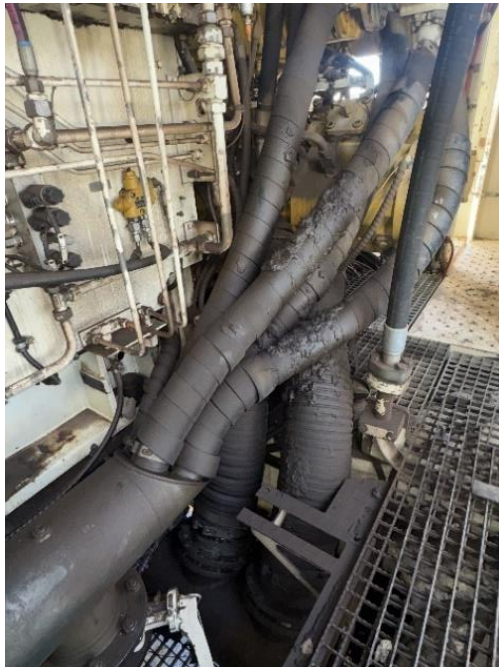
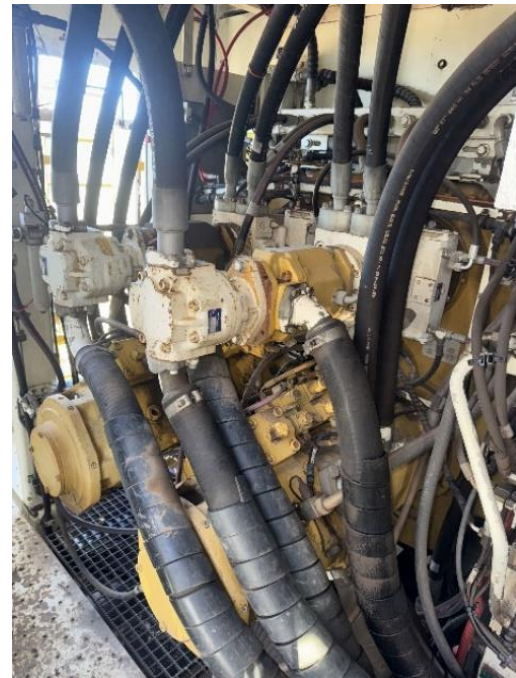
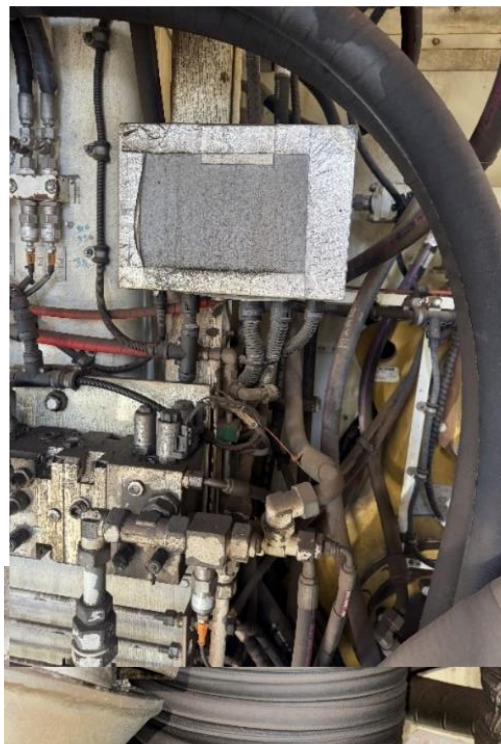
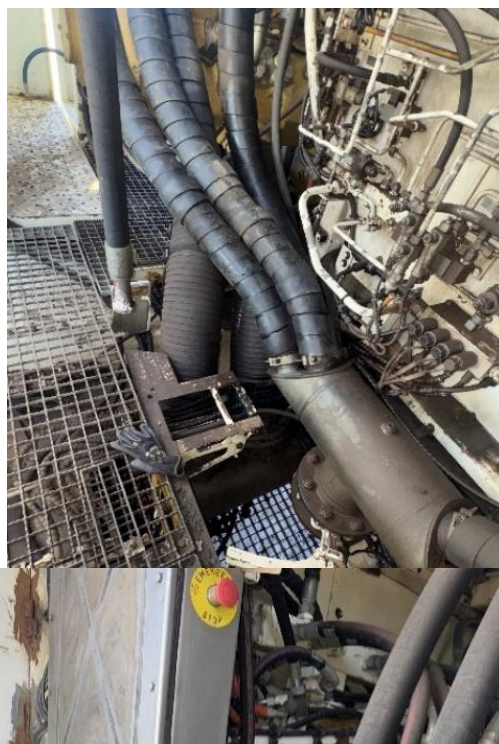
| Location | L/H | R/H |
|---|---|---|
| Fluid Leaks | Slight leak around lower clamps on MP3/4 suction hose. | Slight leak around slew charge pump sectioning. |
| Hoses | Hoses in pump bay looked ok at time of inspection. Was a number of stiff hoses, would suggest replacing if to go back to work. | Hoses in pump bay looked ok at time of inspection. Was a number of stiff hoses, would suggest replacing if to go back to work. |

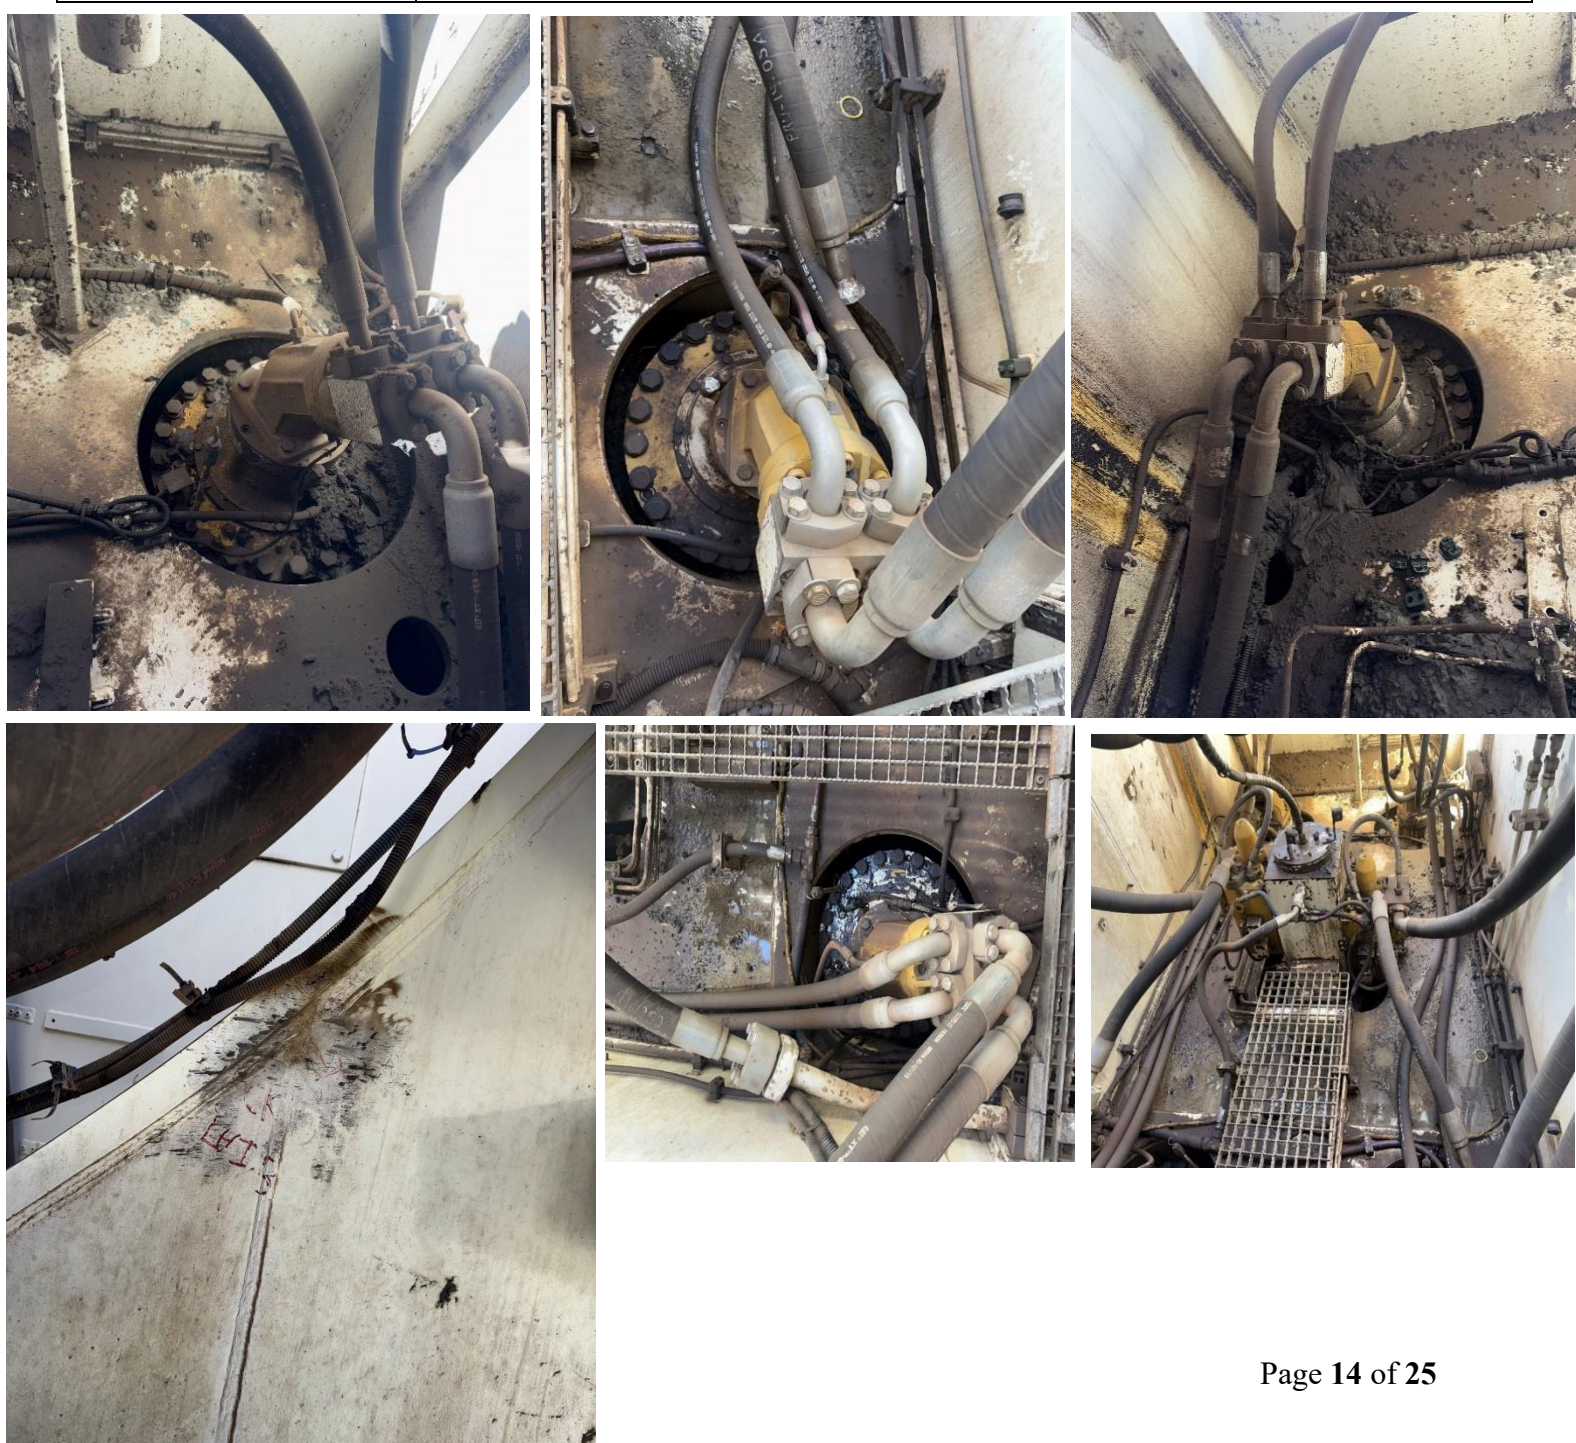
| Location | Comments |
|---|---|
| Piping/Hoses | RH Travel pipe missing. Runs along RHS of upper structure.<br>All hoses visually ok. Some slightly stiff but all in ok condition. |
| Swing Transmissions | Wet around LHR box, all other boxes in ok condition at time of inspection. |
| Other | Crack on ski ramp LH inboard side roughly 150mm. |

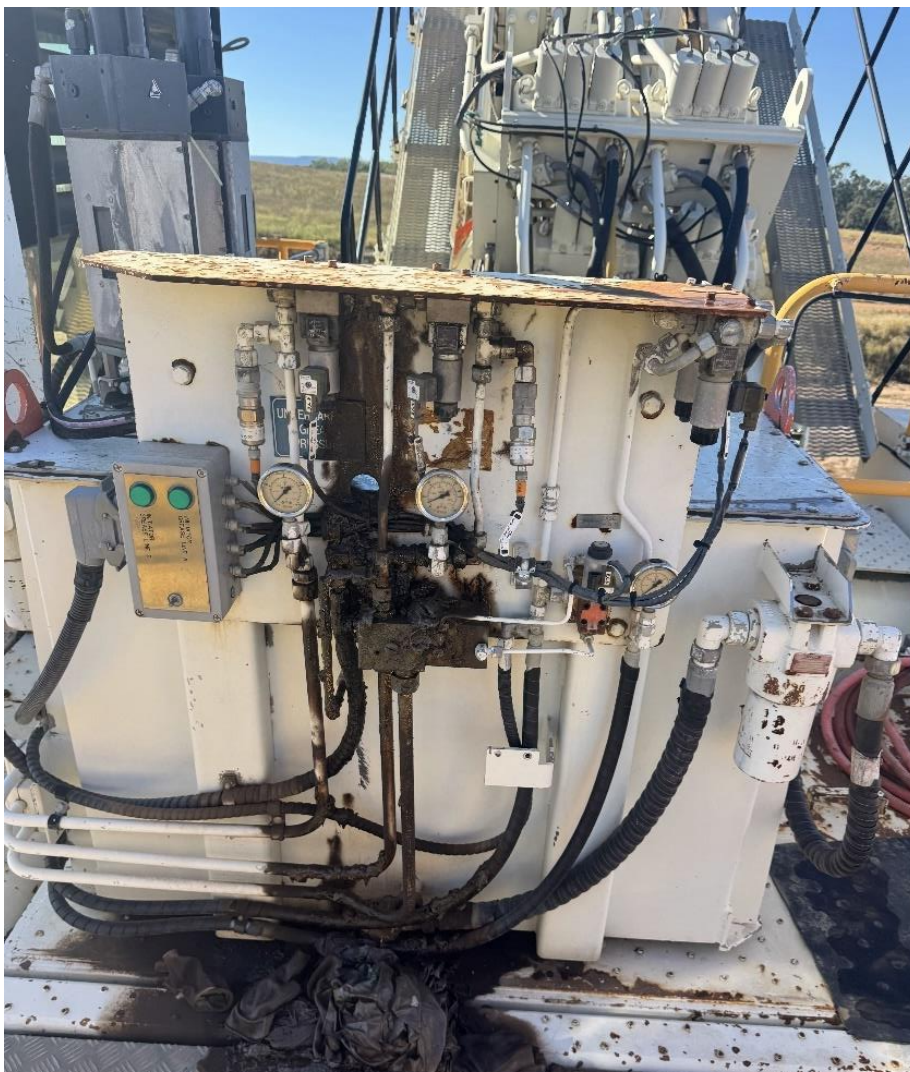
| Location | Comments |
|---|---|
| Fluid Leaks | Grease leak at change over valve. No other leaks visible at time of inspection. |

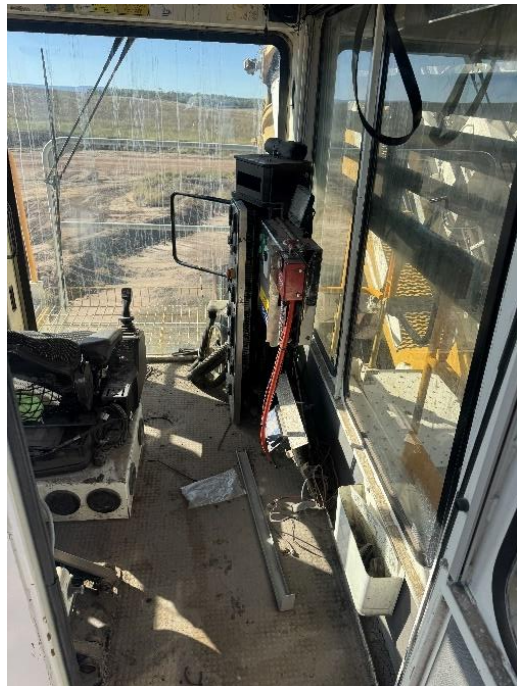
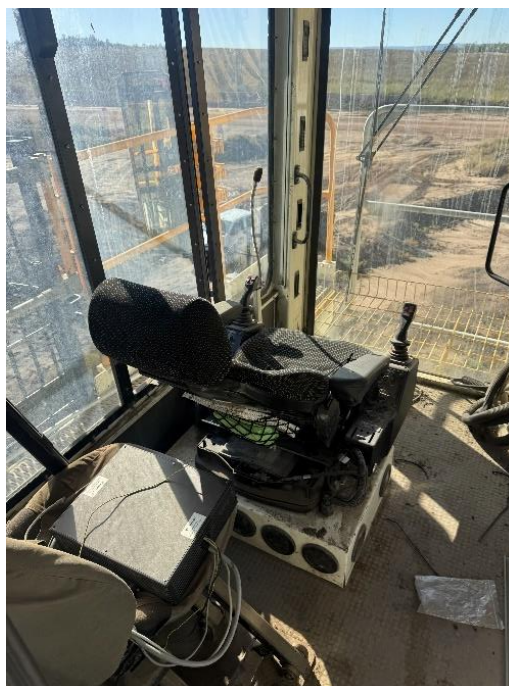
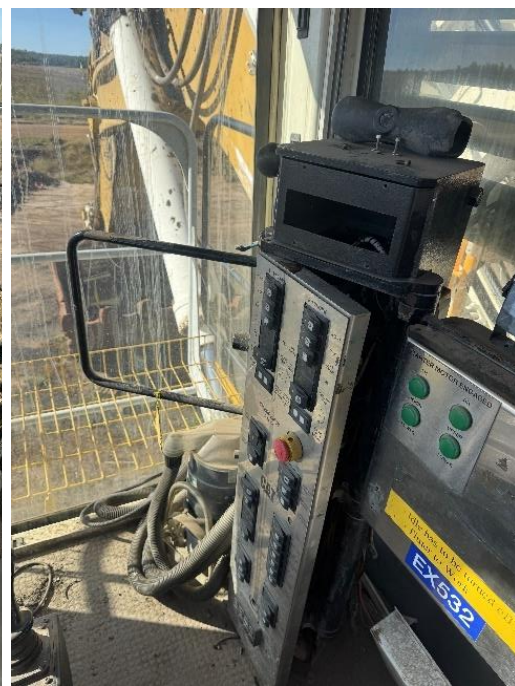
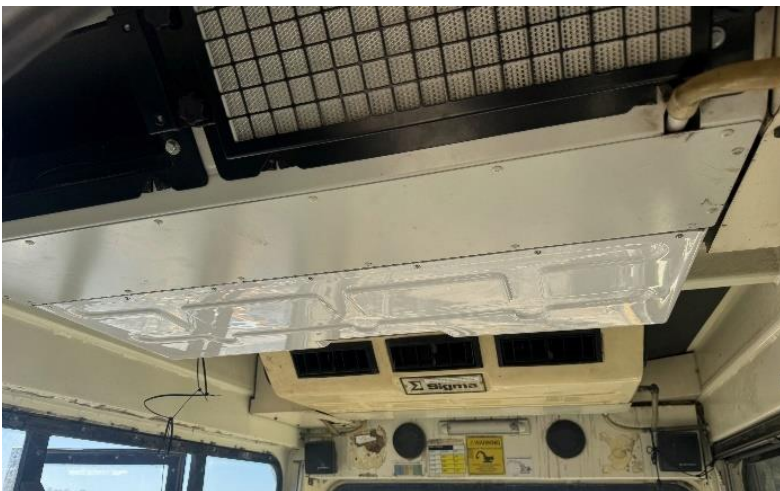
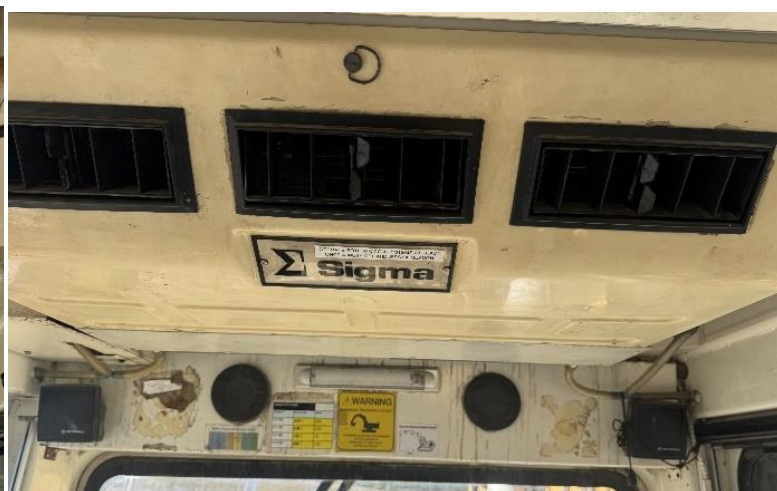
| Location | Comments |
|---|---|
| Instrument Panel, buttons, lights etc | BCS Screen removed from cab. BCS tower open, does look like anything else has been taken from here. |
| Cab seals | Cab seals worn. |
| Other | <p>Cab not very clean.</p> <p>Cracks found on LHS of cab shell.</p> <p>Cracks also found at rear RH corner behind door.</p> <p>LH cab blind removed.</p> <p>Rear evaporator unit in cab looks new, filter missing from it. Did not notice anything else removed from units at time of inspection.</p> |

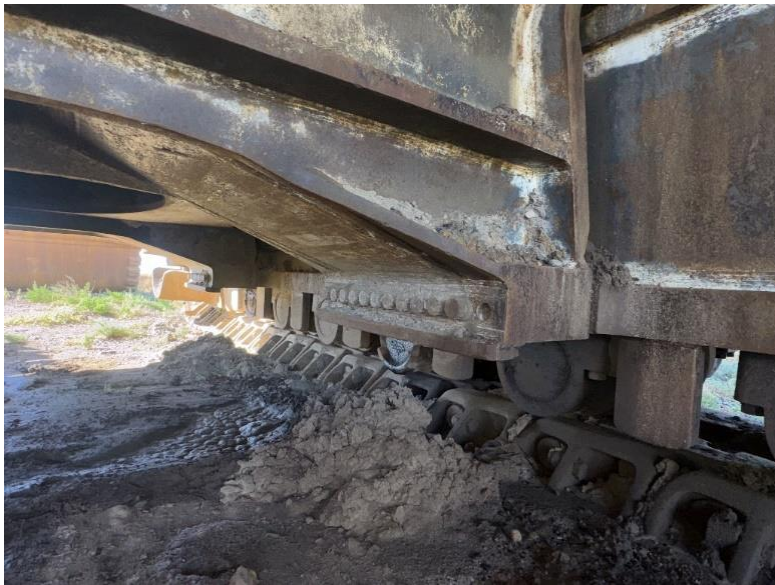
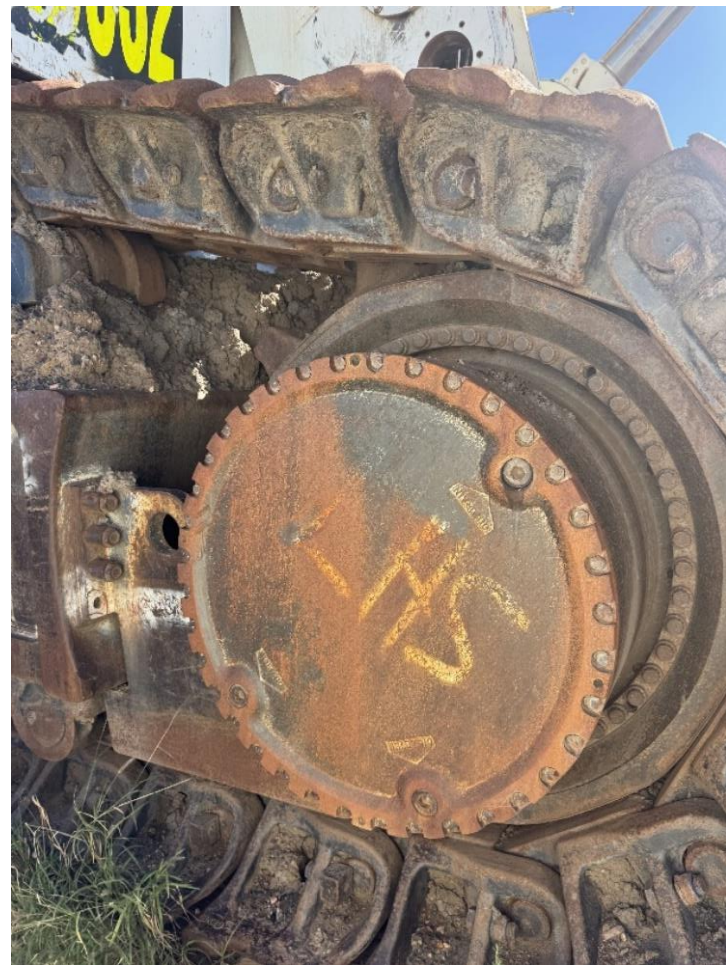
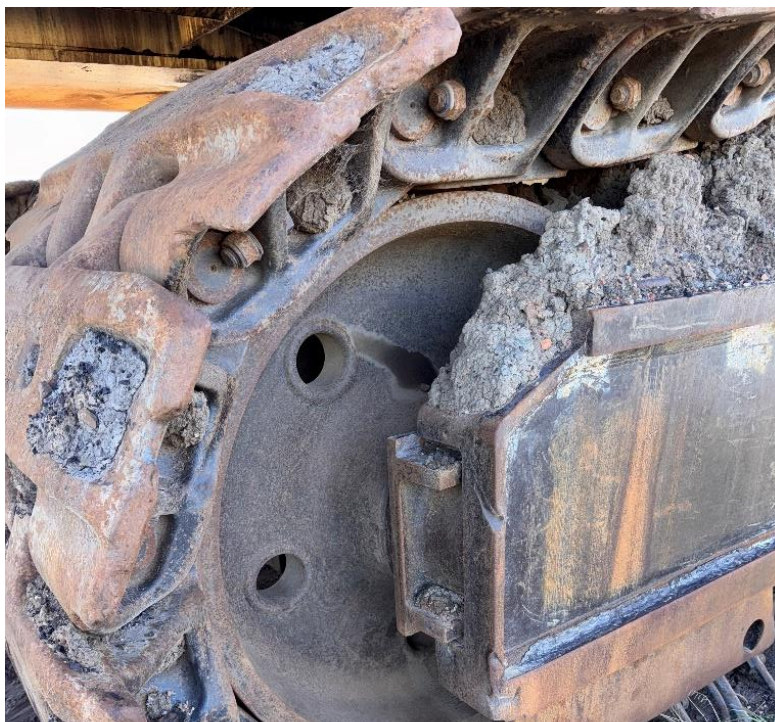
| Location | Comments |
|---|---|
| Mounting Bolts | Front Horizontal Mounting bolt is broken. |
| Lower Rollers | Pos 2 & 6 look to be leaking grease at outer cap. |
| Idler | Idler looks ok, hasn't failed/collapsed. Slides worn. |
| Sprocket | Sprocket has excessive wear. Would suggest changing out with new tracks. |
| Final Drive / Travel motors | Slight leak around rear travel motor. |
| Track | Tracks look worn. Pins also look worn. No missing retainer bolts at time of inspection. |

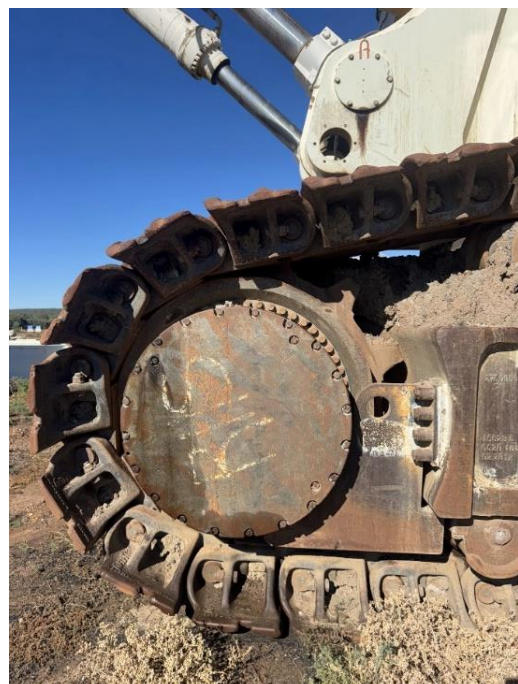
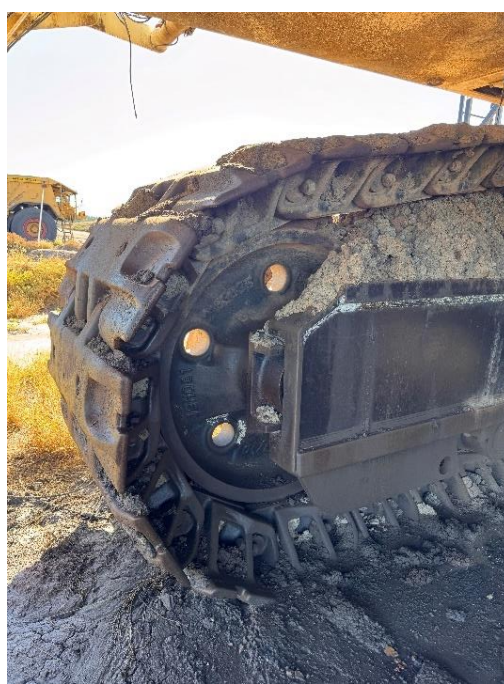
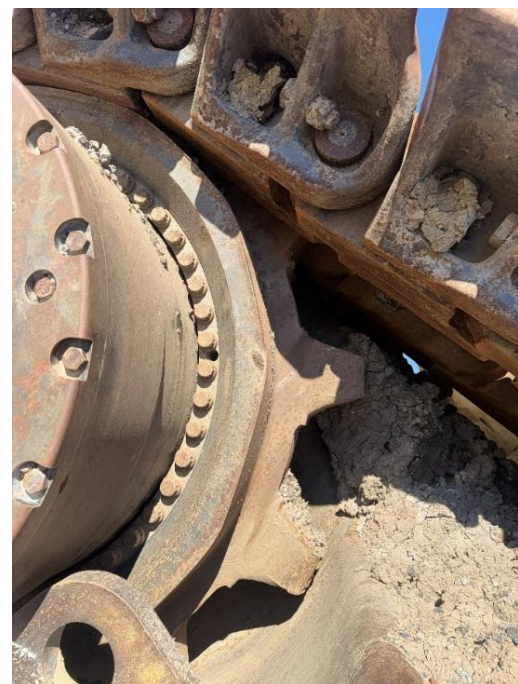
| Location | Comments |
|---|---|
| Mounting Bolts | Rear Horizontal Mounting bolt is broken. |
| Lower Rollers | Pos 1 looks to have collapsed and is leaking. |
| Sprocket | Sprocket has excessive wear. Would suggest changing out with new tracks. |
| Track | Tracks look worn. Pins also worn. No missing retainer bolts at time of inspection. |
