MAJOR INSPECTION REPORT

Manufacturer	Terex	Crane Model	Franna AT-20
Plate Registration Number	AT20 #3613	Owner	Sarina Crane Hire
Year of Manufacture	2005	Owner's Reference	3613

CRANE SAFETY CERTIFICATE - MAJOR INSPECTION

CERTIFICATE № 00091-003

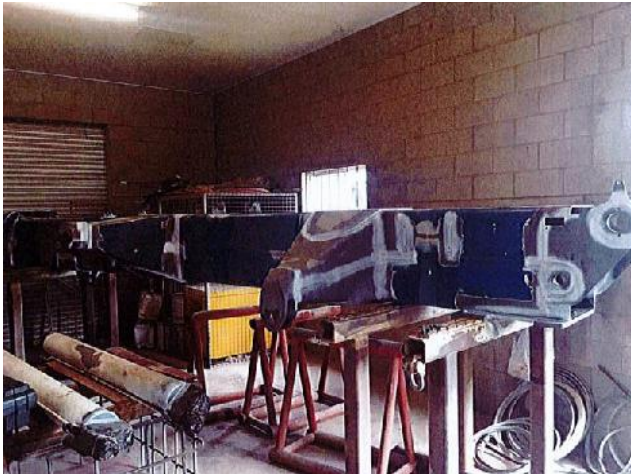
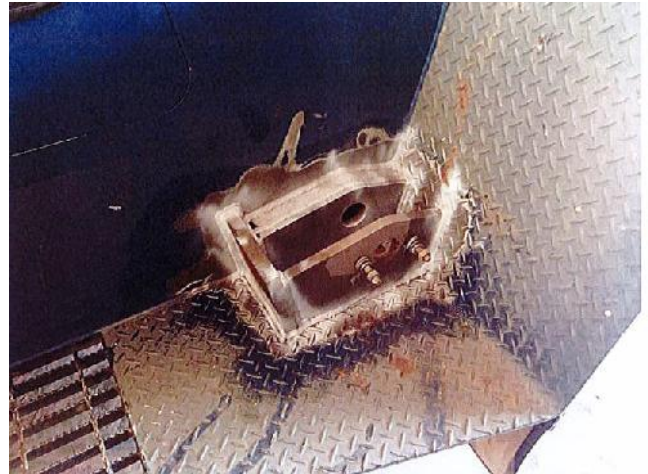
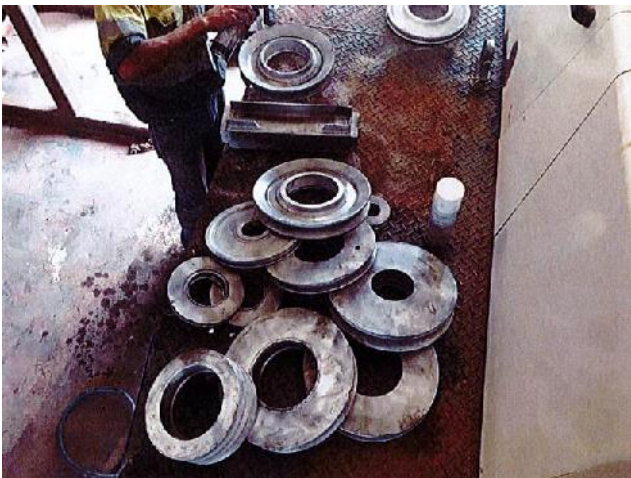
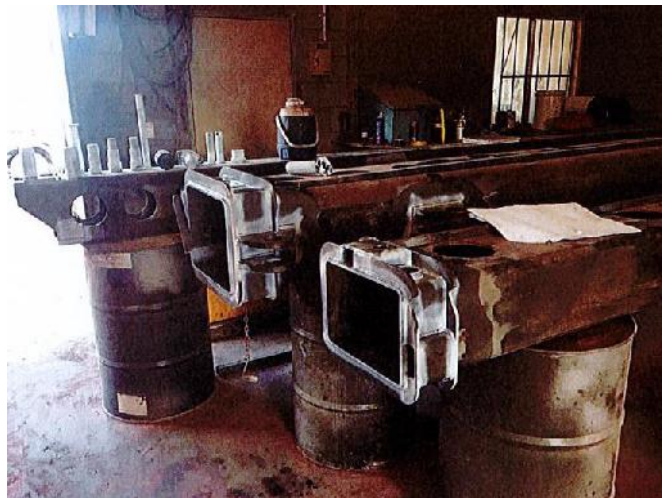
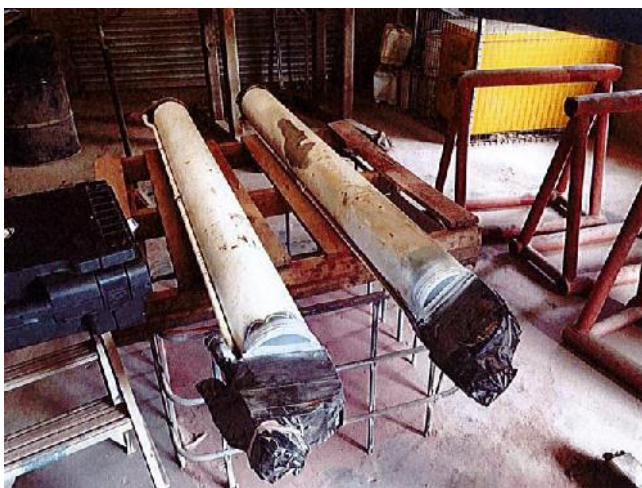
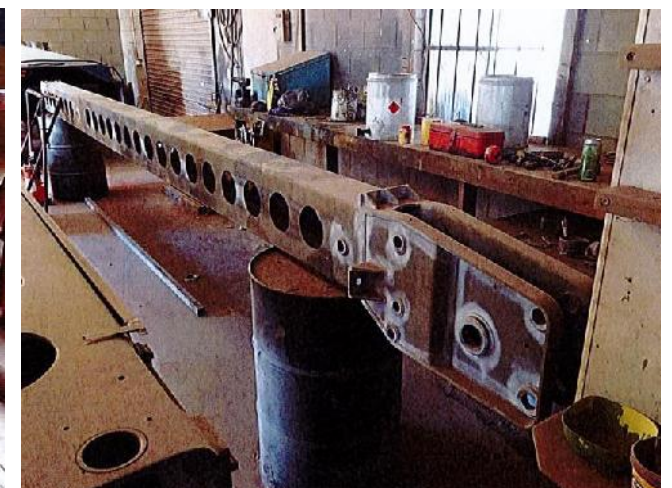
KEY INSPECTION ITEMS**Boom, Sheaves and Luff Cylinders**

The crane boom, rams and sheaves were disassembled. Cracking was found which has since been repaired and re-tested with no defects found.

All items have been repaired or replaced and returned to service.

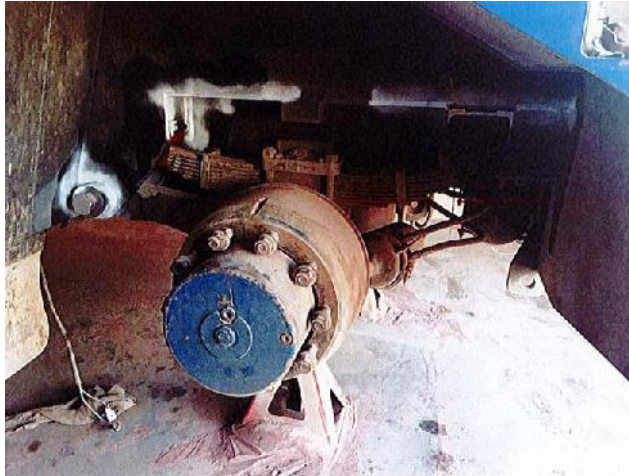
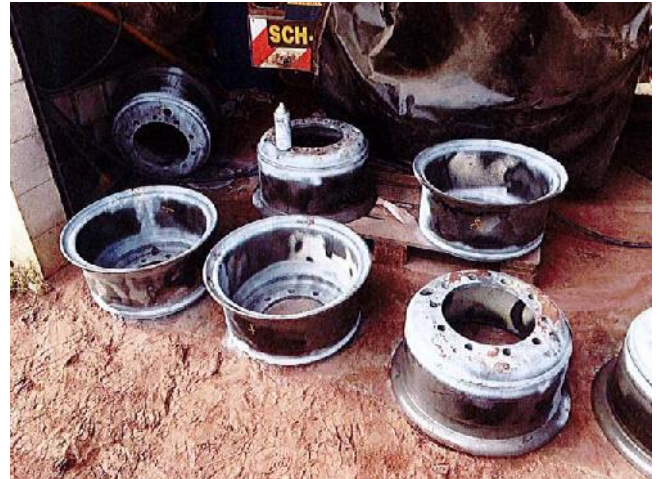
Wheels

All rims were inspected using MPI cracking was found along the weld seam on six of the eight wheels. Five of the eight rims were replaced with the remaining repaired and re-inspected.

All items have been repaired or replaced and returned to service.

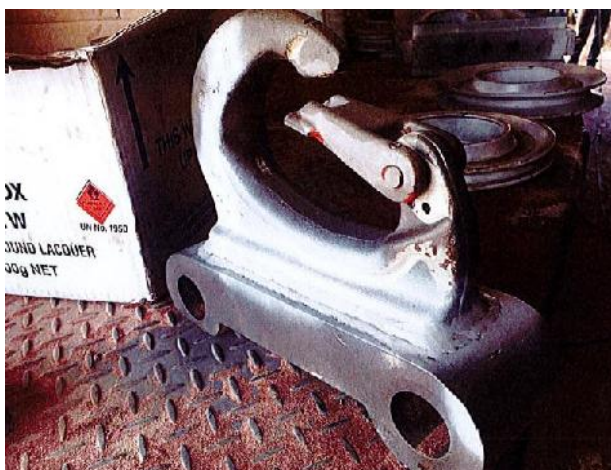
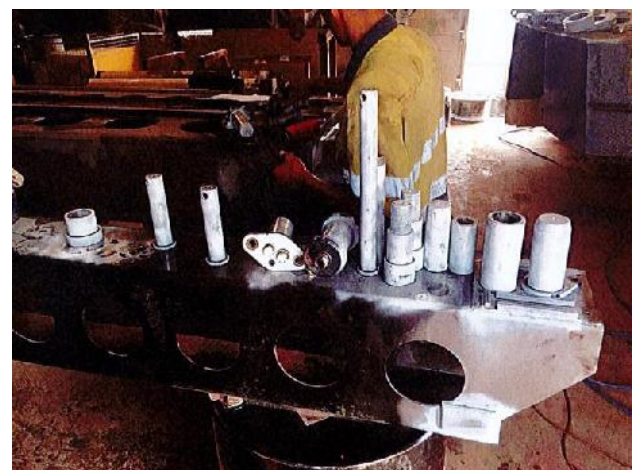
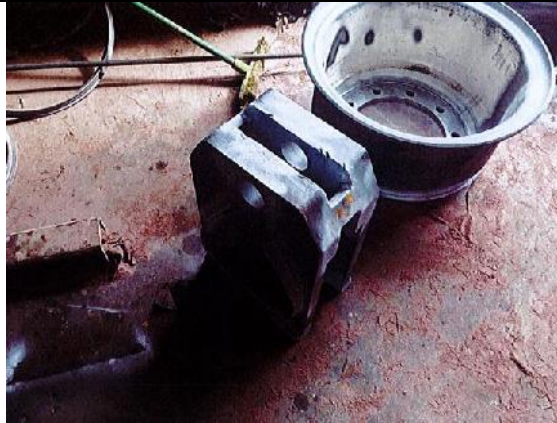
Hook and Pins

Hook and pins were examined and non-destructively tested. Cracking and porosity was found, repaired and re-tested with no further defects noted.

All items have been repaired or replaced and returned to service.

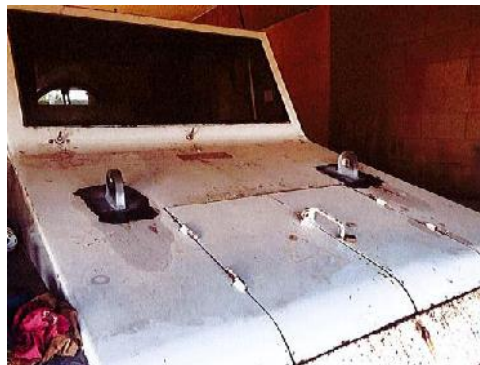
Lifting Lugs

Lifting lugs were examined using MPI no defects or cracking was found.

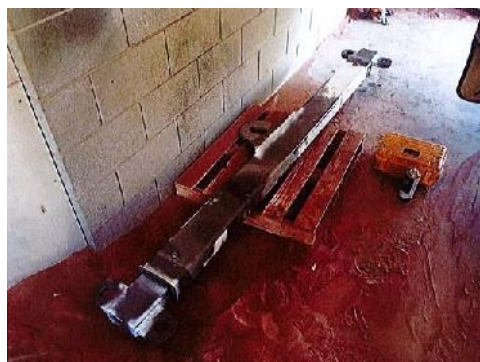
Lifting and Spreader Bar

The lifting and spreader bar was evaluated using MPI and ultrasonic inspection. No cracking or anomalies were found with an average wall thickness of 4.7 – 5.6mm found over 16 separate spot inspections.

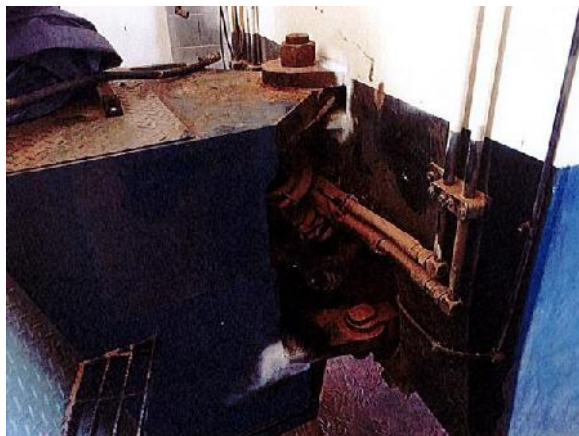
Steering Lugs

The steering lugs were disassembled and non-destructively tested. No defects were found.

Items have been deemed fit to return to service.

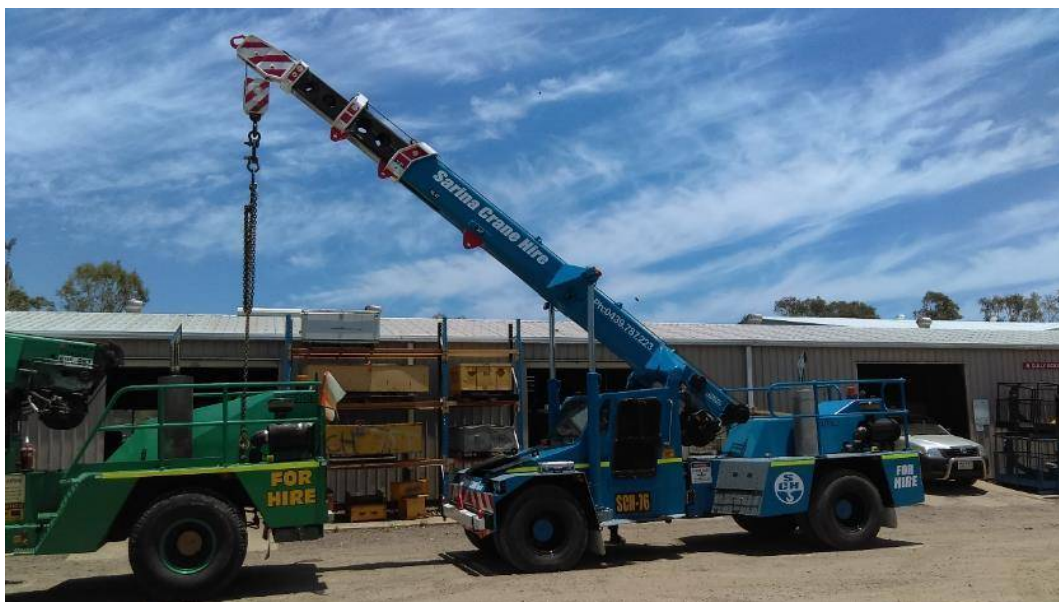
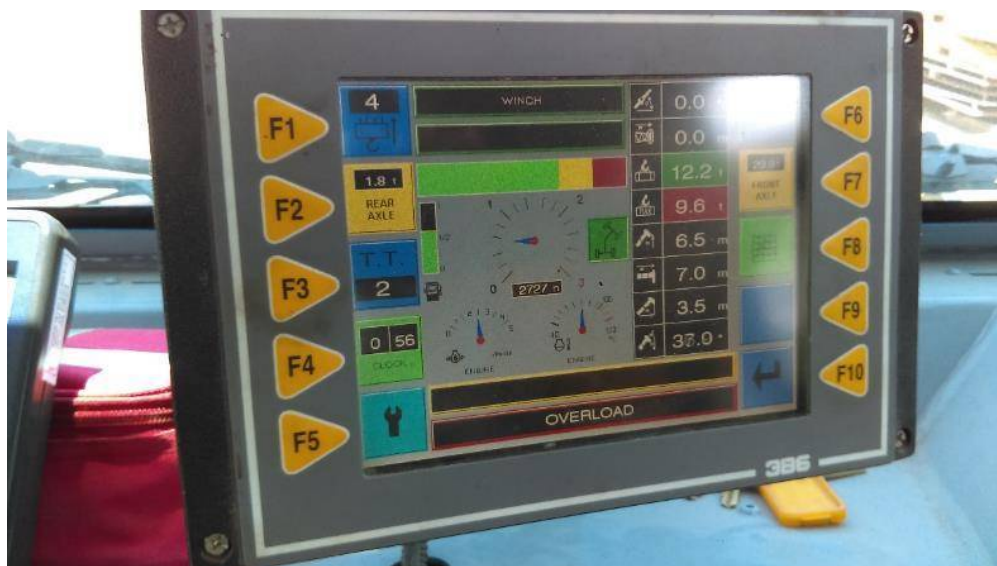
Load Testing		AS1418.5 – 2013	
Test Date	02/12/2016	Reference Document	00091-003-N001A
Test Type	Line Pull	Load Measurement Method	Calibrated Load Cell
Test Load	4604 kg	Test Status	Pass
New winch fitted for major inspection.			
Test Type	Structural	Load Measurement Method	Calibrated Load Cell
Test Load	3055 kg	Test Status	Pass
Test Type	Stability	Load Measurement Method	Calibrated Load Cell
Test Load	12 060kg	Test Status	Pass

Test Description – Structural, stability and line pull tests utilized a load cell to measure a non-suspended load.
 Load testing was observed by FIELD Engineers on the 02/12/2016.
