Field Inspection Report

Date: May 13, 2025 File Number: VNDT-1050

Inspection Location: Tharrow Crane Shop Inspection of: Ferrari Articulating Crane

Serial Number: 96058

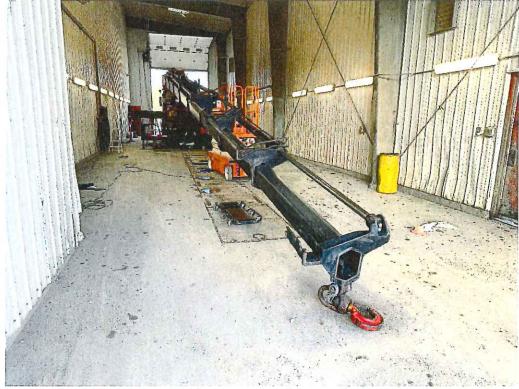
Figure 1. Articulating crane at the time of inspection.
