Paver and Screed Wear Part Inspection

Inspection Number	27227529	Customer No	2969536482
Serial Number	GNZ00375	Customer Name	TWIN CITY CONSTRUCTION SERVICES INC
Make	CATERPILLAR	Completed On	2026-02-10 3:15:19 PM
Model	AP655D	Inspector	Ashley Taylor
Equipment Family	Large Asphalt Paver	PDF Generated On	2026-02-10
Asset ID	GNZ00375	SMU	3649 Hours
Location	25846 115 Ave, Parkland County, AB	Coordinates	688.421187970944, -53.5659674881493, -113.756096445169

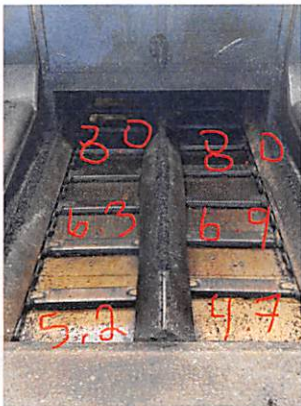
2.1 Feeder Bed Plates

0-49% WORN

Comments: RH = 8.0+6.3+5.2
LH = 8.0+6.9+4.7
Average = 6.5

65 millimeters

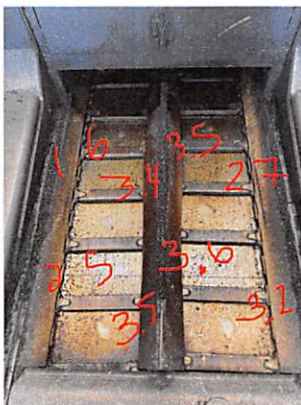
2.2 Feeder Chain Guards

>50% WORN

Comments: RH=1.6+2.5+3.4+3.5
LH=3.5+3.6+3.2+2.7
Average =3

3 millimeter

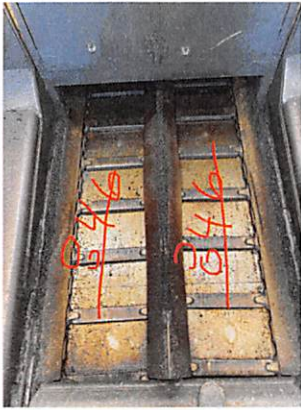
2.3 Feeder Chain

0-49% WORN

846 millimeters

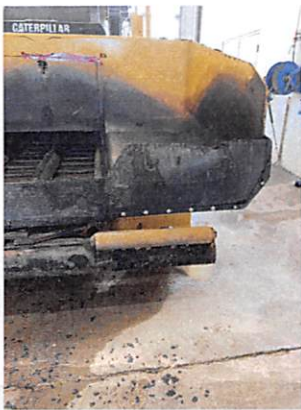
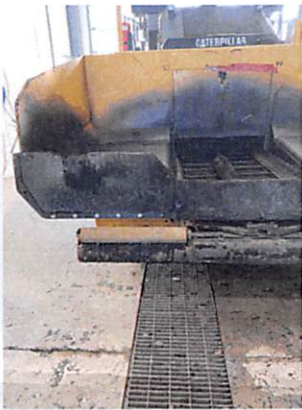
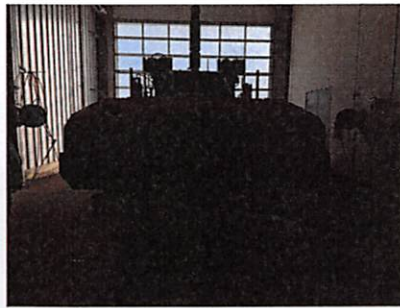
● 2.4 Push Roller / Truck Hitch

NORMAL

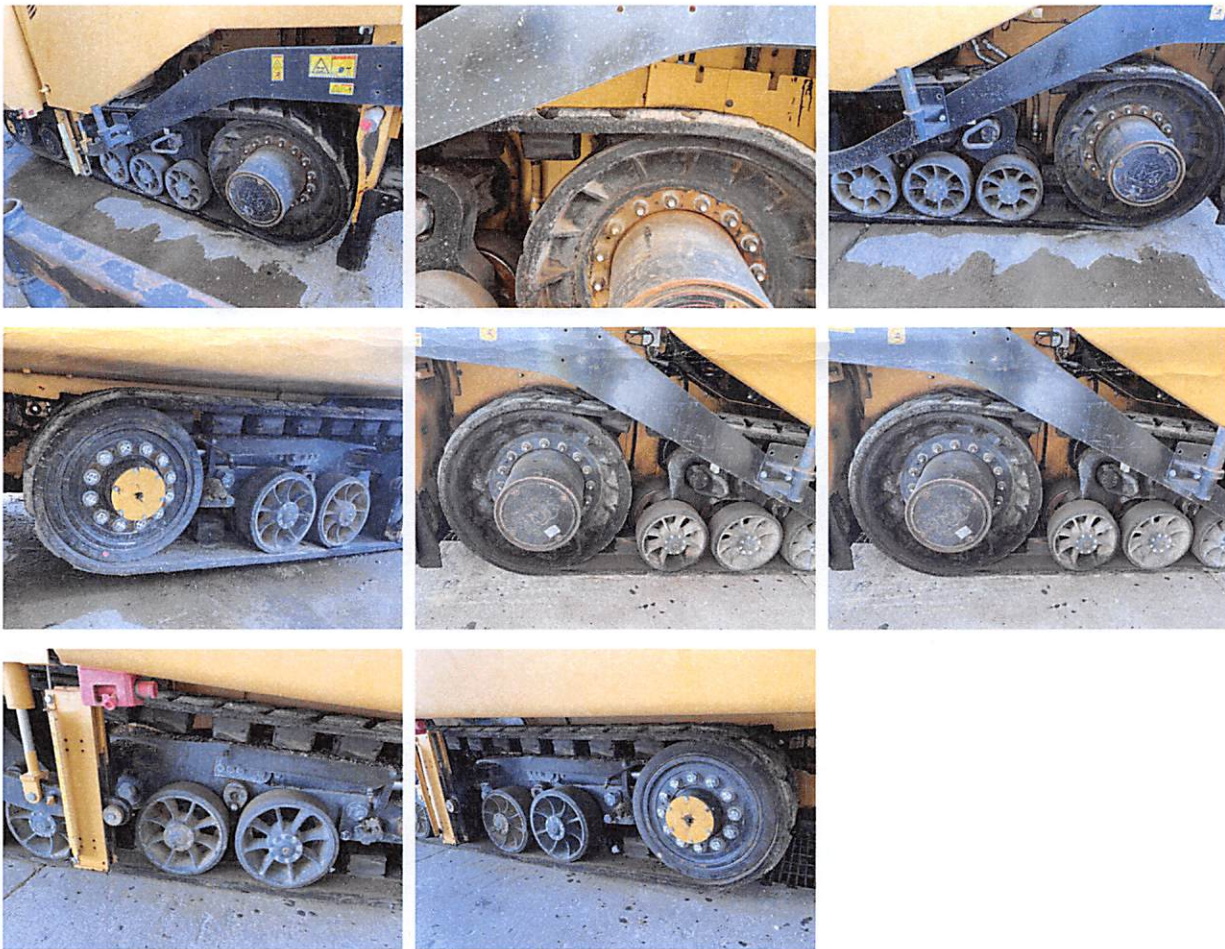
● **2.6 MTS Belts**

0-49% WORN

Comments: LH=53+53+51+52
RH=51+51+48+48

50.8 millimeters

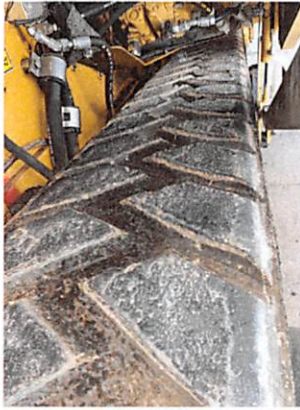
Image Comment(s):RH

NORMAL

Comments: Tread looks good, no visible cracks or bulges

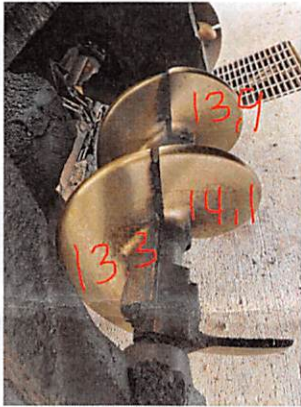
Image Comment(s):LH

0-49% WORN

Comments: LH=13.3+13.9+14.1
RH=13.3+13.1+14.5

13.7 millimeters

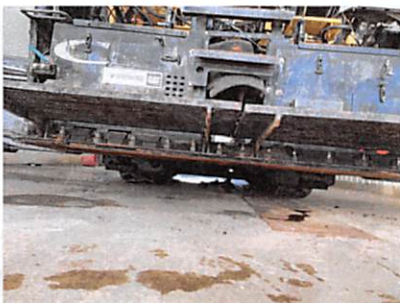
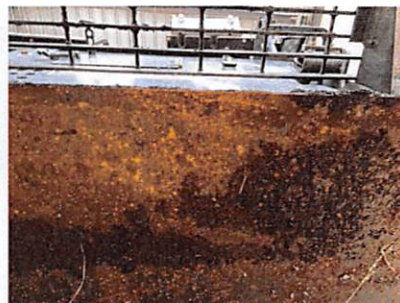
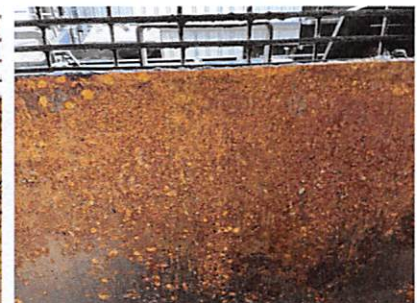
● 3.1 Screed Plates

0-49% WORN

Comments: Across plate LH to RH:
12.3, 12.2, 12.2, 12.1, 11.9, 11.7

12.0 millimeters

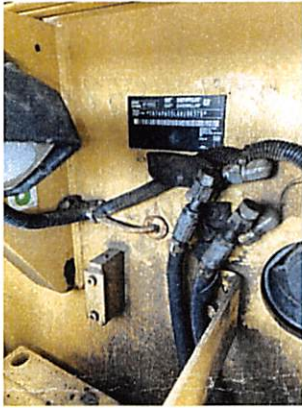
4.1 Take photo of SMU

Comments: Confirmed hour meter reading
