CEA Service Job Sheet - QLD

No.
00251

Complaint 1 Fault
Inspection on JCB 540-70

Carried out pre-purchase inspection as per JCB sheet

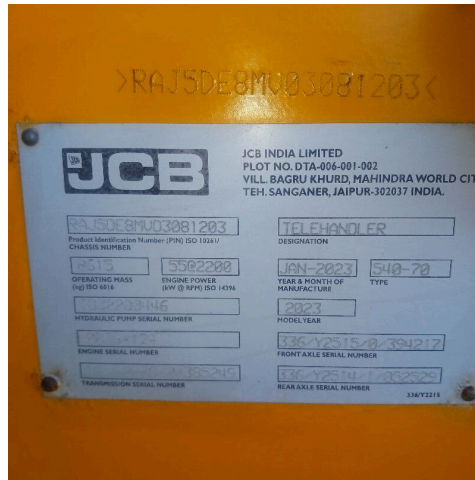
Machine Serial Number Photo

Machine Serial Number
3081203

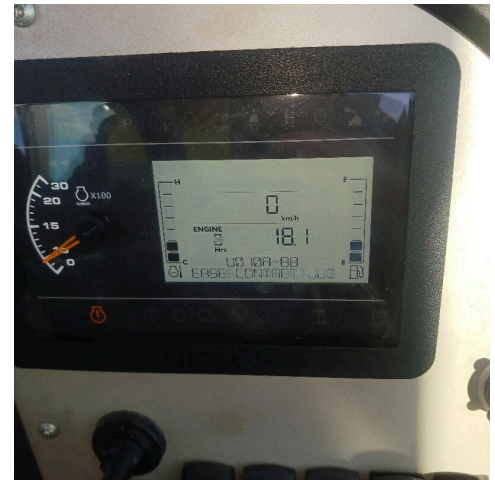
Machine Hours Photo

Machine Hours
18

Customer asked to check if hours is correct, hours seems to be correct

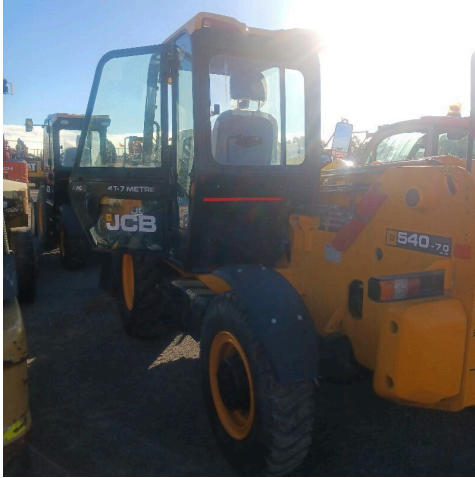
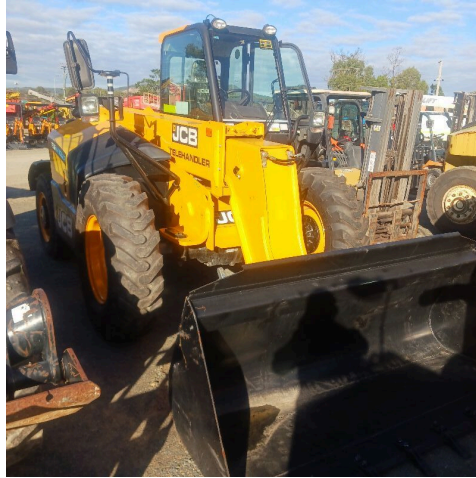
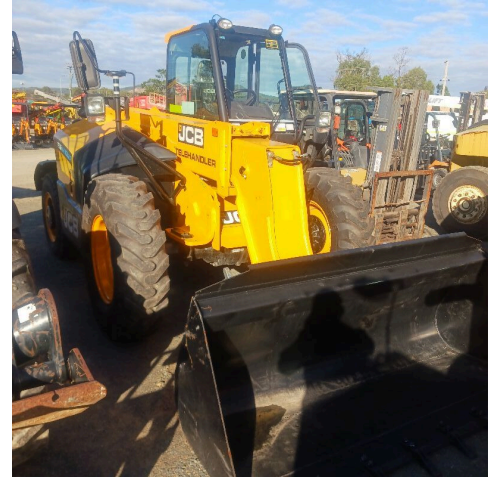
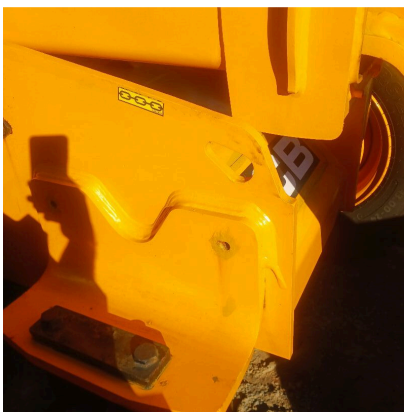
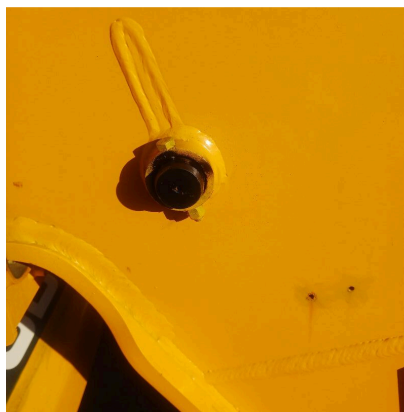
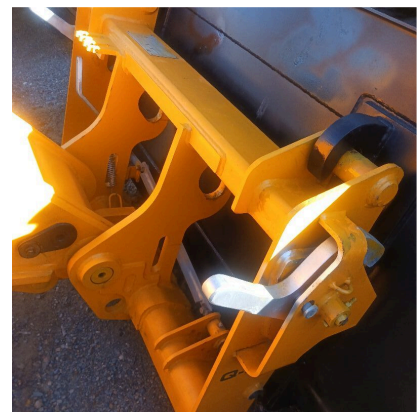
Faults found on inspection:

Rust on the whole machine

Boom has a lot off Rust on welds

Paint correction on machine has been poorly done, oversprayed and mismatch of colours

Door strap too short, door only opens halfway.

LH top mirror and bracket have broken off

Rear working lights are missing

Rear window latch is broken

Bottom engine cover is missing

Tilt cylinder has rust on rod

Load charts are damaged and missing

Front wiper blade needs replacement

Wiper motor is faulty

Hazard lights are not working

Rear door hinges are rusted, door is not moving

Reverse alarm is not working

Boom extension numbers have come off

Boom lift cylinder has rust on rod
Transmission has been over filled
Error code for live link
Error codes for engine EGR unit and can error
Took hydraulic pressure all in specifications
Engine runs good
Transmission works ok
Brake and park brake works
