Condition and Valuation Survey Report

Raman I Ramp Barge

Accurate Appraisals & Marine Surveys Ltd.
735 Cherry Point Road
Cobble Hill, BC
V0R 1L3

February 25, 2021

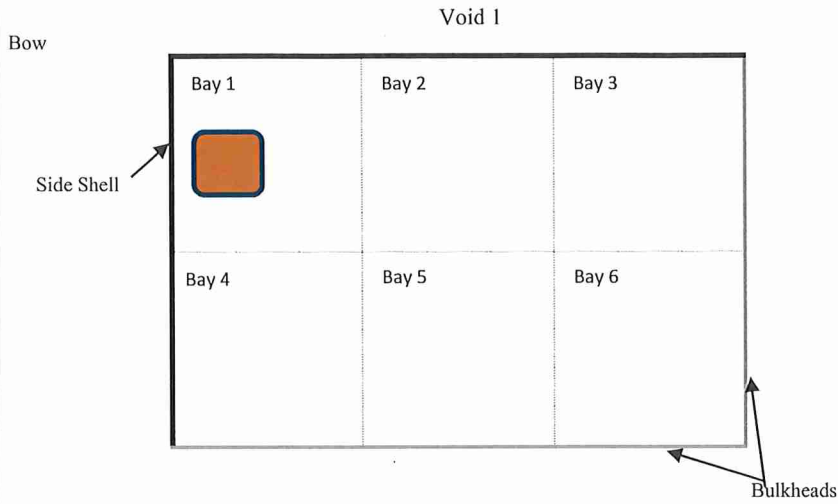
- 2021 repair to side shell corner; welded at bow rake with all new material
- 1/2" steel

- Good condition
- 4" hole between Void 1 and 5 is capped at 2' mark on hull

- Repair to hull and side shell at bow rake with 1/2" steel plate

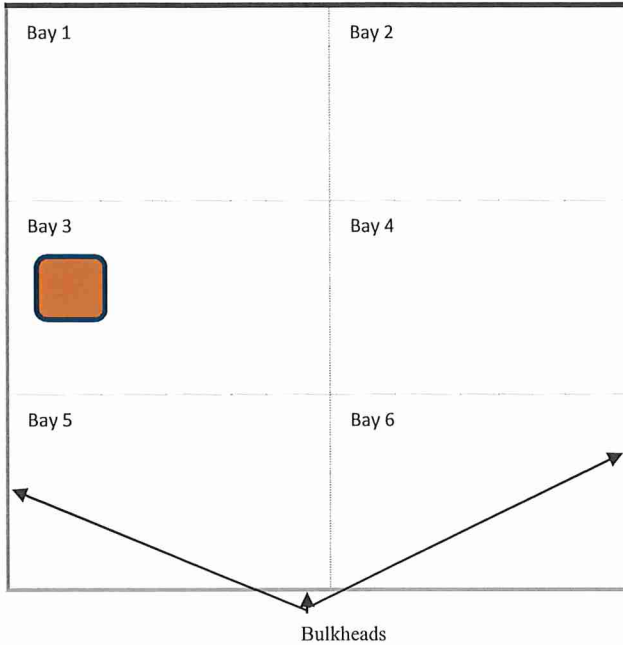
Void 3

- New in February 2021
- 24" x 24" flush mount
- 8 bolts with sealant

- Good condition

- Rake on hull has bilge blocking
- Good condition

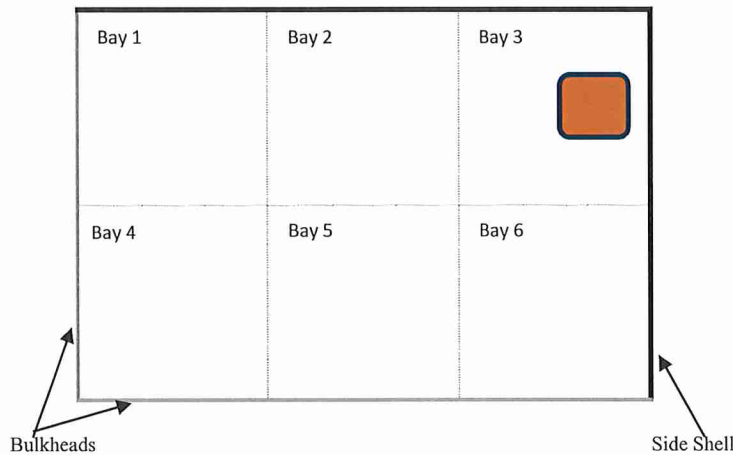
Void 4

- Repair to side shell corner welded at bow rake with all new material
- 1/2" steel

- Good condition

- Repair to hull and side shell at bow rake with 1/2" steel plate

- Voids are water-tight

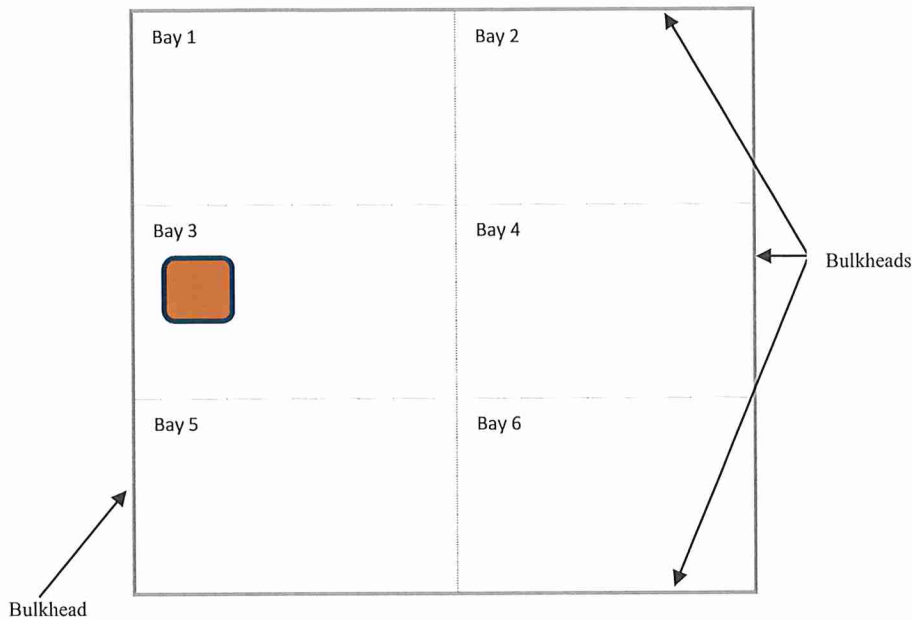
Void 7

- Good condition
- Old bolt bins on wall
- Electrical & hydraulic conduits through top of bulkheads - wires & hoses removed
- Access from Bay 7 to Void 11

- Good condition

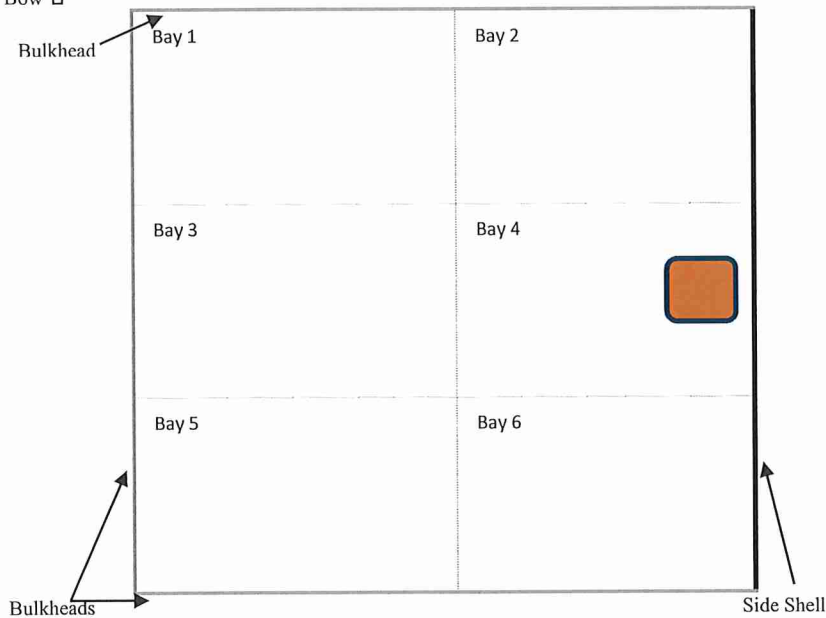
- Void 8 viewed from hatch opening only. Welders were installing hatch.

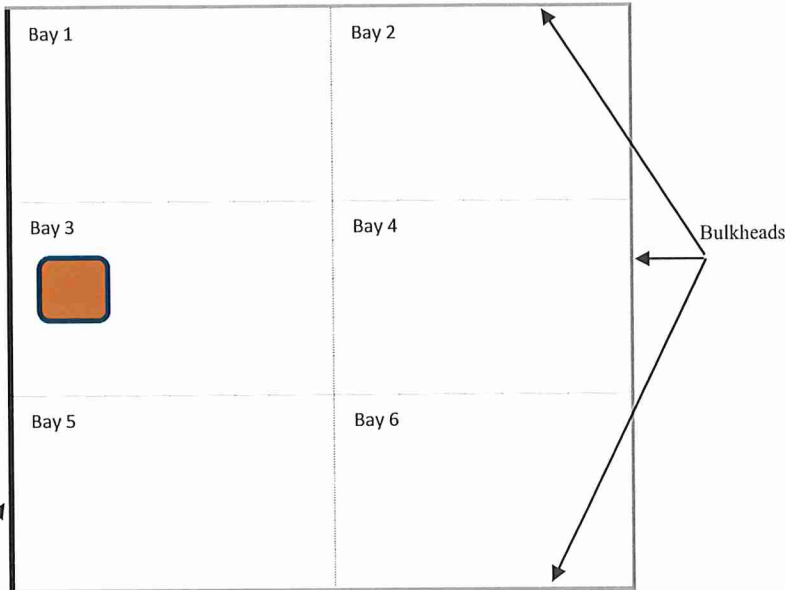
Void 9

- Good condition
- **1/2" mud on hull plating

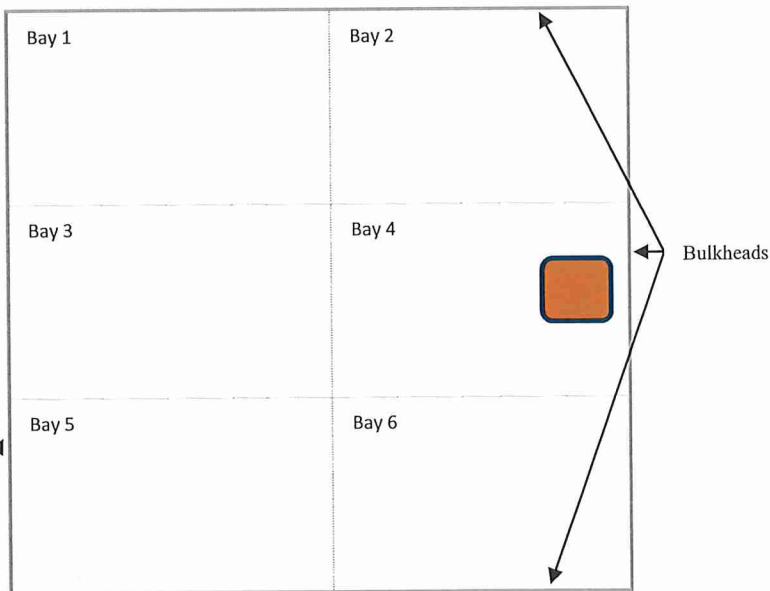
Void 10

- Moderate set over Bay 6 between B-LF and bulkhead
- Electrical & hydraulic conduits through top of bulkheads - wires & hoses removed

- Moderate set-up in Bay 6

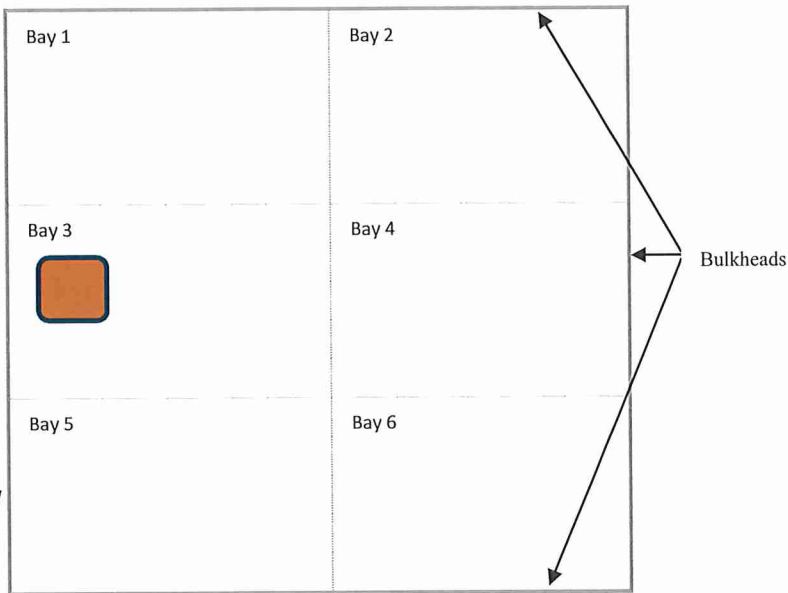
- Good condition
- Electrical & hydraulic conduits through top of bulkheads - wires & hoses removed
- Three steel tanks sealed off and fillers welded closed on deck - not used
- Access from Bay 7 to Void 11

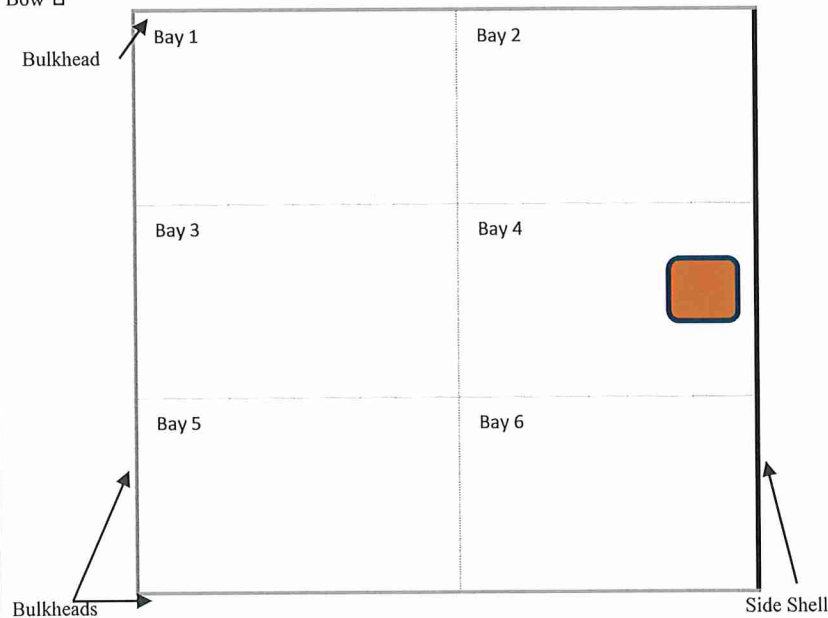
Void 12

- Moderate set-up in Bay 3
- B-LF in good condition

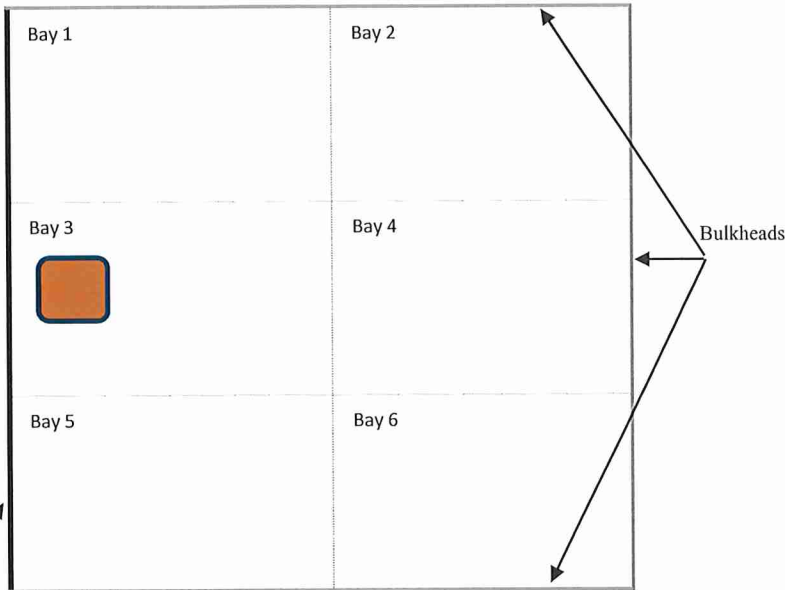
Void 13

- Good condition
- **1" mud on hull plating

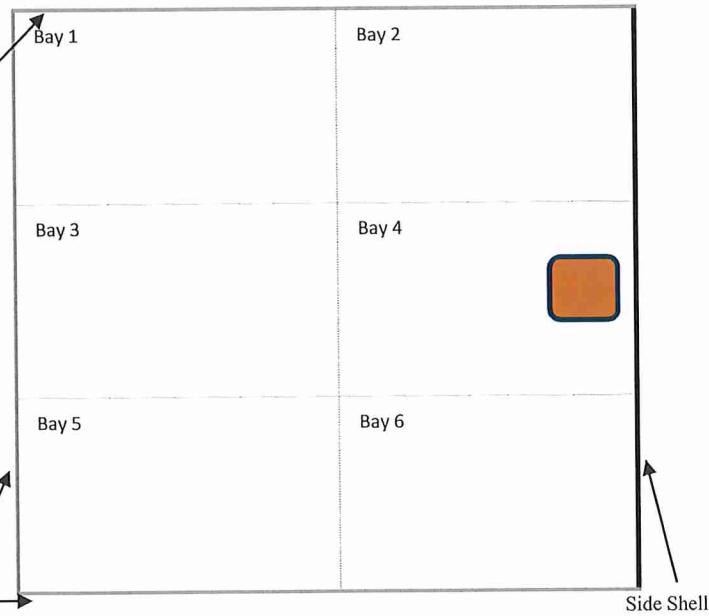
Void 16

Void not viewed.

Hatch was being installed by welders.

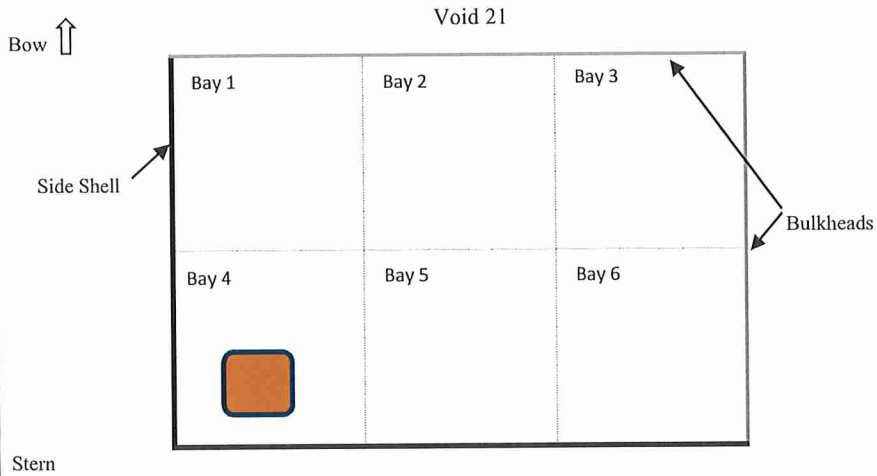
- Repair to side shell corner welded at bow rake with all new 1/2" steel plate

- Repair to hull and side shell at bow rake with 1/2" steel plate
