Condition & Valuation Survey Report

Alaska Plaza – Deck Barge

Renamed and registered
as Ramrap (April 2024)

Re: Survey of Alaska Plaza

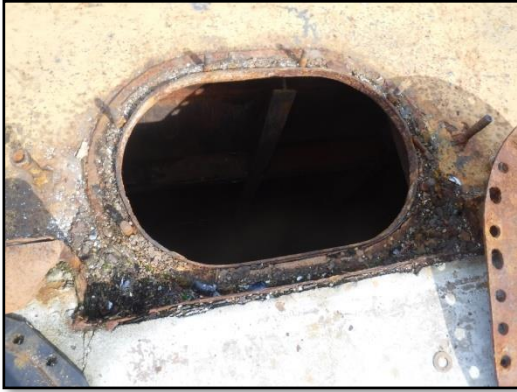
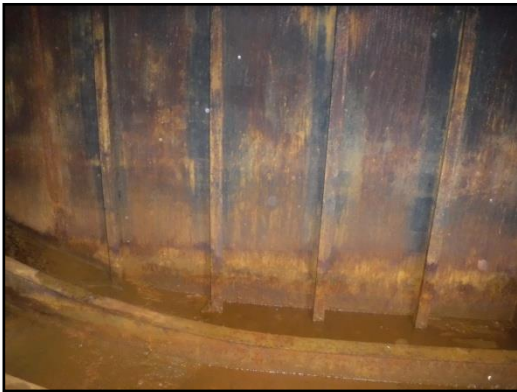
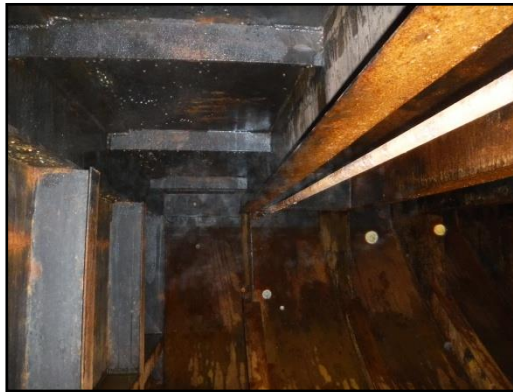
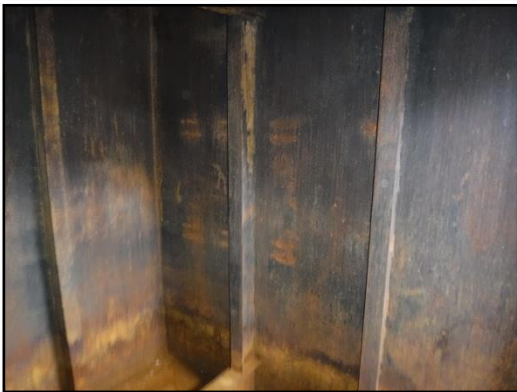
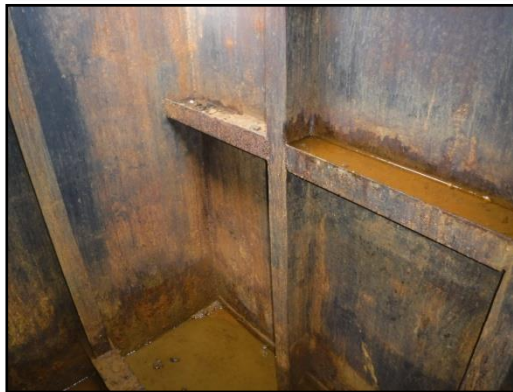
Port Bow Rake

- Deck ~40%
- Side shells ~40%
- Bulkheads ~40%
- Hull ~40%

- Good condition

- Frames in good condition

- Work done - good condition

- 2" water

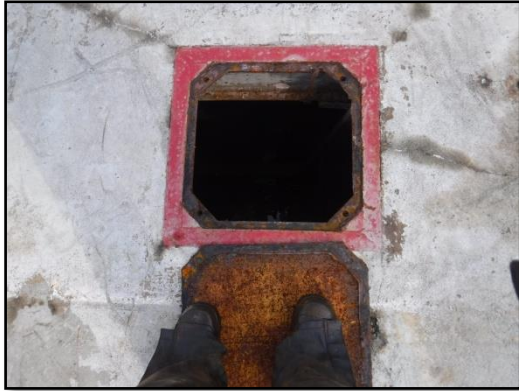
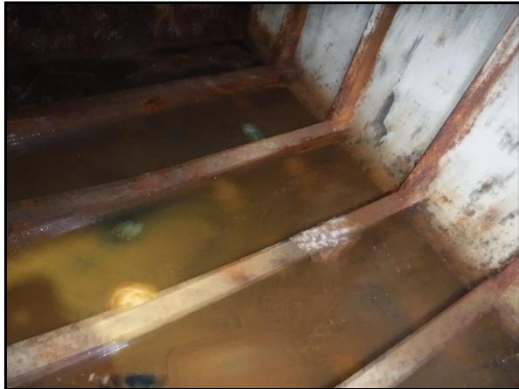
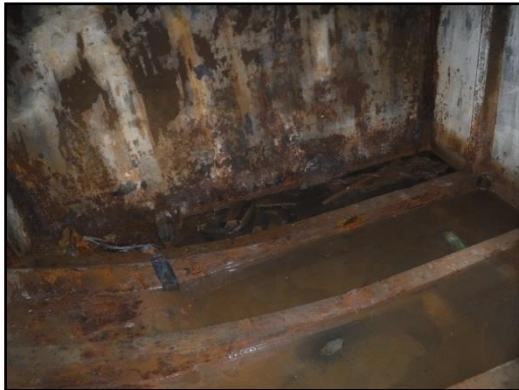
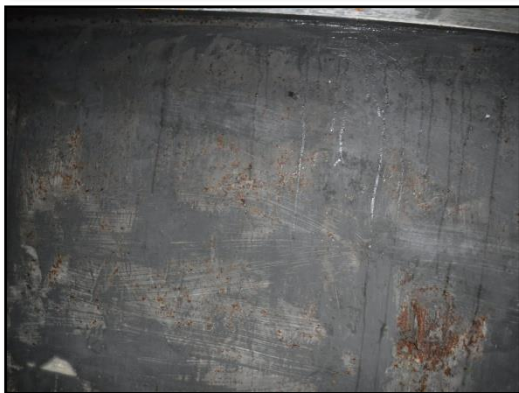
Centre Bow Rake

- Deck ~80%
- Side shells ~50%
- Bulkheads ~40%
- Hull ~40%

- Good condition

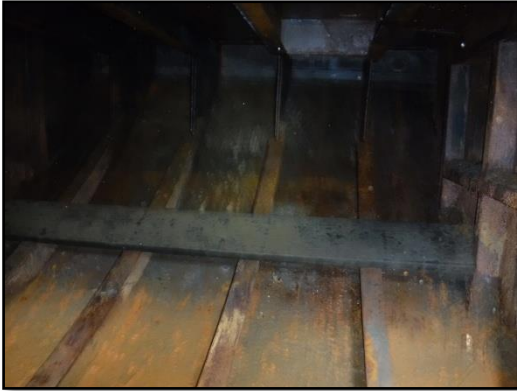
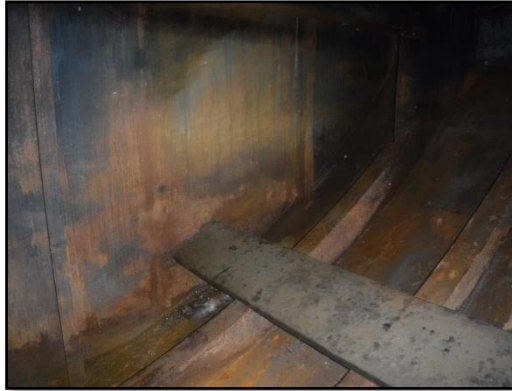
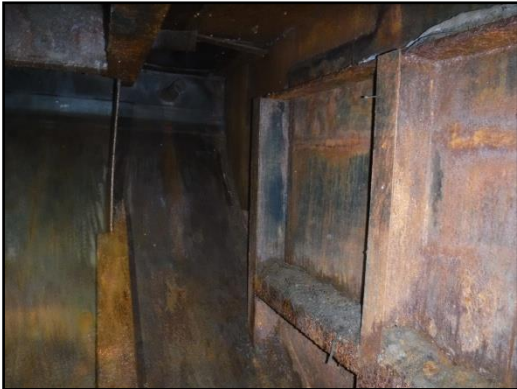
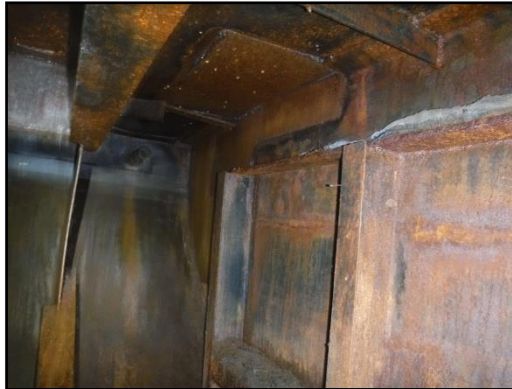
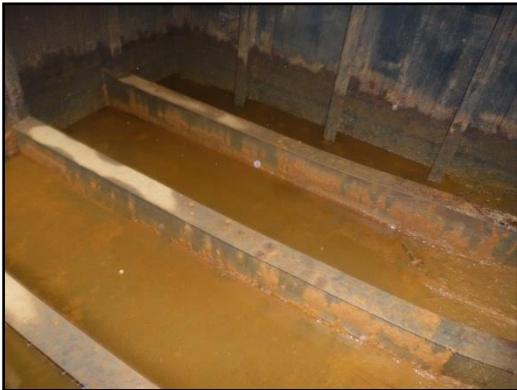
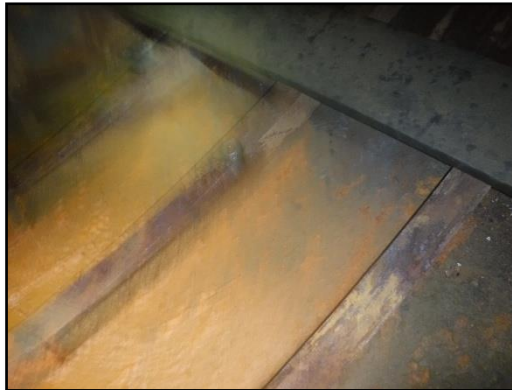
Starboard Bow Rake

- Deck ~80%
- Side shells ~40%
- Bulkheads ~20%
- Hull ~30%

- D-TF light set-over

- SS-LF light set-in

- Fair condition
- Moderate rust

- Fair condition

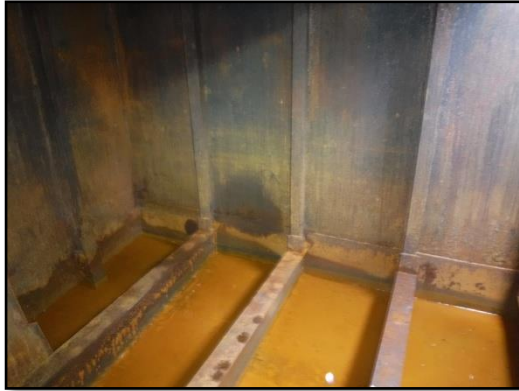
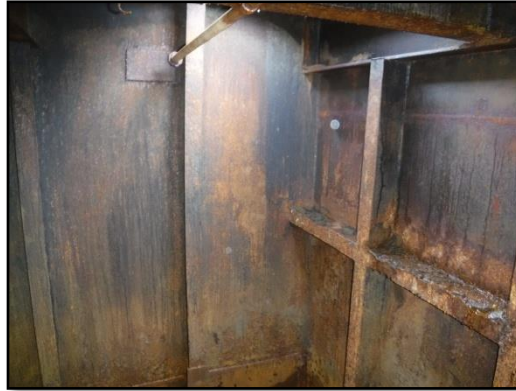
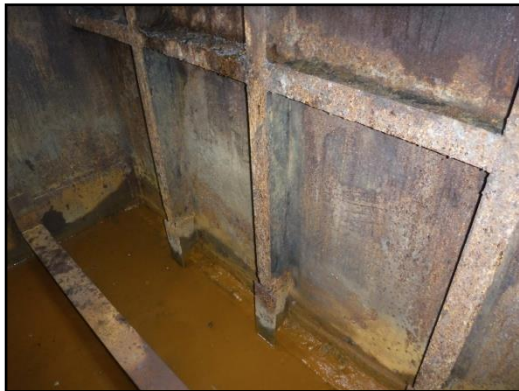
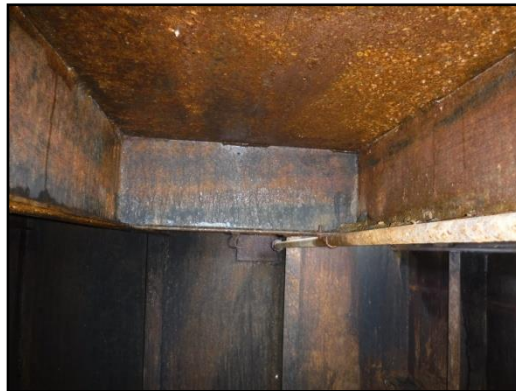
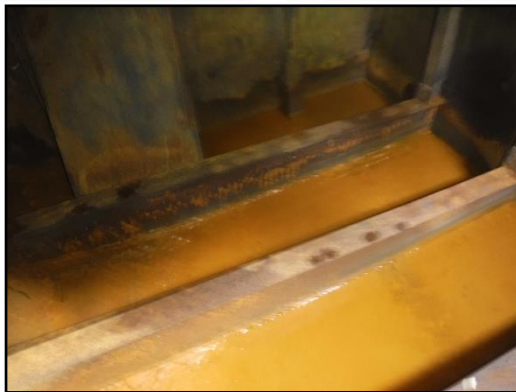
Port 1

- Deck ~40%
- Side shells ~40%
- Bulkheads ~30%
- Hull ~10%

- 1" water

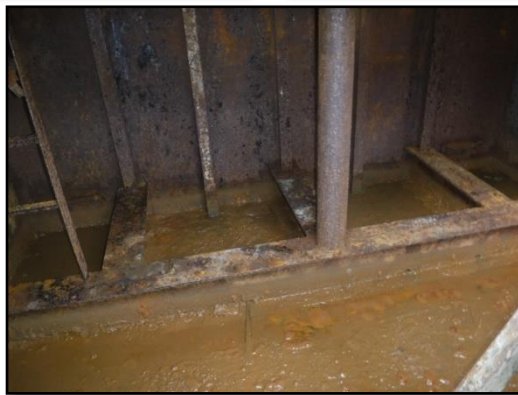
Centre 1

- Fair condition

- D-TF light set-in

- Welded patch from old piping from decommissioned fuel tank

- Light set-in

- 1.5" water

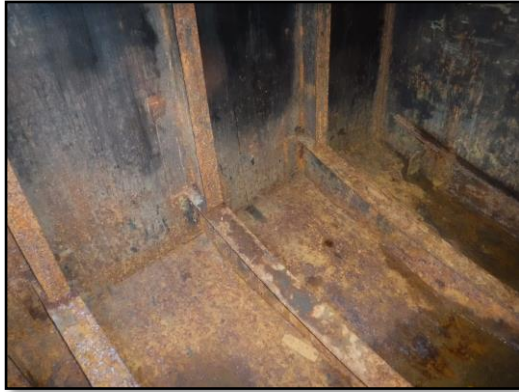
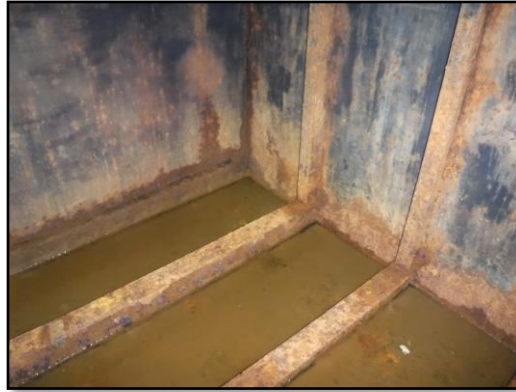
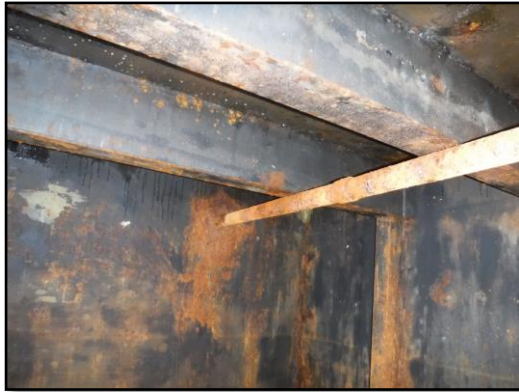
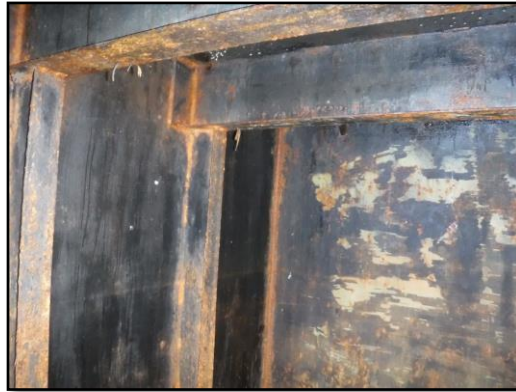
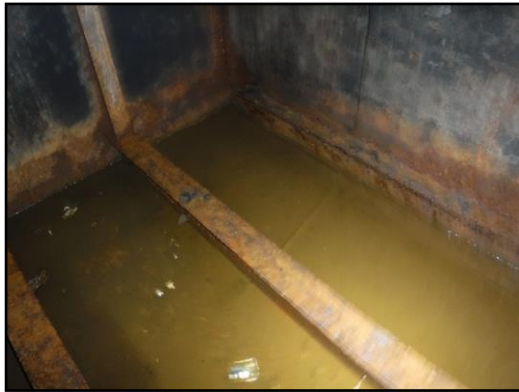
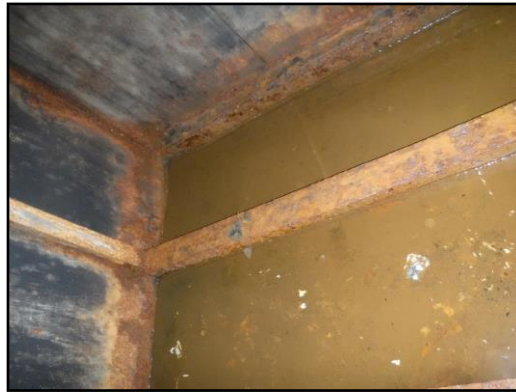
Starboard 1

- Fair condition

- B-LF light set-in

- ~1" water

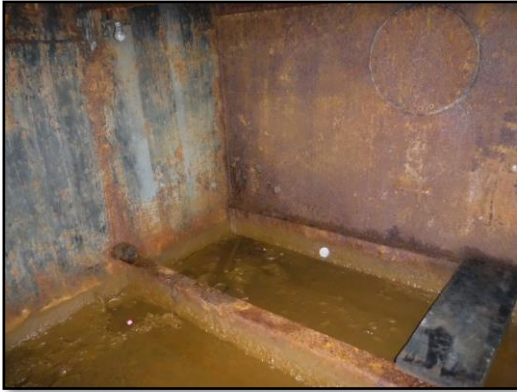
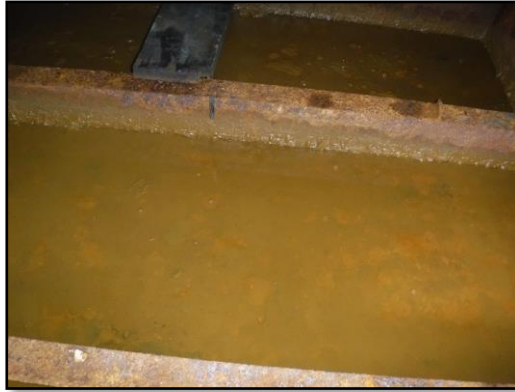
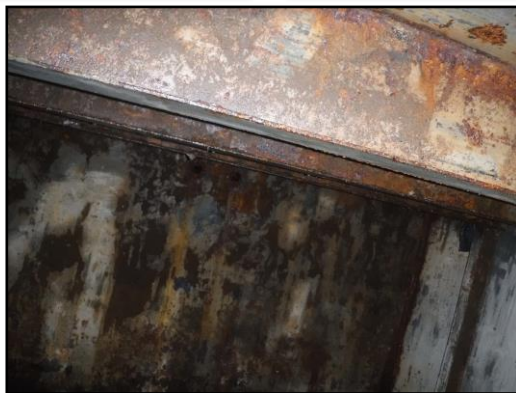
Port 2

- 24" x 20" flush
- 21" x 13" opening – bar restricts entry access
- **Bolt-down with gasket

- Fair condition

- B-LF light set-up at port stern

- Conduit holes in bulkhead
- ~1" water

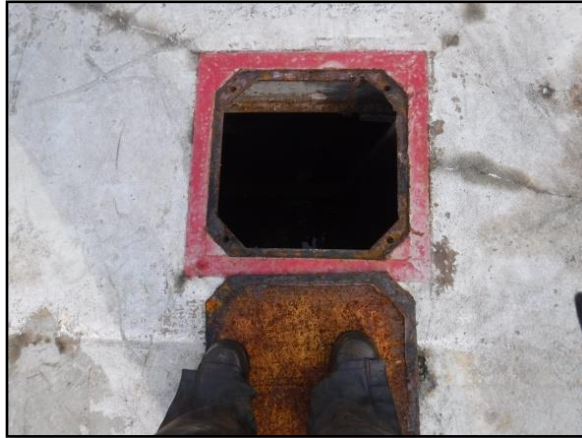
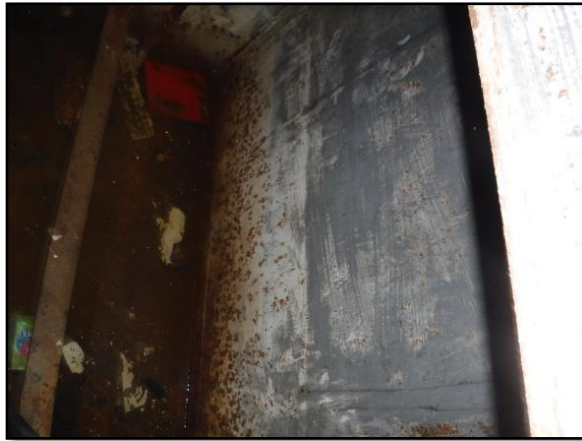
Centre 2

- Wood ladder missing all rungs - **poor condition

- D-TF light set-in

- B-LF light set-up

- 3" water
- Not entered – ladder in poor condition

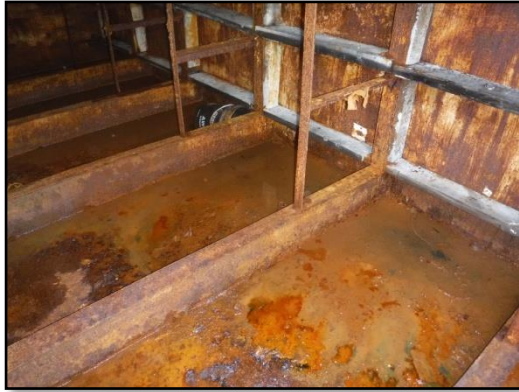
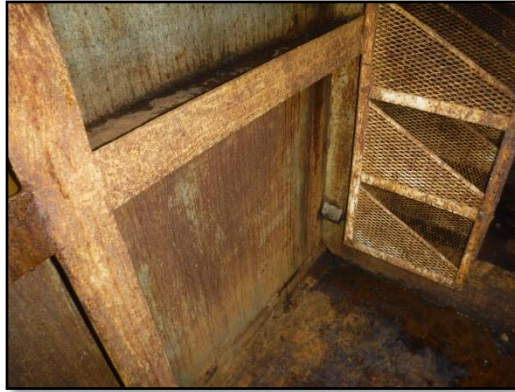
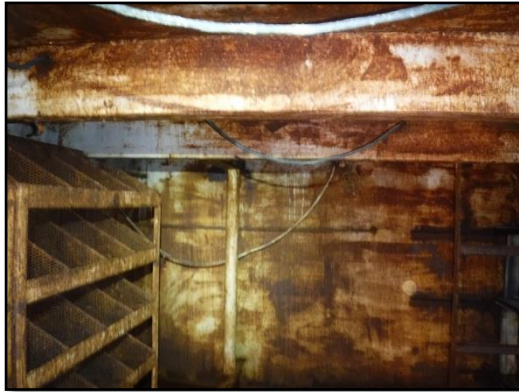
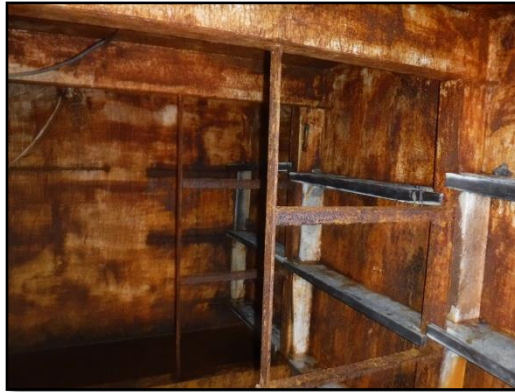
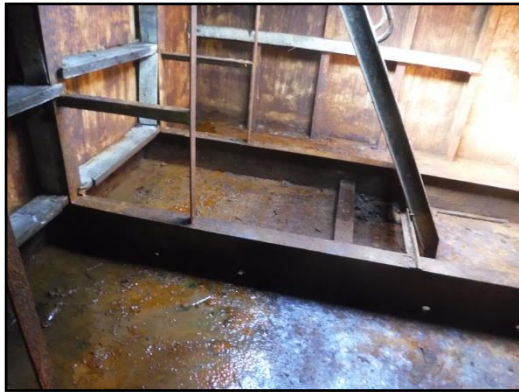
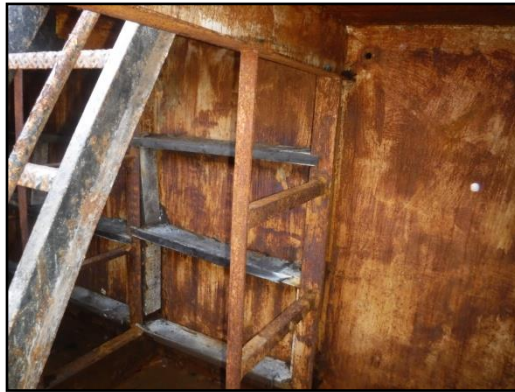
Starboard 2

- SS-LF light set-in

- B-LF light set-up

- Old shelving in void

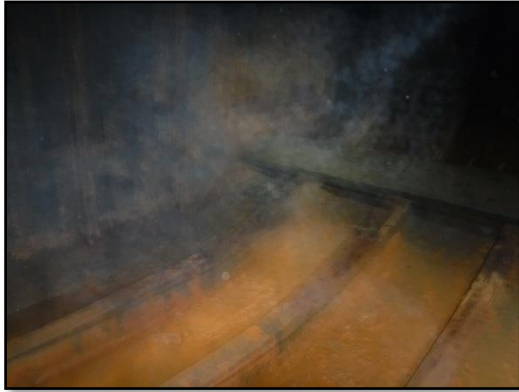
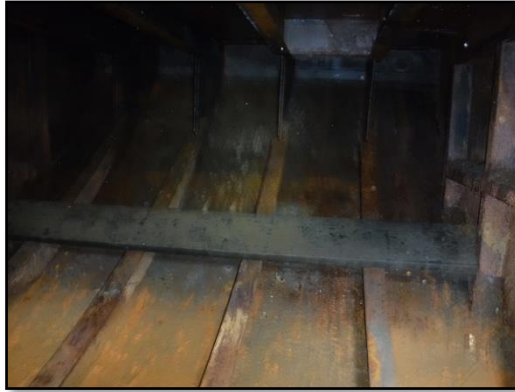
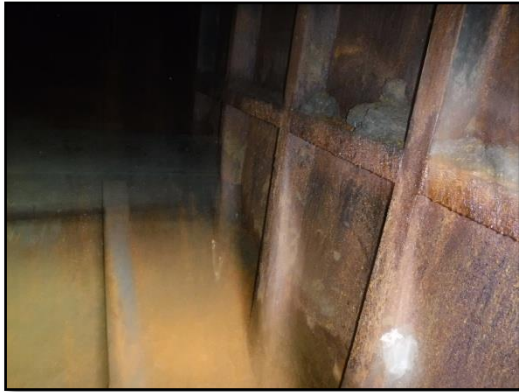
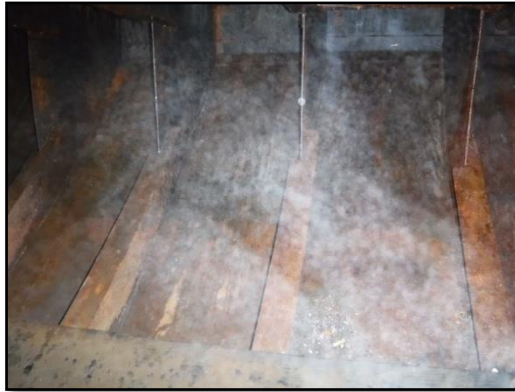
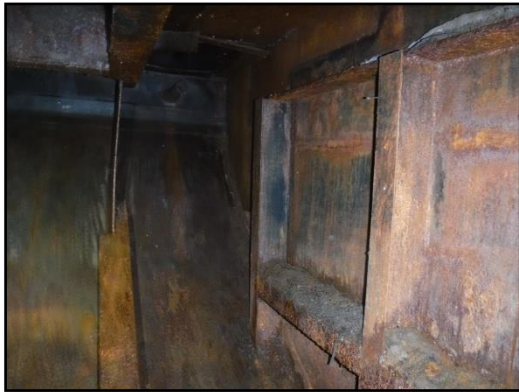
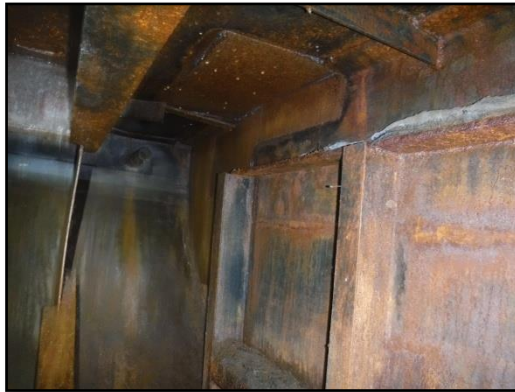
Port Stern

- D-TF light set-in

- Fair condition
- ~10% wasted

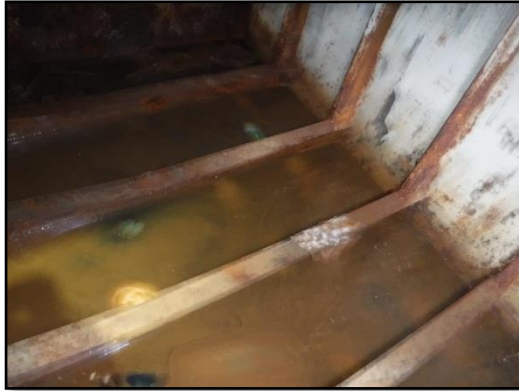
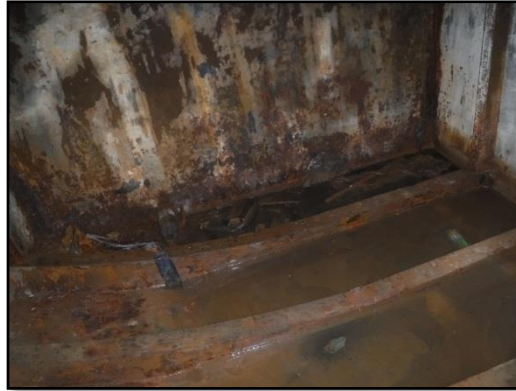
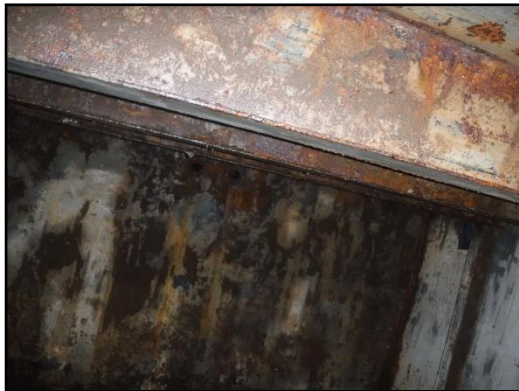
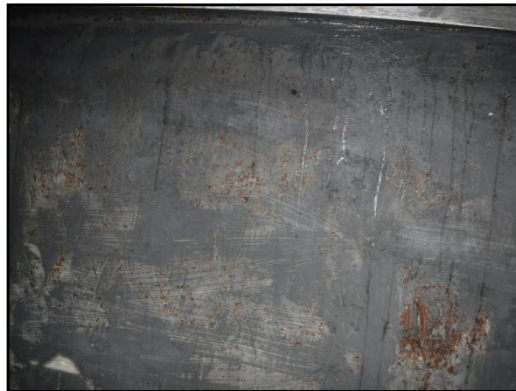
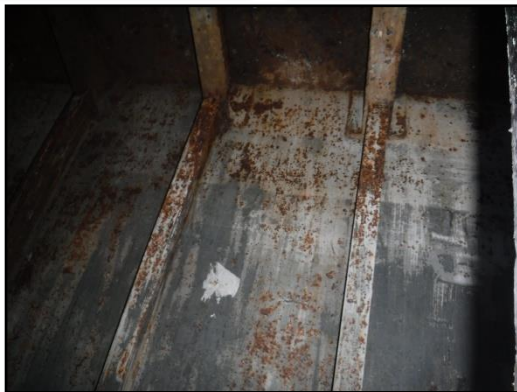
Centre Stern

- Deck ~40%
- Bulkheads ~40%
- Hull ~10%

- ~2" water

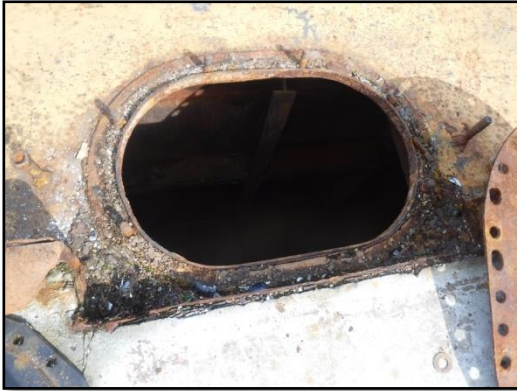
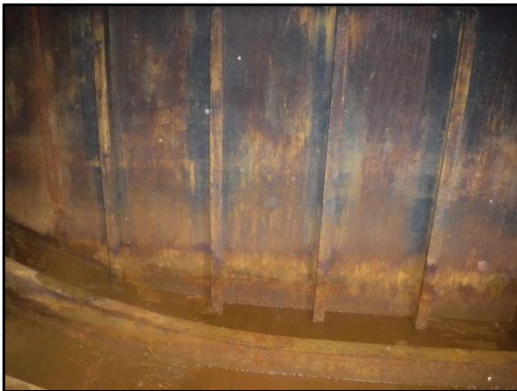
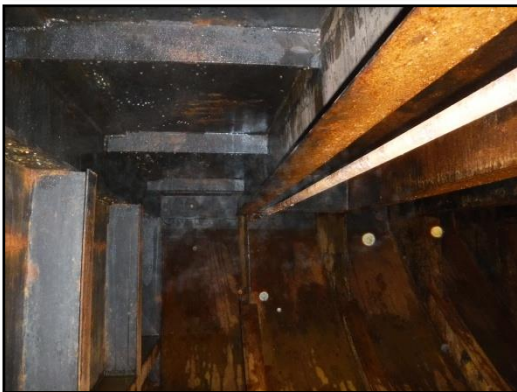
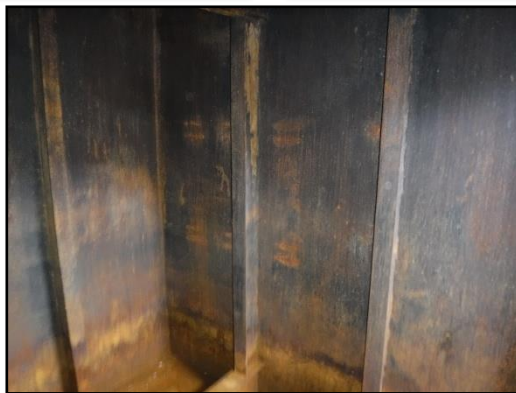
Starboard Stern

- Fair condition

- ~2" water
