Survey Report

*JB McCarron
(Seaspan 156)*

Accommodation & Helicopter Service Barge

Re: Survey of Accommodation & Helicopter Service Barge

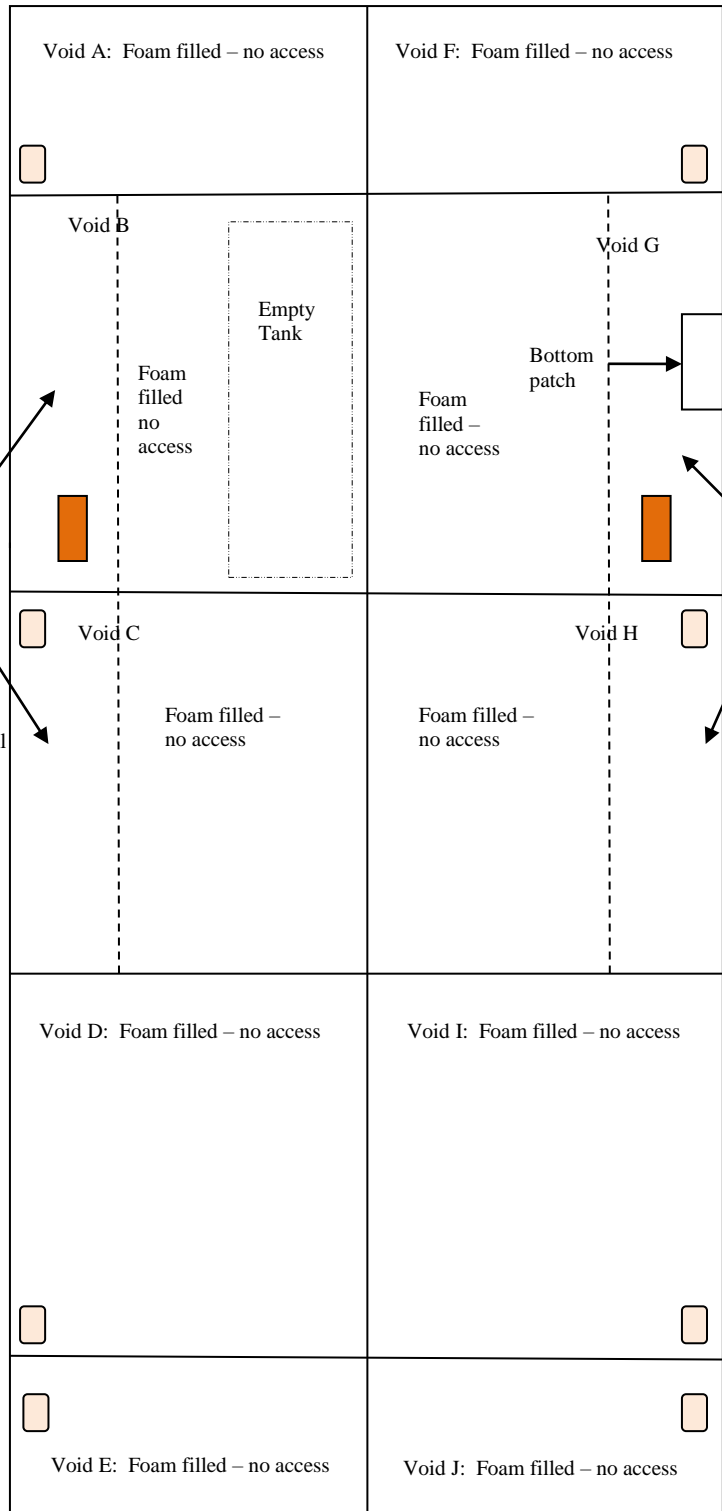
Hull Voids

- In my opinion, the camp and helicopter facilities are in good condition. The hull was in fair condition at the time of the inspection.
- Water levels appeared consistent throughout Voids with sea level – it is assumed there is a leak in the hull.

7 anodes bolted on exterior length of hull

~2' space between foam & side shell

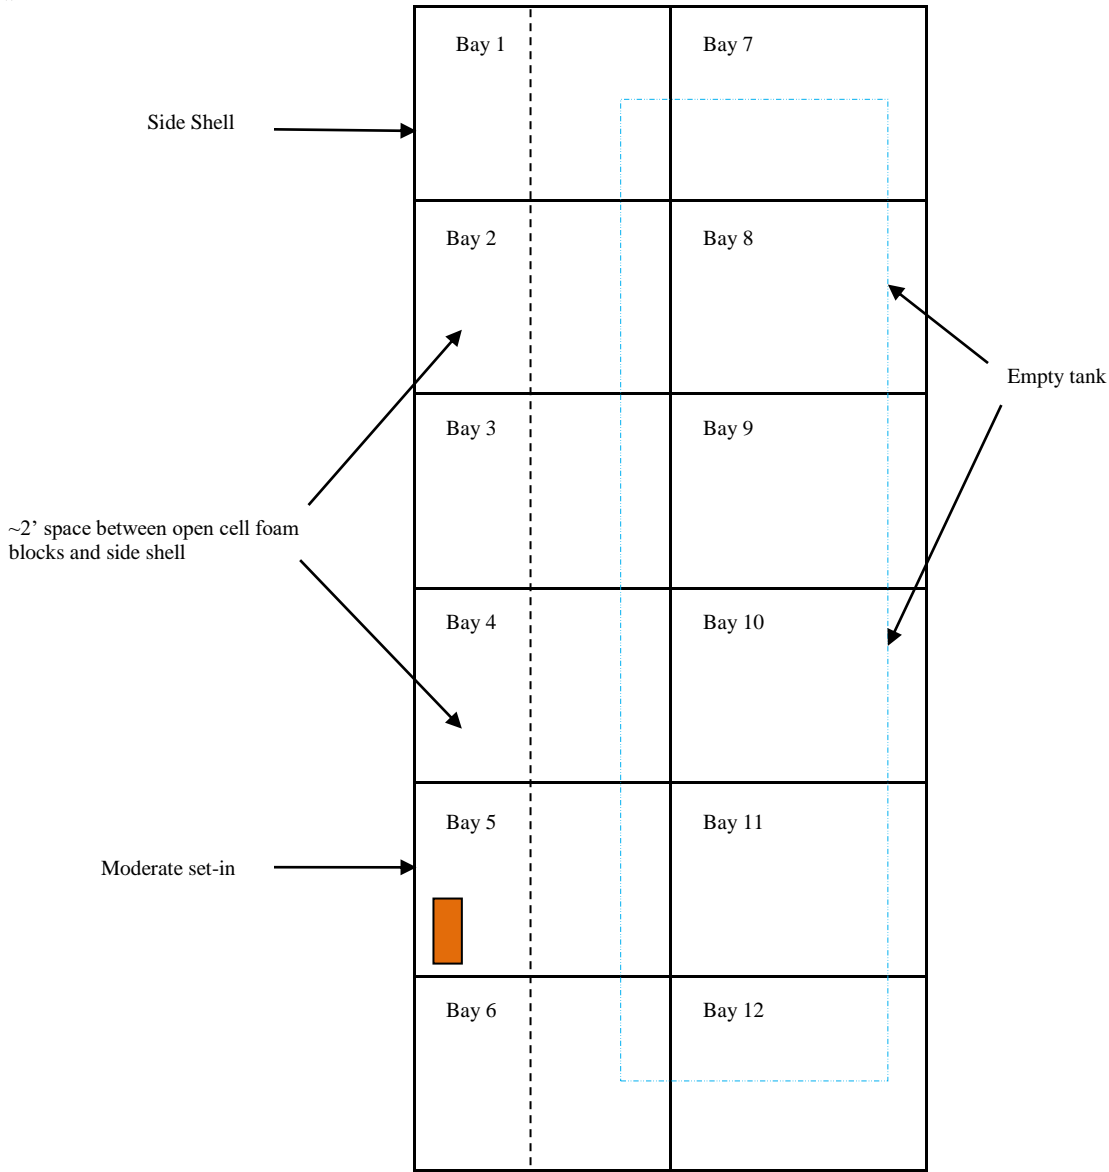
- Void entered down hatch to water level
- Open cell foam blocks installed in all Bays with ~2' space between side shell and foam blocks. Reported to surveyor that 38,000 L tank was empty and left in place when foam blocks installed
- Visible paint coating @ ~30%
- Reported four Z13 zincs installed on interior of hull

- Reported that recommendations in 2017 report have been completed

Coating	Unable to view
Deck	Unable to view
Bulkhead	Unable to view
Floor	Unable to view
Notes	Unable to enter Void
Void B	
Void Access	24" x 60" hatch /w stairs in good condition Steel cover, no coaming, bolted down with 4 wing nuts
Coating	~30%; visible section of side shell showing signs of heavy corrosion
Deck	Unable to view
Bulkhead	Unable to view
Floor	Unable to view
Notes	Void entered down hatch to water level Open cell foam blocks installed in all Bays with ~2' space between side shell and foam 38,000 L tank reported empty and left in Void at time of foam installation

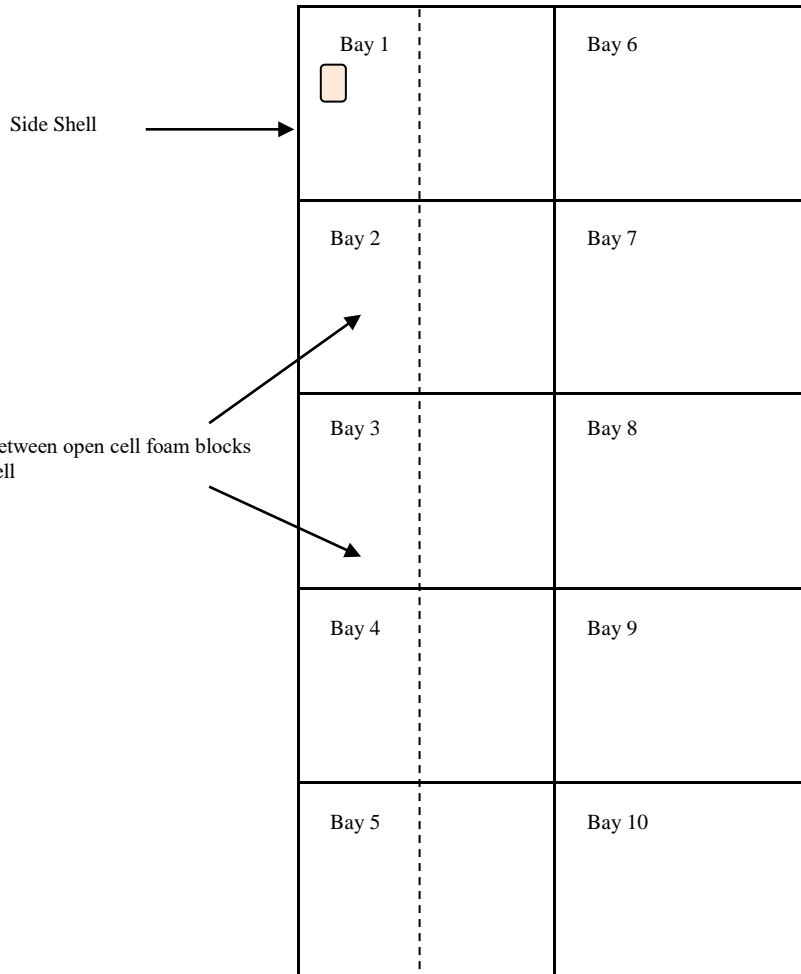
- Void not entered
- Open cell foam blocks installed in all Bays with ~2' space between side shell and foam blocks
- Reported four Z13 zincs installed on interior of hull

- Reported that recommendations in 2017 report have been completed

Barge Description (cont.)	
Voids (cont.)	
Void C	
Void Access	21" x 11" manhole in good condition 3" coaming, gasket, stainless bolts, cover – in good condition
Coating	Unable to view
Deck	Unable to view
Bulkhead	Unable to view
Floor	Unable to view
Notes	Unable to enter Void Open cell foam blocks installed in all Bays with ~2' space between side shell and foam
Void D	
Void Access	21" x 11" manhole in good condition 3" coaming, gasket, stainless bolts, cover – in good condition
Coating	Unknown
Deck	Unable to view
Bulkhead	Unable to view
Floor	Unable to view
Notes	Unable to enter Void
Void E	
Void Access	21" x 11" manhole in good condition 3" coaming, gasket, stainless bolts, cover – in good condition
Coating	Unable to view
Deck	Unable to view
Bulkhead	Unable to view
Floor	Unable to view
Notes	Unable to enter Void
Void F	
Void Access	21" x 11" manhole in good condition 3" coaming, gasket, stainless bolts, cover – in good condition

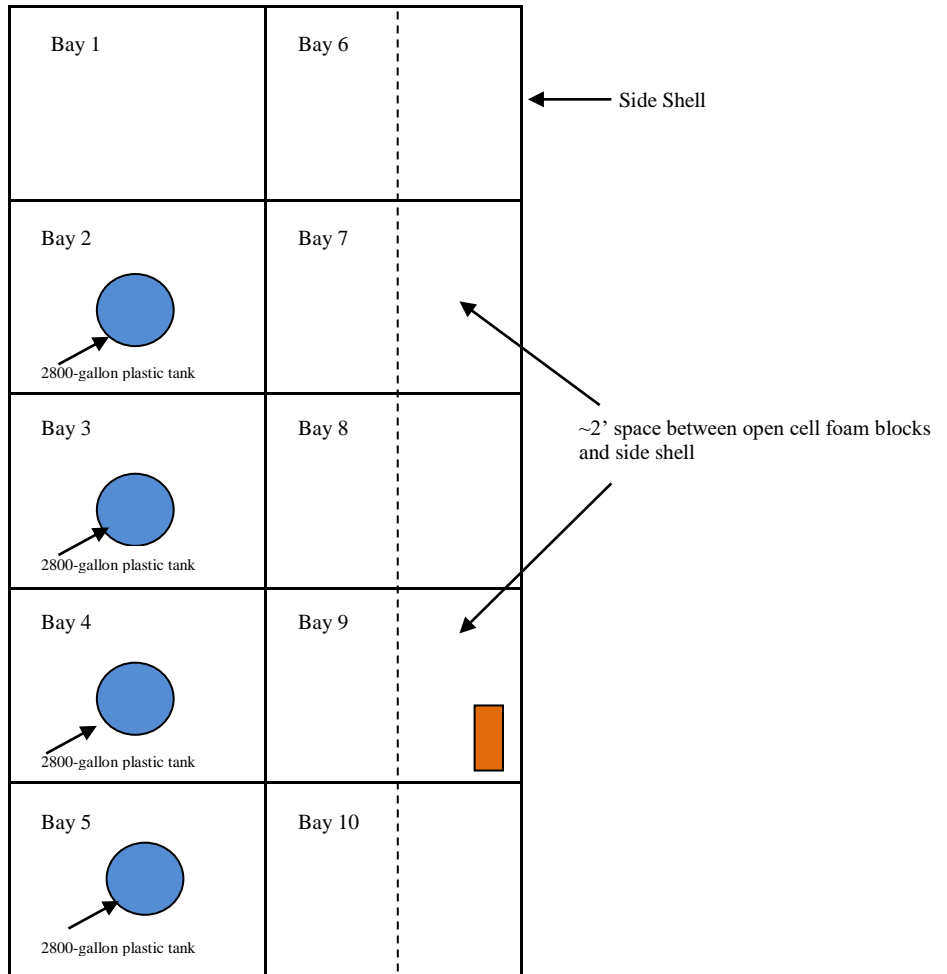
- Void entered down hatch to water level
- Open cell foam blocks installed in all Bays with ~2' space between side shell and foam blocks. Reported to surveyor that plastic tanks were empty and left in place when foam blocks installed
- Visible paint coating @ ~40%
- Reported four Z13 zincs installed on interior of hull

- Reported that recommendations in 2017 report have been completed

Coating	Unable to view
Deck	Unable to view
Bulkhead	Unable to view
Floor	Unable to view
Notes	Unable to enter Void
Void G	
Void Access	24" x 60" hatch /w stairs in good condition Steel cover, no coaming, bolted down with 4 wing nuts – in good condition
Coating	~40% on visible section
Deck	Unable to view
Bulkheads	Unable to view
Floor	Unable to view
Notes	Void entered down hatch to water level Open cell foam blocks installed in all Bays with ~2' space between side shell and foam Plastic tanks reported empty and left in Void at time of foam installation

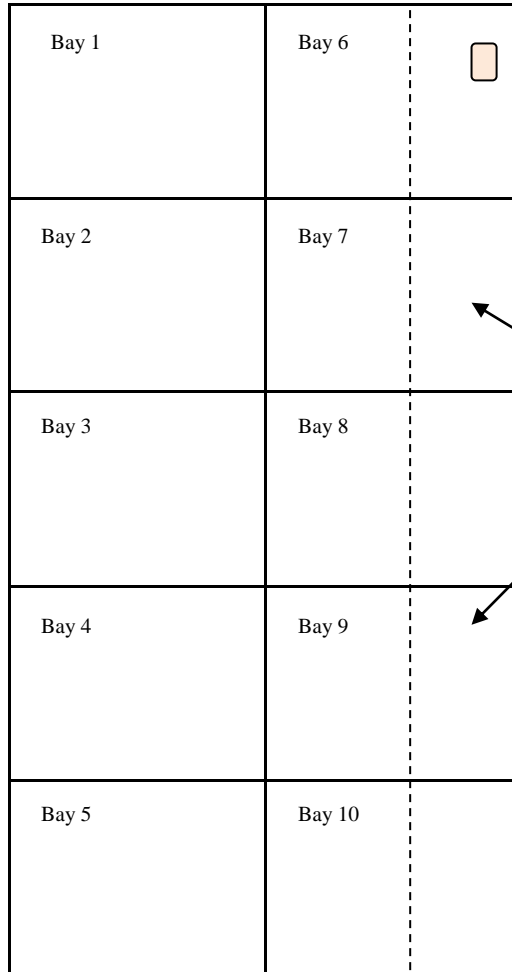
- Void not entered
- Open cell foam blocks installed in all Bays with ~2' space between side shell and foam
- Reported four Z13 zincs installed on interior of hull

- Reported that recommendations in 2017 report have been completed

Barge Description (cont.)	
Voids (cont.)	
Void H	
Void Access	21" x 11" manhole in good condition 3" coaming, gasket, stainless bolts, cover – in good condition
Coating	Unable to view
Deck	Unable to view
Floor	Unable to view
Notes	Unable to enter Void Open cell foam blocks installed in all Bays with ~2' space between side shell and foam
Void I	
Void Access	21" x 11" manhole in good condition 3" coaming, gasket, stainless bolts, cover – in good condition
Coating	Unable to view
Deck	Unable to view
Bulkhead	Unable to view
Floor	Unable to view
Notes	Unable to enter Void
Void J	
Void Access	21" x 11" manhole in good condition 3" coaming, gasket, stainless bolts, cover - in good condition
Coating	Unable to view
Deck	Unable to view
Bulkhead	Unable to view
Floor	Unable to view
Notes	Unable to enter Void
