## MEMORANDUM

To: Gord Closson, South Coast Standing Stem  
From: Iain Mill, Senior Naval Architect  
Prepared By: Shaun Wallis, Junior Marine Systems Engineer  
Date: 2019-04-08  
RE: **JB McCarron Barge Stabilization Refit Review**

J.B. MCCARRON BARGE  
STABILITY ASSESSMENT

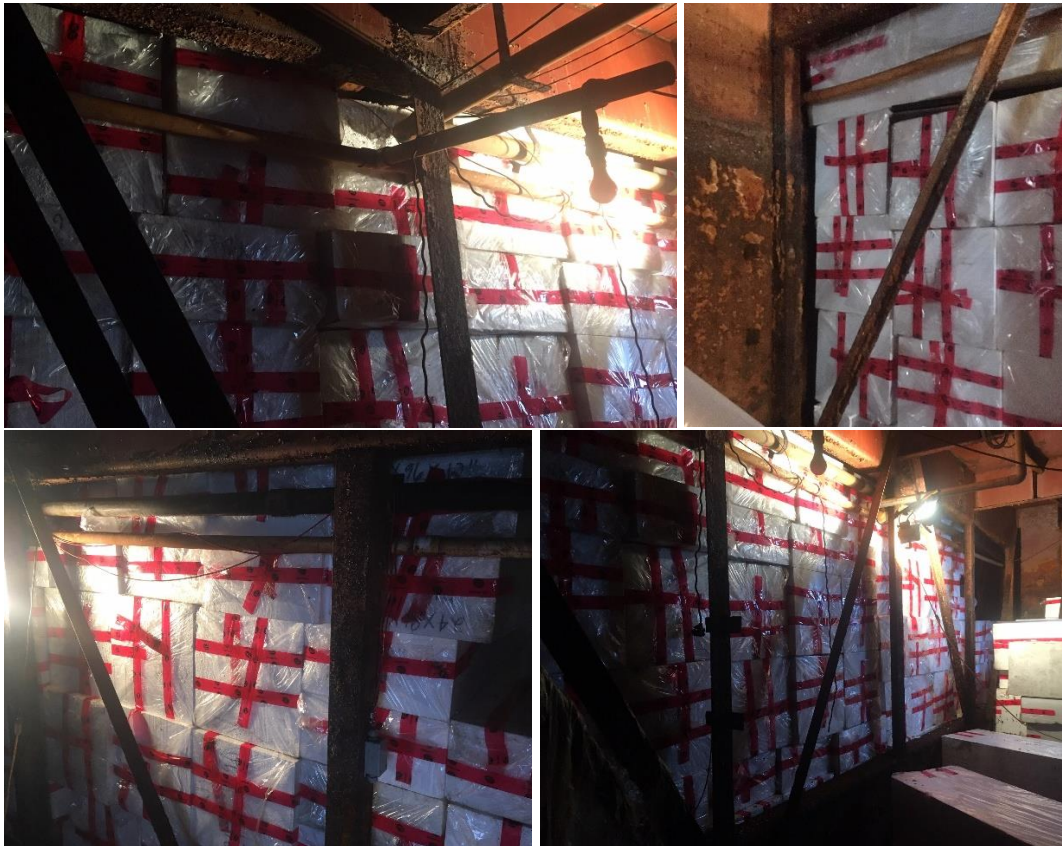
South Coast Standing Stem has filled Voids B, C, G and H with closed cell foam blocks wrapped in plastic. The work has been completed to the satisfaction of 3GA Marine Ltd.

*Figure 1 Foam block installation*

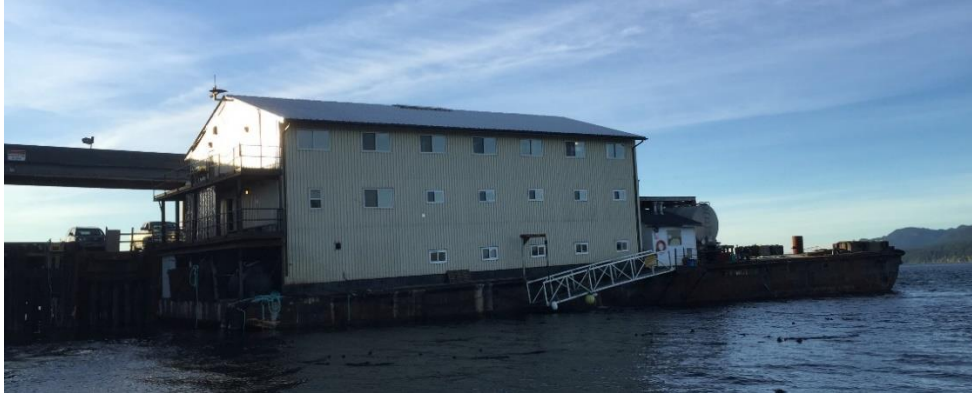
*Figure 2 J.B. McCarron Barge prior to refit*

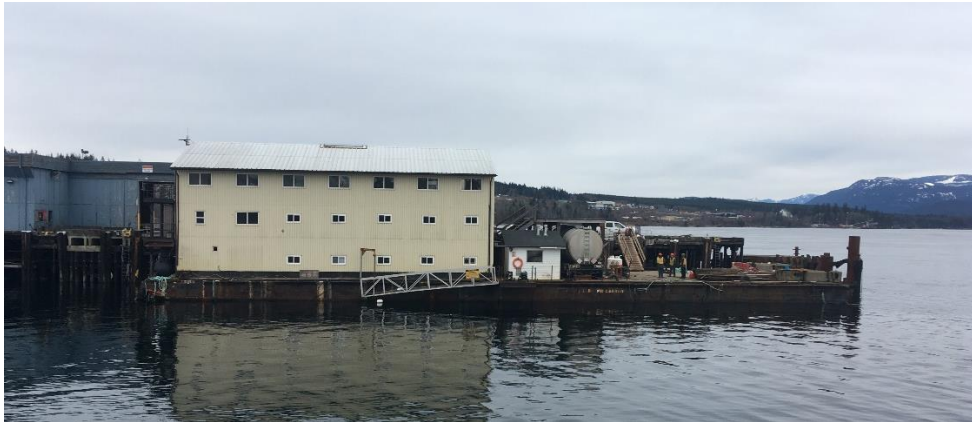
*Figure 3 J.B. McCarron Barge after refit*

3GA Marine Ltd is satisfied that the modifications to the barge have been carried out as described in the attached report, that the vessel is floating in a stable upright condition, and that the condition of the vessel is suitable for the intended operations.

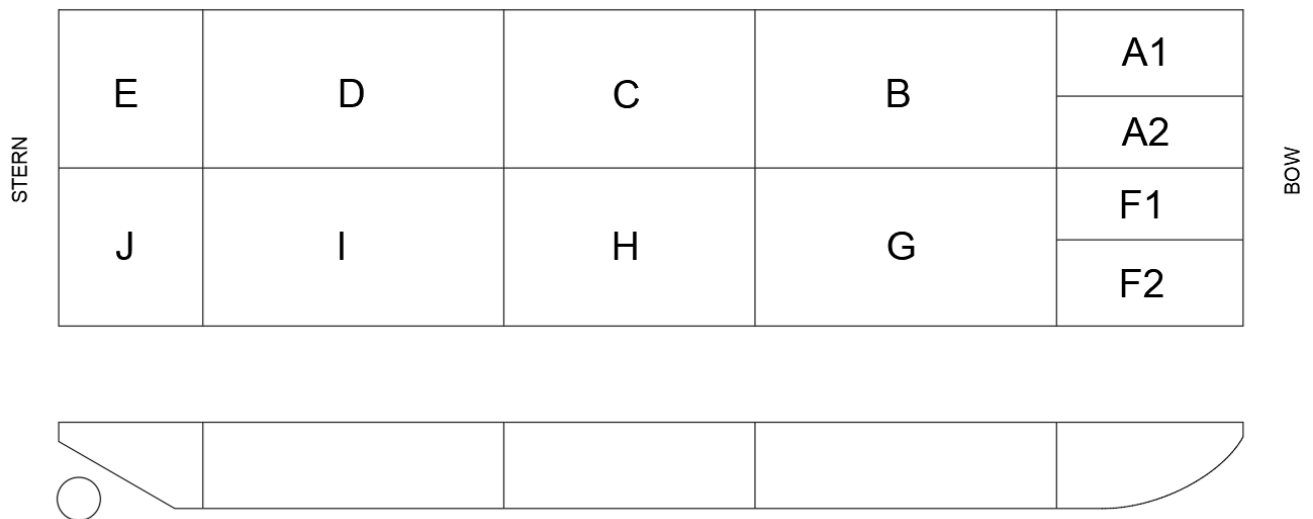
Figure 1 - Hull void spaces. Note the submerged cylindrical tank attached to the aft end of the vessel.

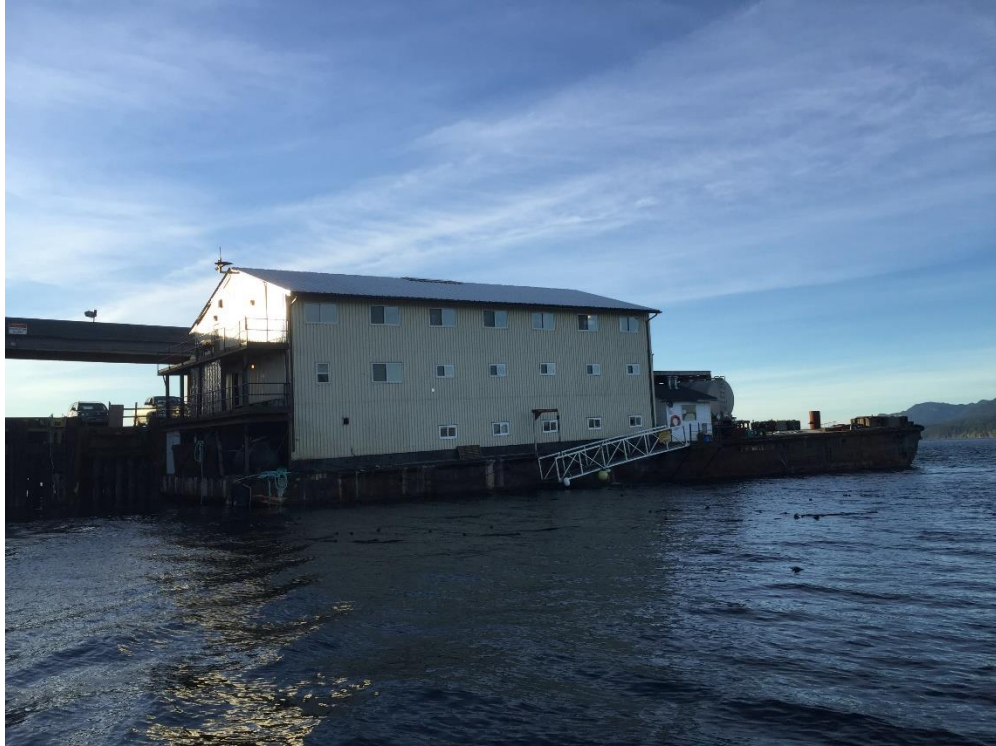
*Figure 2 - Exterior view of the barge*

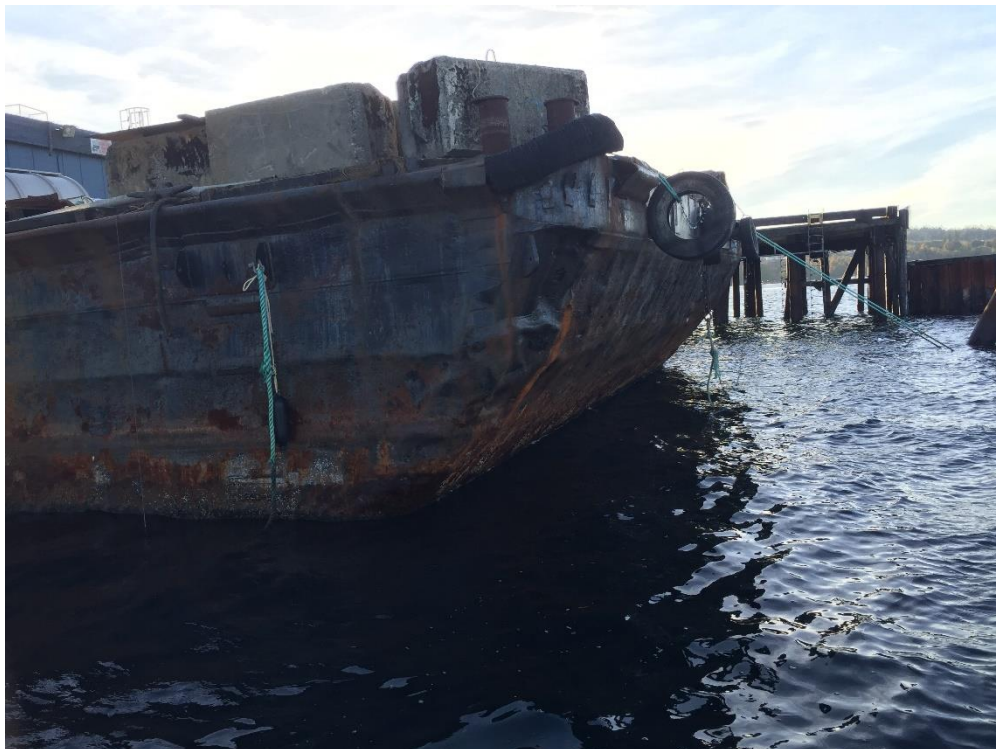
*Figure 3 - view of the bow of the barge*

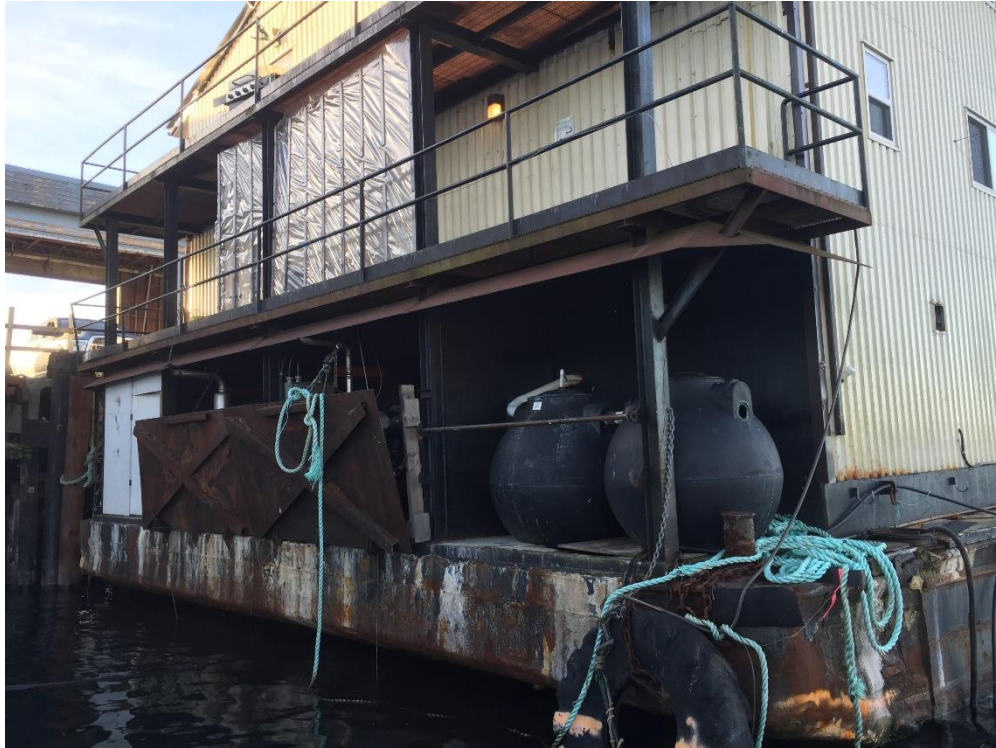
3GA Marine inspected the barge at the former pulp mill in Campbell River on September 26<sup>th</sup>, 2018. The barge is currently sitting with a substantial trim by the stern. The void spaces were inspected as far as possible. The vessel's freeboards were measured at all four corners of the vessel.

Figure 4 - View of the stern of the barge

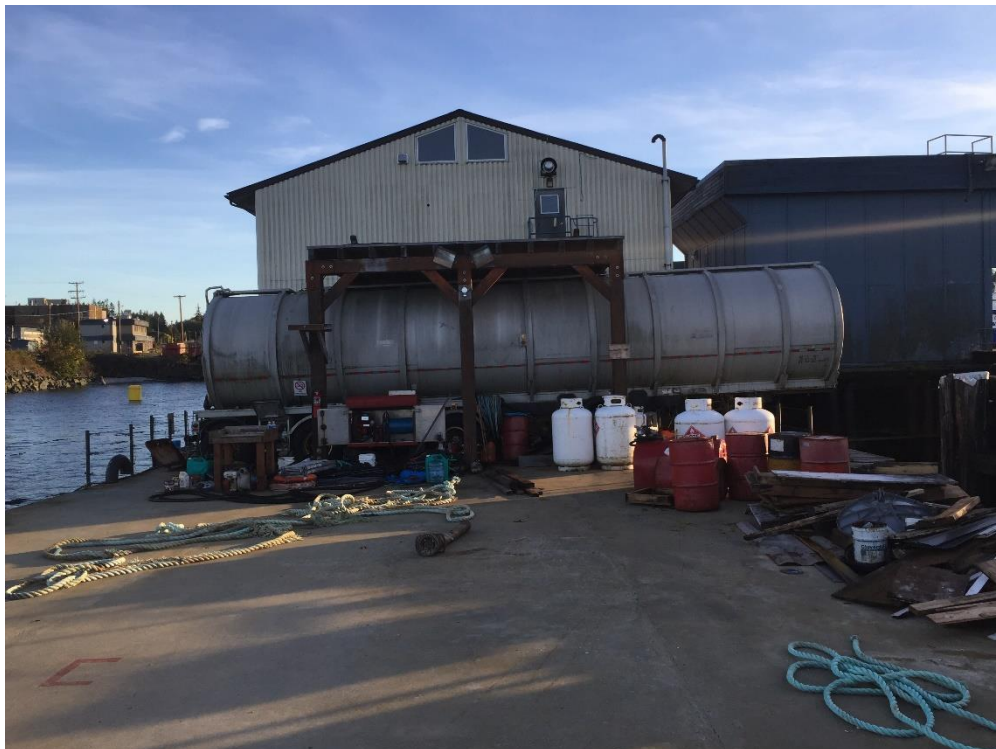
Figure 5 - View of the main deck of the barge

1. Fill the fresh water tanks to approximately 50% full.
2. Remove the sediment from the bottom of the accessible void spaces. Remove any garbage and unnecessary equipment from the spaces.
3. Remove and relocate the equipment from the void spaces. If the water and fuel tanks are to remain in the void spaces, the connections to these tanks should be made as directly as possible with as few fittings as possible. Any valves should be located outside of the spaces to be filled with foam. It should be noted that the piping to and from these tanks, as well as the tanks themselves, will be inaccessible once the spaces are filled with foam and the spaces flooded.
4. Fill Voids B, C, G and H with foam.
5. Remove the concrete blocks from the main deck forward.

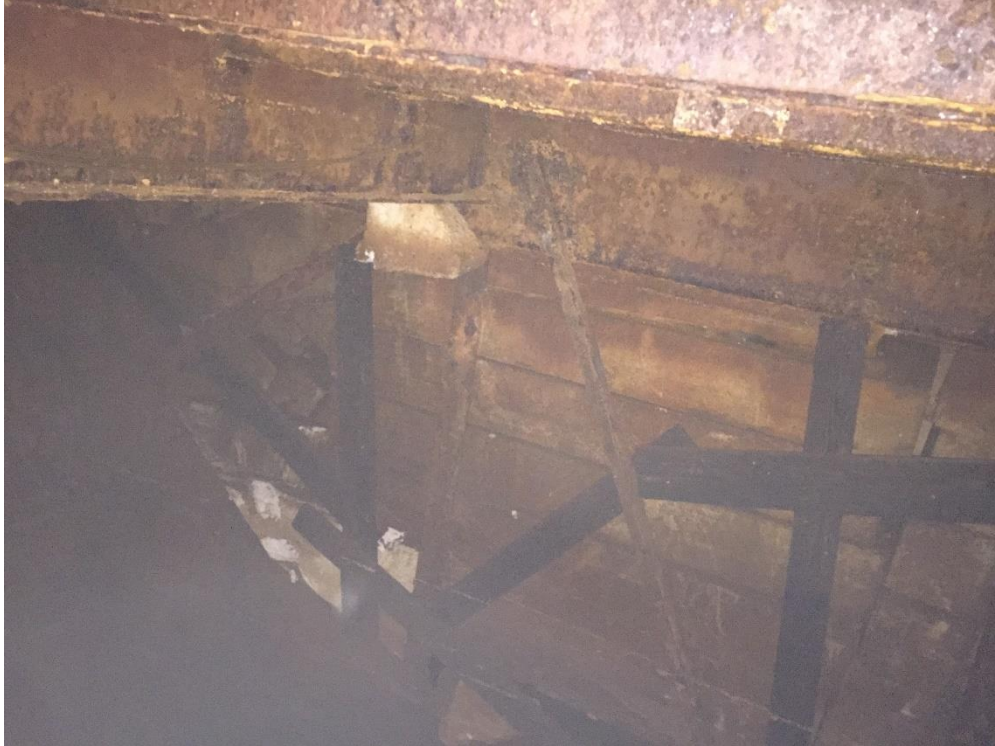
Void Space	Description
A	The inner portion of the space (A2) is filled with foam blocks. The outer portion of the space was partially flooded with water. Any water added to this space is reported to drain out of the space. The water level inside the space is consistent with the water level outside the vessel. It is assumed there is a leak in the hull below the foam.
B	This space was dry. There is sediment in the bottom of the space, and a poor condition wooden walkway/floor within the space. This space also contains a large cylindrical tank. It was reported that this tank is empty, and only fitted for the purpose of draining the aviation fuel into in the case of a helicopter incident on the main deck.
C	This space was inaccessible, but was reported to be dry. None of the data observed contradicted this statement.
D	This space was inaccessible. It was reported that the previous owner filled this space with spray foam. It is assumed that the spray foam used was closed cell foam.

Figure 6 - View inside Void A, showing the foam installed in the inboard portion of the space

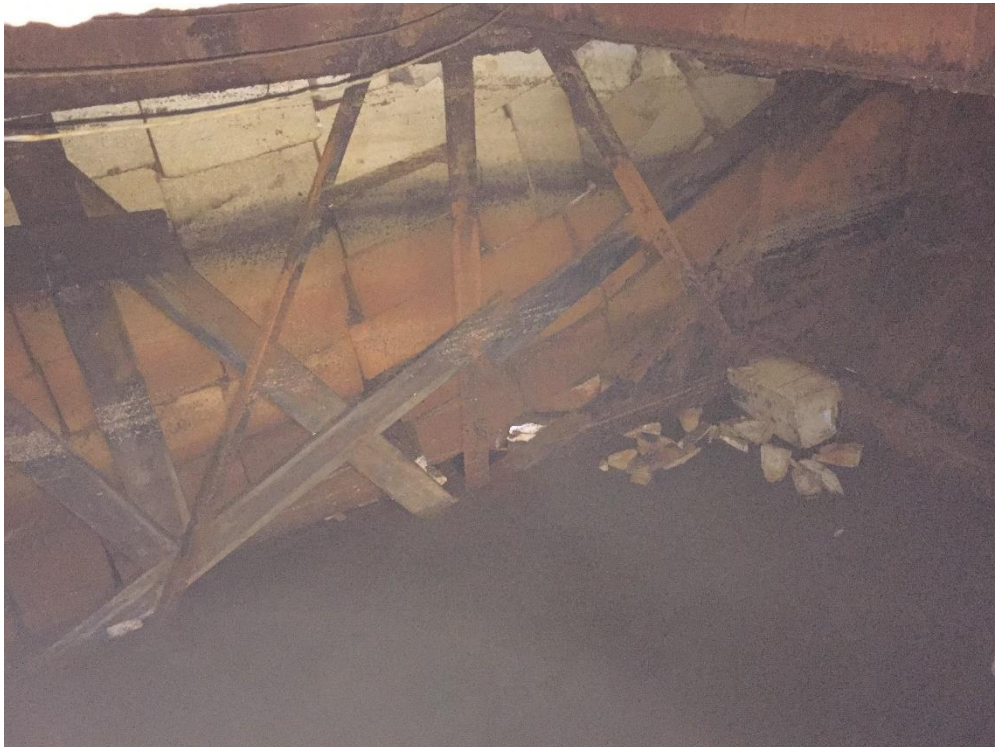
E	This space was inaccessible. This space is filled with expanded polystyrene foam blocks.
F	The inner portion of the space (F1) is filled with foam blocks. The outer portion of the space was partially flooded with water. Any water added to this space is reported to drain out of the space. The water level inside the space is consistent with the water level outside the vessel. It is assumed there is a leak in the hull below the foam.
G	This space was dry. There is sediment in the bottom of the space, and a poor condition wooden walkway/floor within the space. This space also contains four large cylindrical fresh water tanks. It was reported that these tanks were 3/4 full. This space also contains the desalination equipment for generating fresh water from sea water.
H	This space was empty aside from a small quantity of water in the bottom of the space. There appeared to be a small leak from Void Space I in to this space. The bilge pump is used to control the volume of fluid in the space.

Figure 7 - View inside Void F, showing the foam installed in the inboard portion of the space

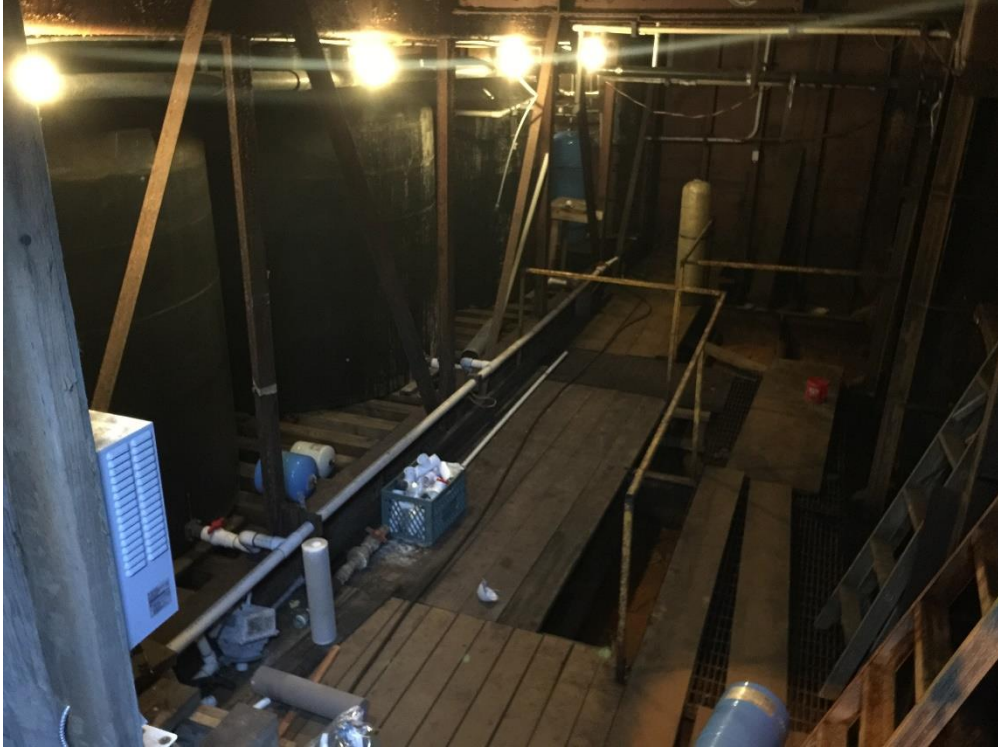
Figure 8 - View inside Void G, showing the FW tanks

Voids B and G are each to be fitted with 130m<sup>3</sup> (4600 cu.ft) of closed cell foam with a density of 2lb per cu.ft. The foam is to be fitted from the bottom shell to the deckhead, and from 10 feet outboard (12 feet from the shell plate) to 20 feet outboard (2 feet from the shell plate). The foam is to be fitted to within 2 feet of the transverse bulkheads at either end of the space. The area where the fuel dump tank is installed does not need to be filled with foam.

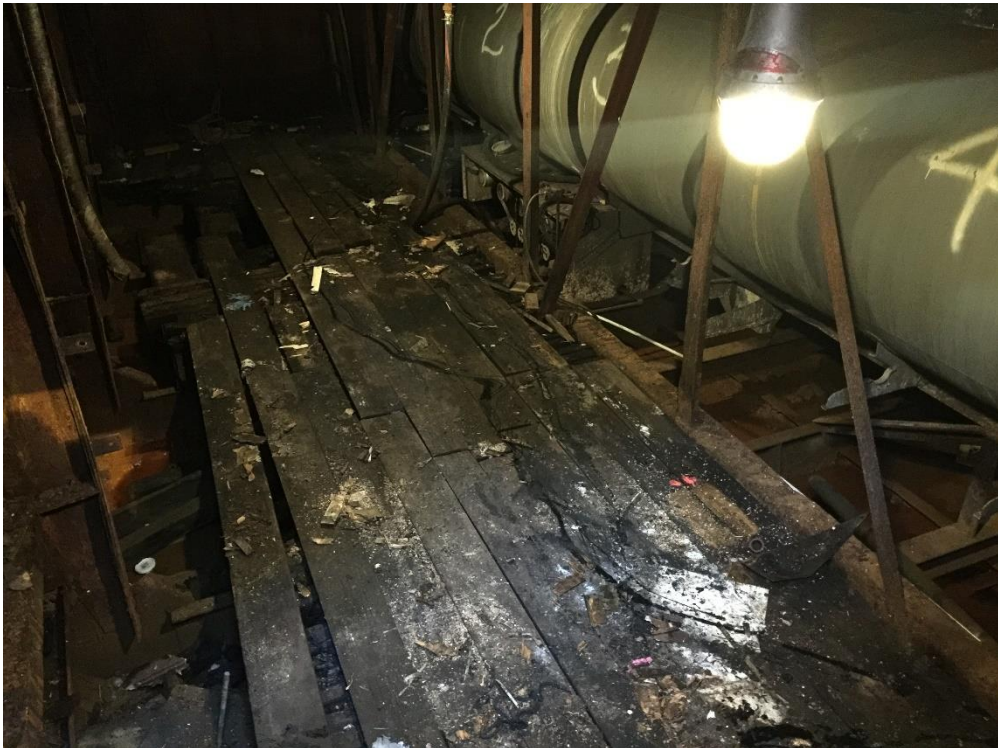
Figure 9 - View inside Void B, showing the aviation fuel dump tanks

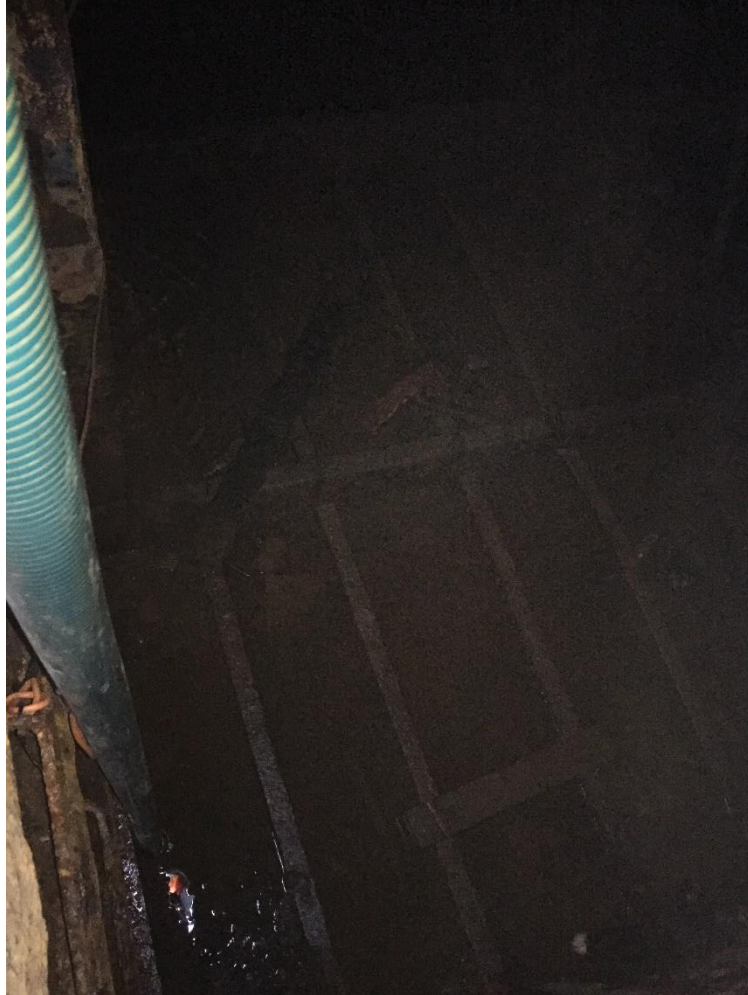
*Figure 10 - View inside Void H*

Voids C and H are each to be fitted with 190m<sup>3</sup> (6700 cu.ft) of closed cell foam with a density of 2lb per cu.ft. The foam is to be fitted from the bottom shell to the deckhead, and to 2 feet from the bulkheads and shell plate in each direction.
