# On-Hire & Insurance Survey Report

## *Pacific III*

*Re: On-Hire Survey of Pacific III*

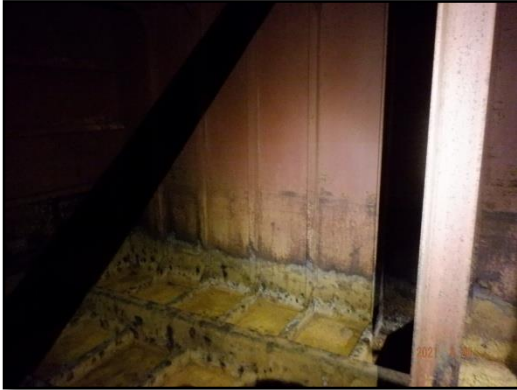
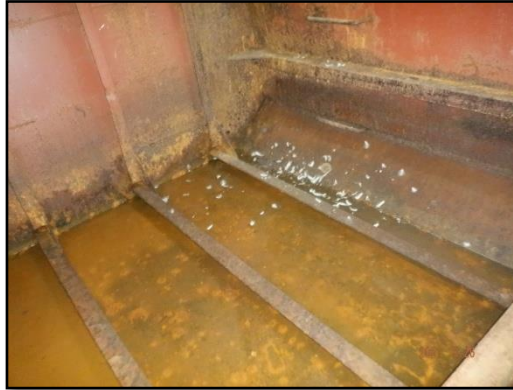
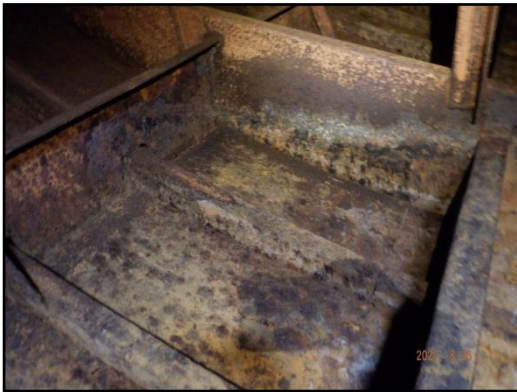
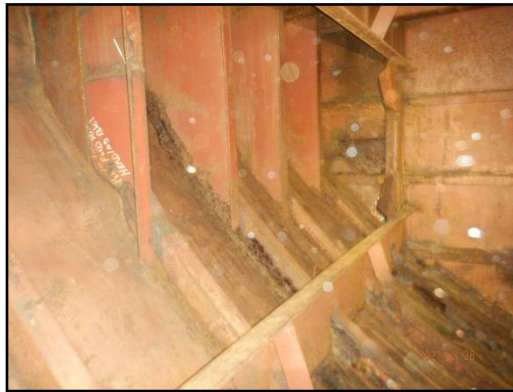
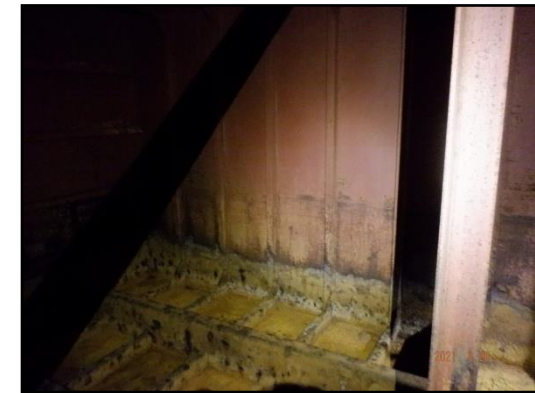
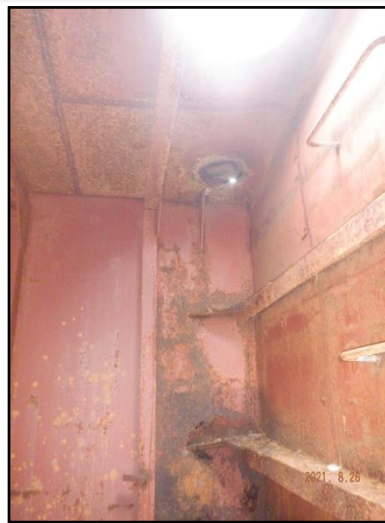
### Void P1

- 14" x 21" with 3" coaming
- 8 bronze bolts & nuts
- Gasket in good condition
- Cover in good condition

- Good condition

- Deck ~40%
- Bulkhead ~40%
- Side Shell ~40%
- Hull ~40%

- Light set-down

- \*\*SS-LS damaged in Bay 6
- Bay 7 #2 SS-P ~40% wasted

- ~30% wasted
- Bay 2 B-P light set-up, but rib doesn't appear damaged

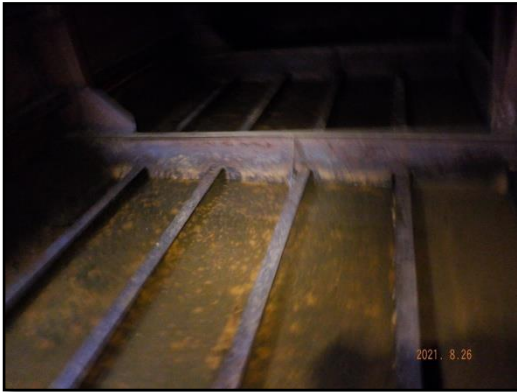
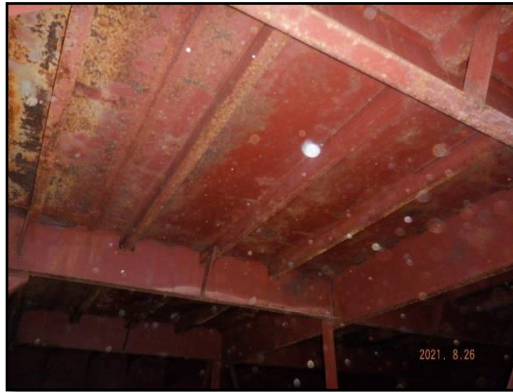
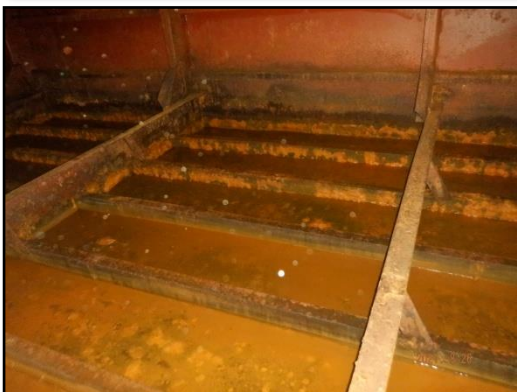
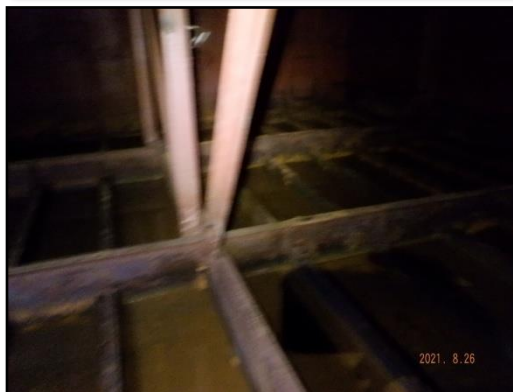
Void P2

- 14" x 21" with 3" coaming
- 8 bronze bolts & nuts
- Gasket in good condition
- \*\*\*Cover damaged

- Fair condition

- Deck ~70%
- Side shell ~30%
- Bulkheads ~60%
- Hull ~30%

- Bay 3 D-TF light set down
- D-P light set-down

- ~30% wasted

- ~10% wasted

- 2" water

- Bilge bracket in Bay 7 appears to have been replaced
- A patch has been welded over side shell in Bay 3

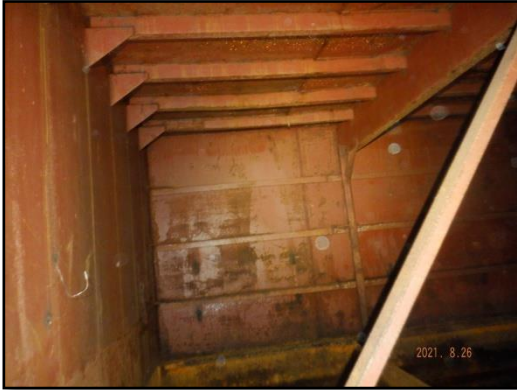
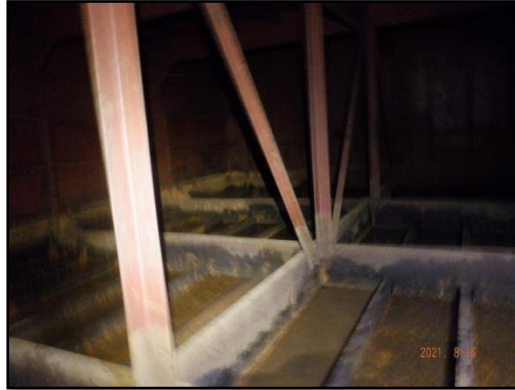
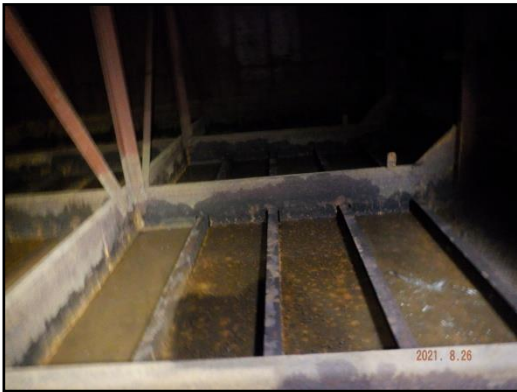
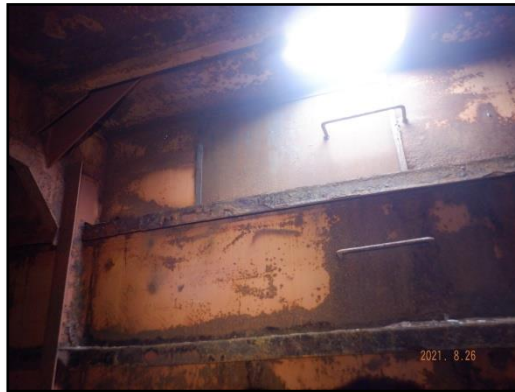
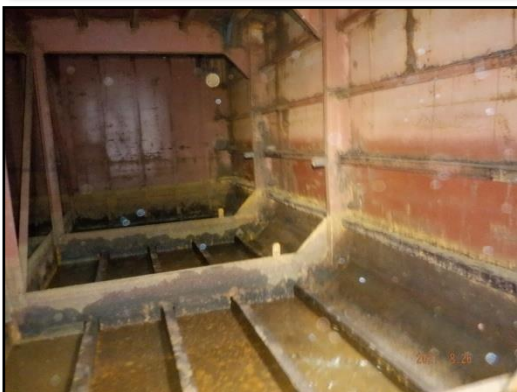
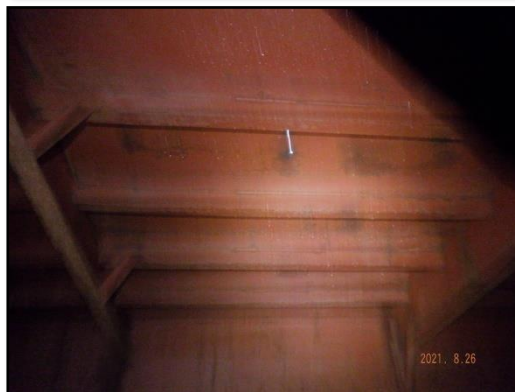
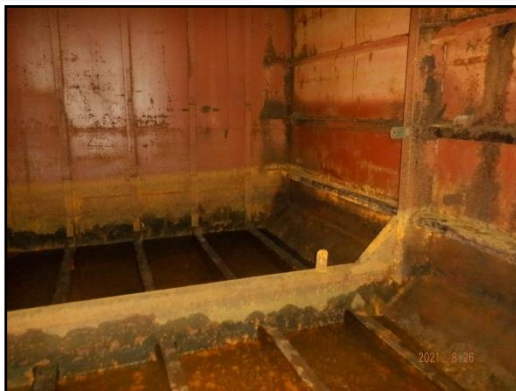
### Void P3

- \*\*2 rungs are damaged

- Deck ~70%
- Side shell ~40%
- Bulkheads ~40%
- Hull ~20%

- Bay 2,3 & 4 D-TF light set down
- D-P light set-down

- SS-LF light set-in ~30% wasted
- SS-P has visible repairs

- Bay 5 BH-S ~40% wasted

- 1" water

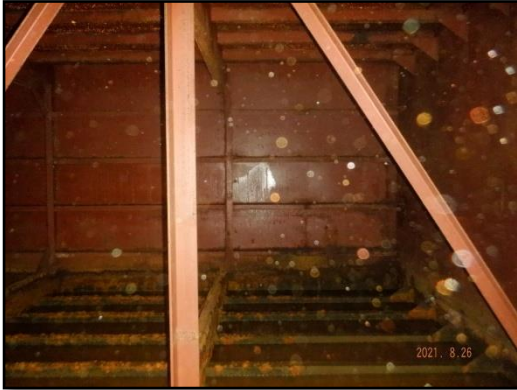
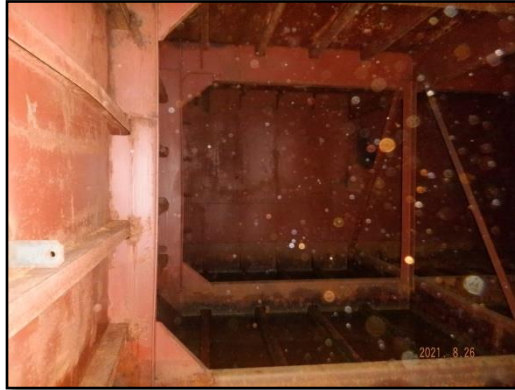
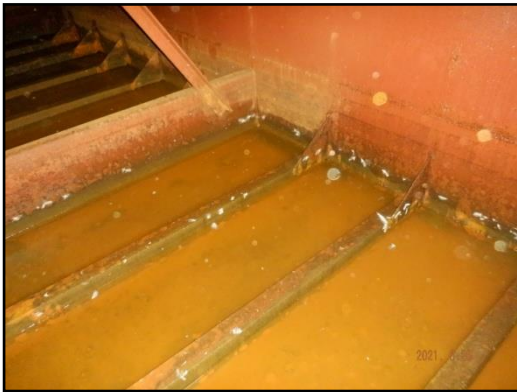
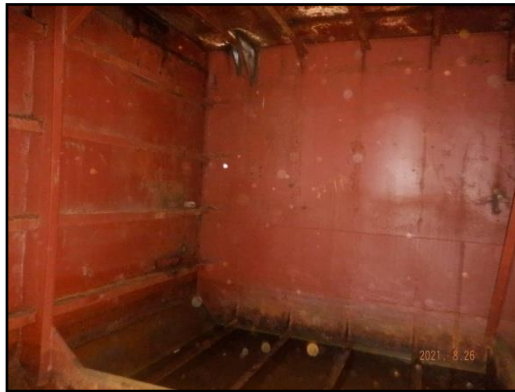
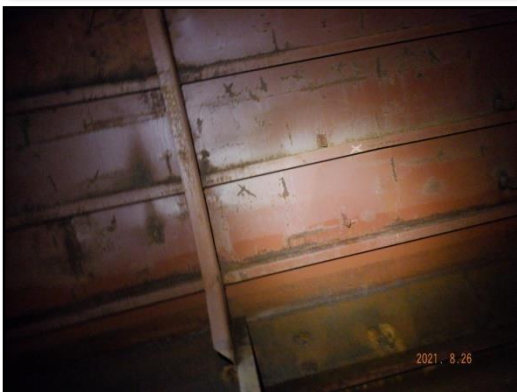
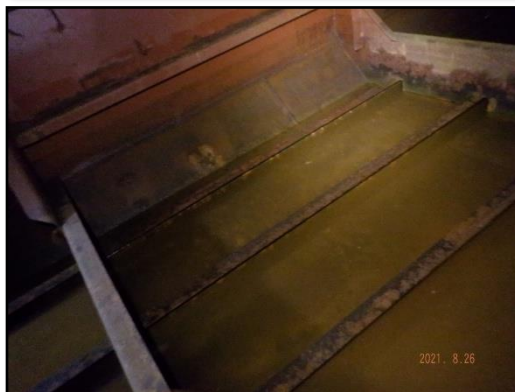
### Void P4

- \*\*Top rung cuts off access to void
- \*\*Missing bottom rung

- Deck ~80%
- Side shell ~40%
- Bulkheads ~60%
- Hull ~10%

- Bay 3 SS-LF moderate set-in
- \*\*Bay 1 SS-LF top #2 wasted ~50%

- Bay 1 bulkhead wasted ~30%

- 5" water

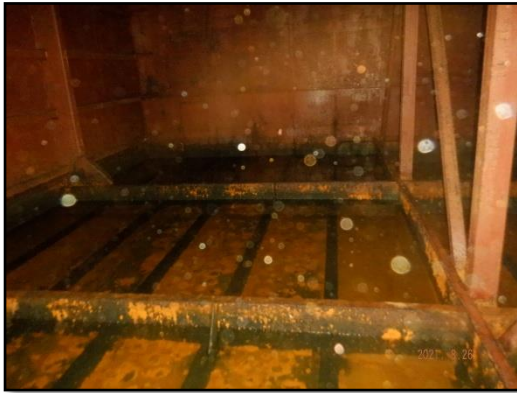
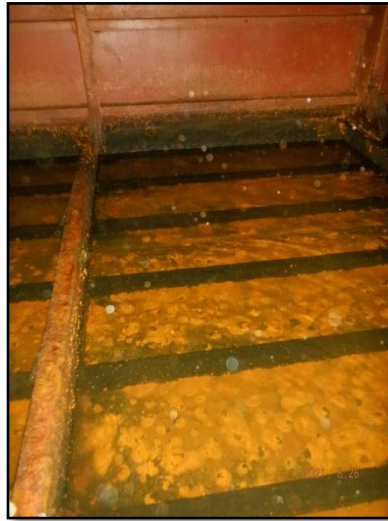
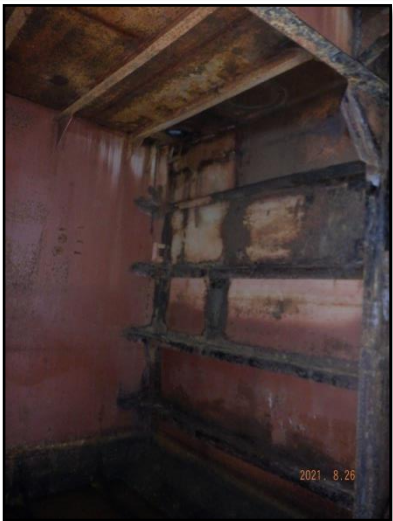
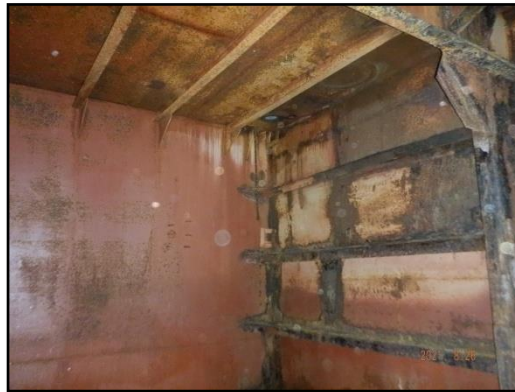
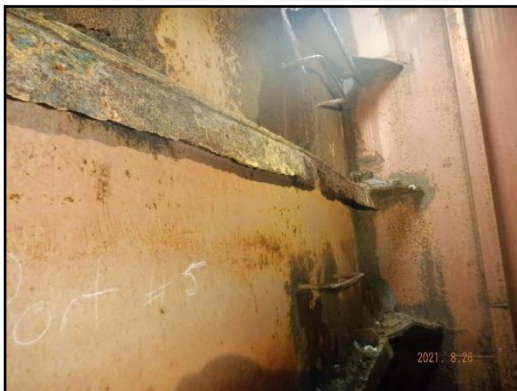
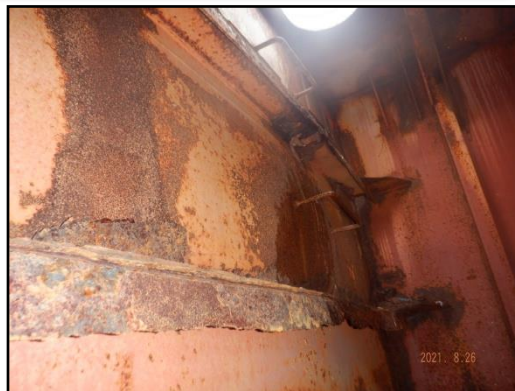
Void P5

- \*\*3 rungs damaged

- Deck ~60%
- Side Shells ~60%
- Bulkheads ~50%
- Hull ~10%

- D-P radius moderate set-down

- \*\*Bay 1 SS-LF #2 side frames ~80% wasted moderate set-in

- 4" water

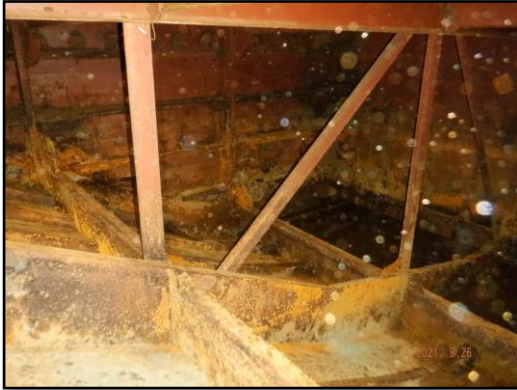
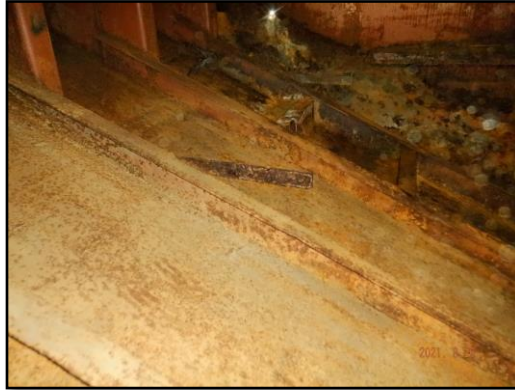
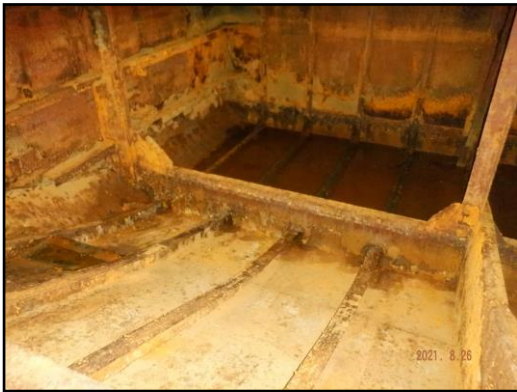
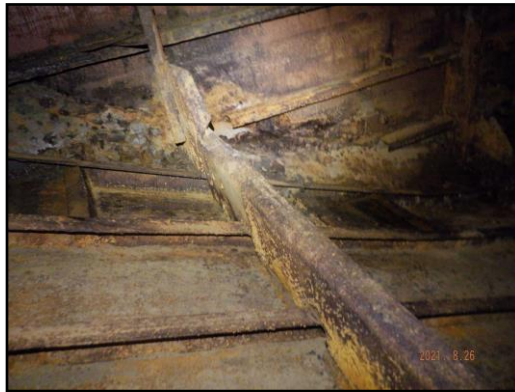
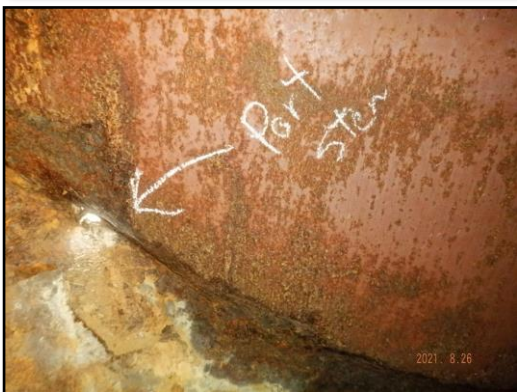
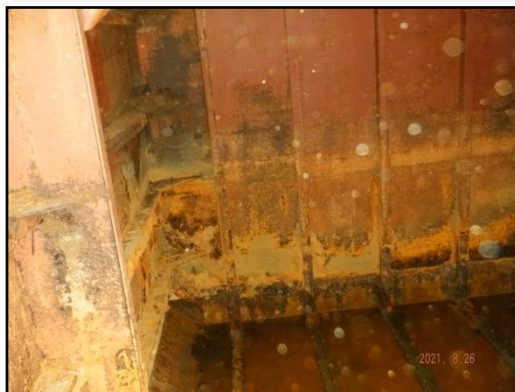
Void P6

- \*\*2 rungs are damaged

- Deck ~50%
- Side shell ~30%
- Bulkheads ~30%
- Hull ~30%

- Bay 3,4,5 D-P light set-down

- Fair condition
- \*\*\*Bay 2 SS-P to B-P is cracked

- Brackets ~30% wasted

- 4" water
- BR-HL light set-over

- Some side shell frames have been replaced

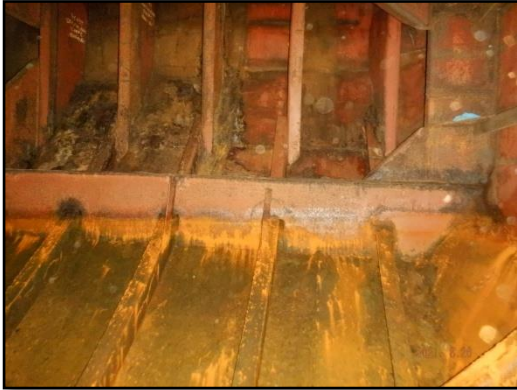
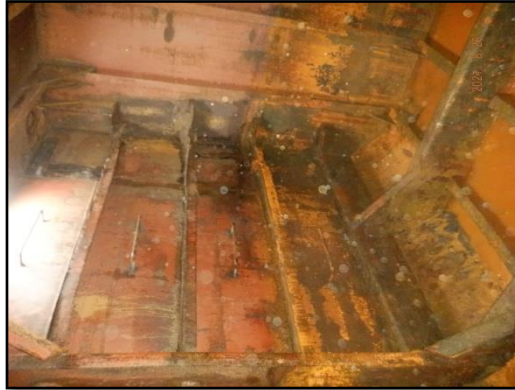
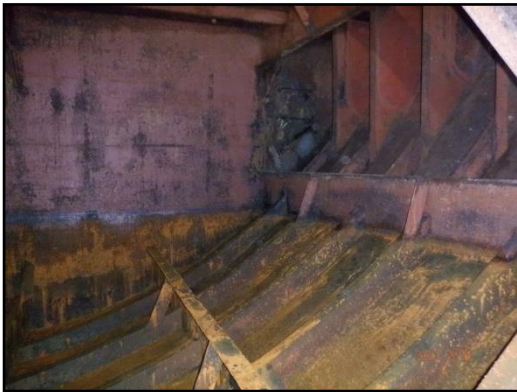
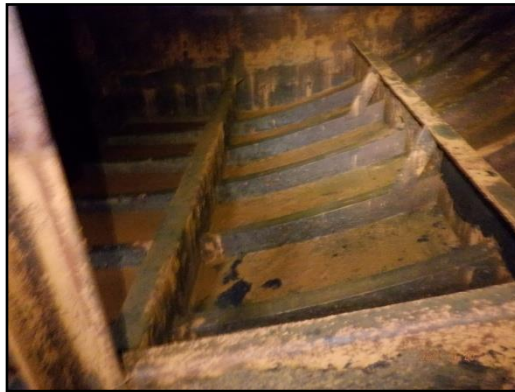
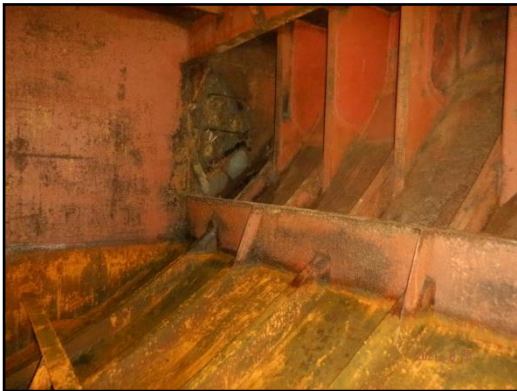
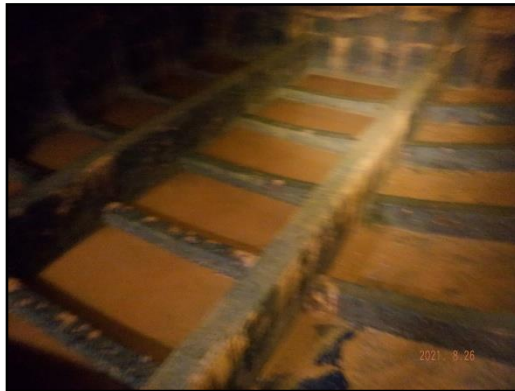
Void S1

- Deck ~20%
- Side shell ~20%
- Bulkhead ~70%
- Hull ~10%

- \*\*Bay 5 1/4" hole in deck

- Moderate set-in
- \*\*Stiffener #4 to bulkhead in Bay 8 ~40% wasted

- Bay 5 ~40% wasted at side shell 3rd frame

- 2" water

- Head log stiffener has been replaced

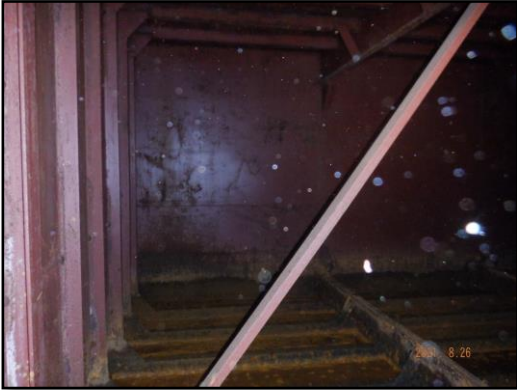
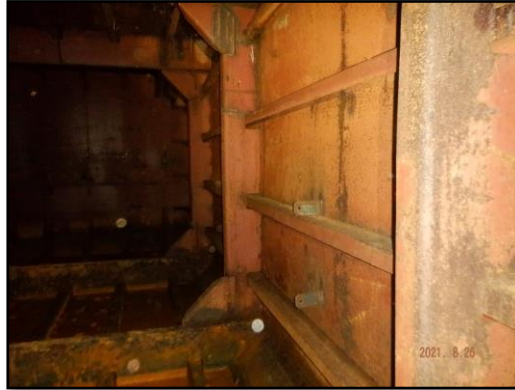
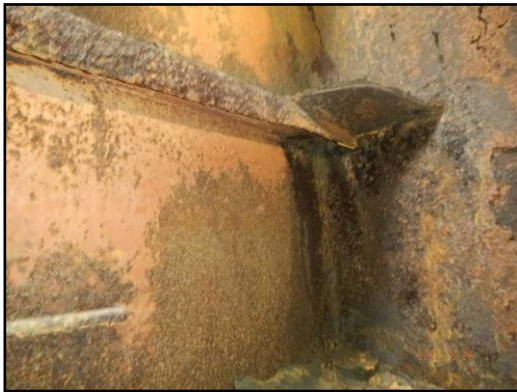
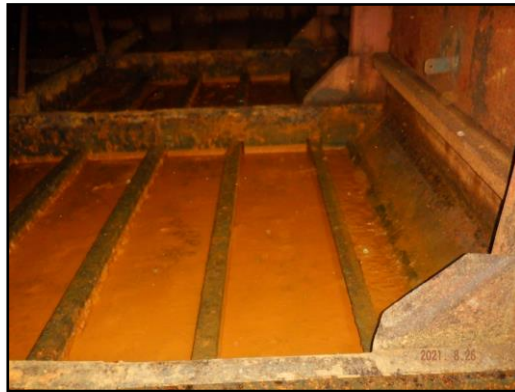
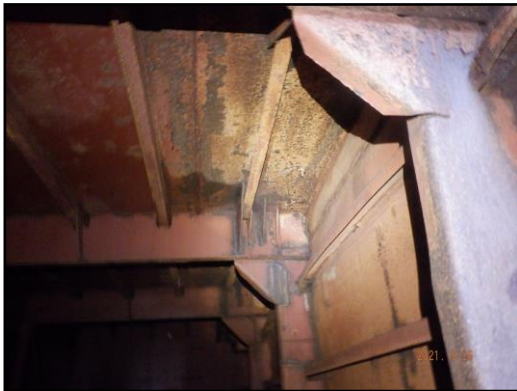
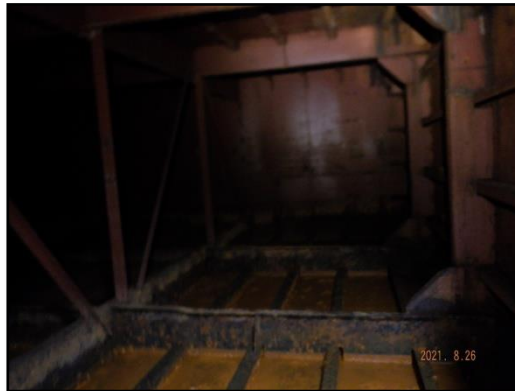
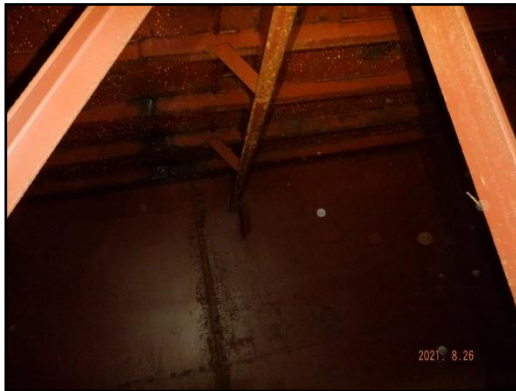
Void S2

- \*\*1 rung in poor condition

- Deck ~60%
- Side shell ~30%
- Bulkheads ~30%
- Hull 0%

- Plating light set-in

- Bay 5 two side shell stiffeners ~40% wasted – moderate set-over

- Bay 5 ~40% wasted at side shell

- Heavy rust
- 1" water

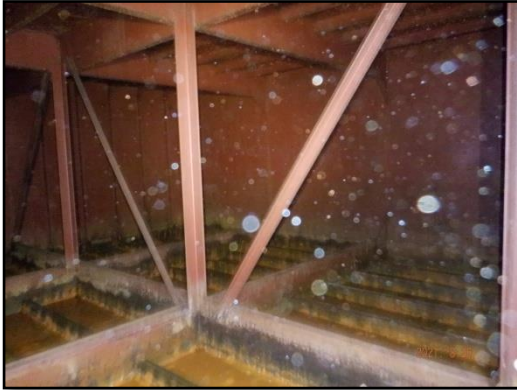
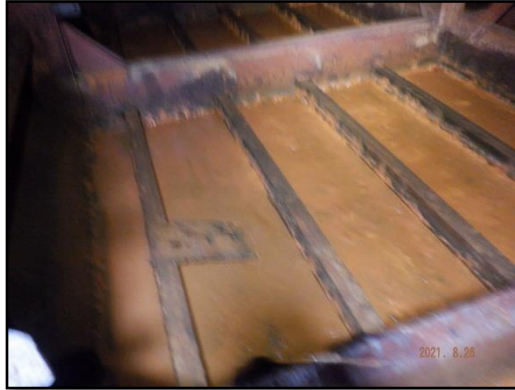
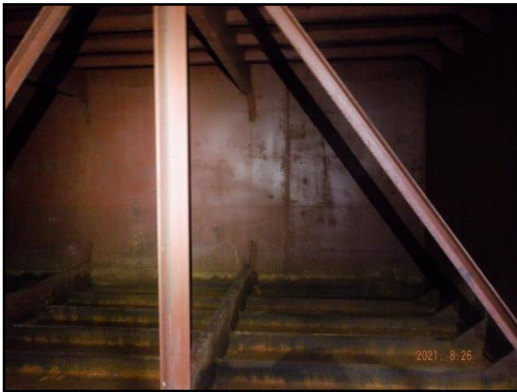
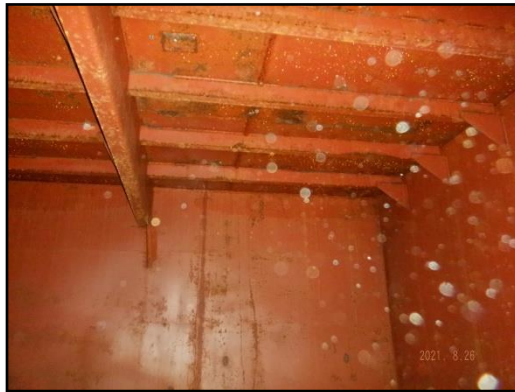
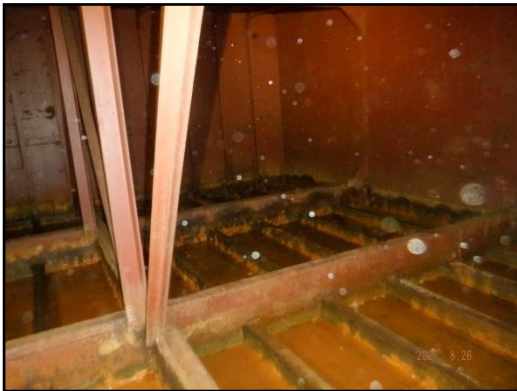
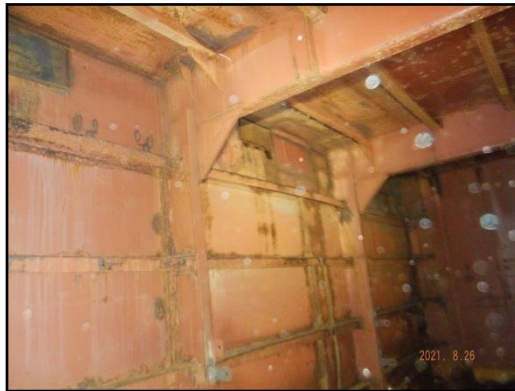
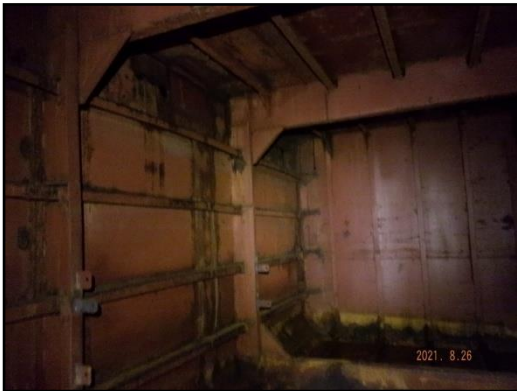
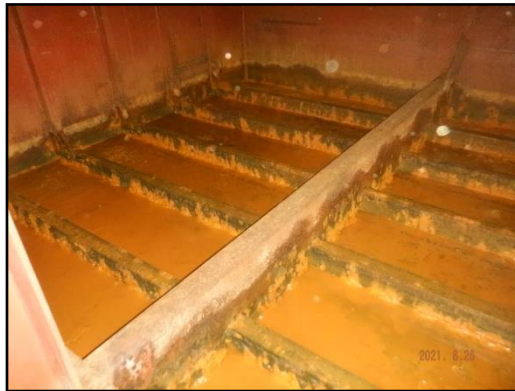
Void S3

- Deck ~50%
- Side shell ~40%
- Bulkheads ~60%
- Hull ~20%

- Bay 5 light set-down

- Bay 2 SS-LF moderate set-in

- Forward bulkhead 40% wasted at side shell

- 1" water

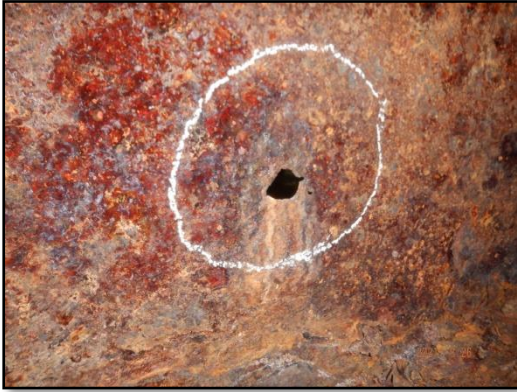
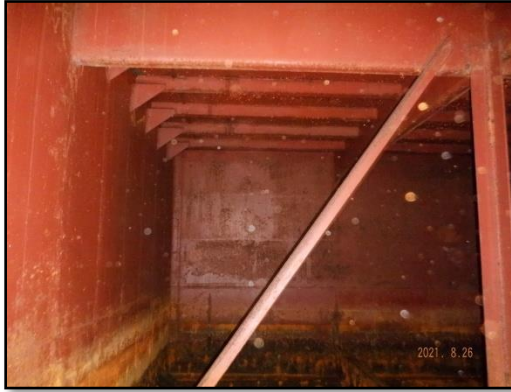
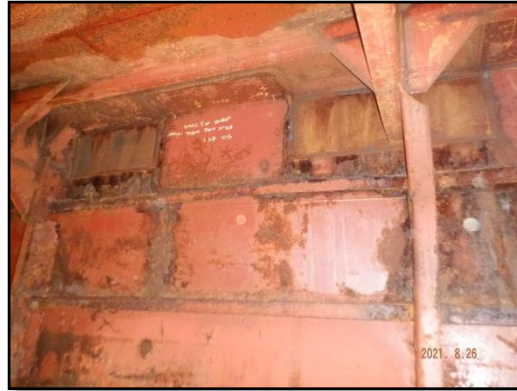
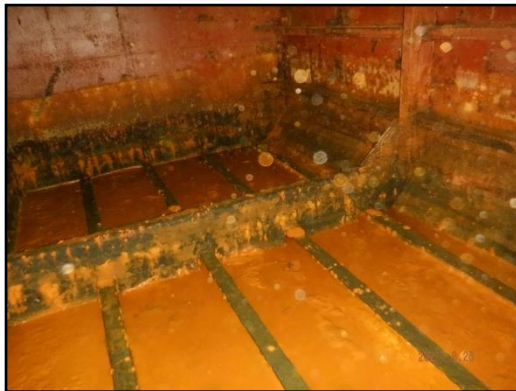
Void S4

- \*\*2 rungs in poor condition

- Deck ~60%
- Side shell ~45%
- Bulkheads ~60%
- Hull ~30%

- SS-G damaged
- SS-VF bay 2 set-over
- \*\*\* Bay 4 SS-P has a hole

- BR-B in Bay 8 ~50% wasted

- 3" water

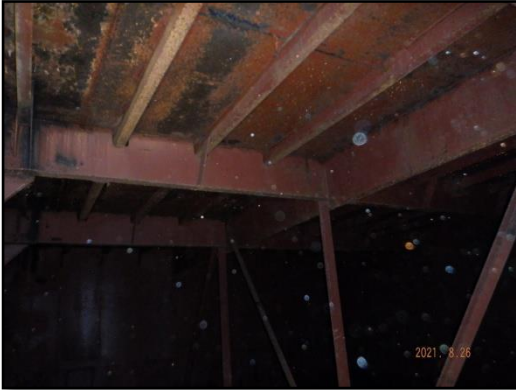
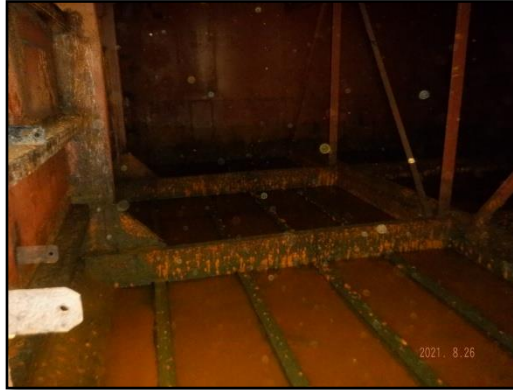
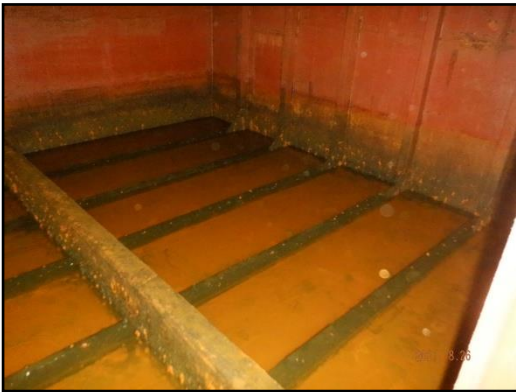
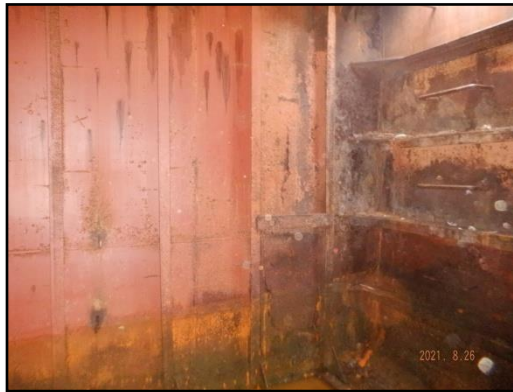
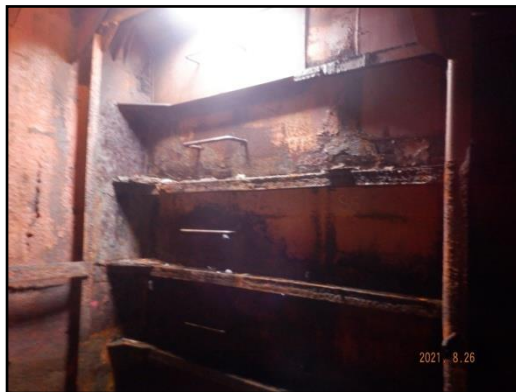
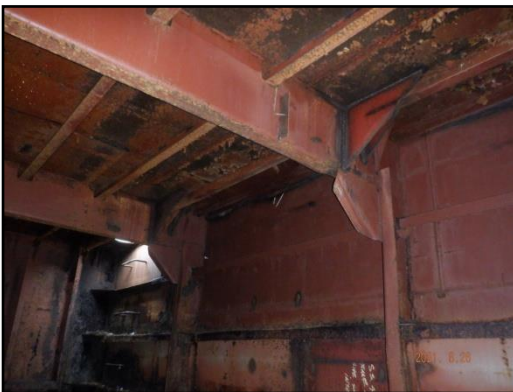
### Void S5

- 14" x 21"
- \*\*\*Bottom coaming in poor condition
- 8 bronze bolts & nuts -\*\*\*1 broken bolt
- Gasket in good condition
- Cover in good condition

- \*\*Poor condition

- Deck ~70%
- Side shell ~40%
- Bulkheads ~40%
- Hull 0%

- Deck plating light set-in

- Bay 1 # 2 SS-LF 40% wasted
- Bay 3 SS-G set over moderate

- Moderate rust

- 10" water
- \*\*Bay 1 to 2 B-TF moderate set-over from side impact

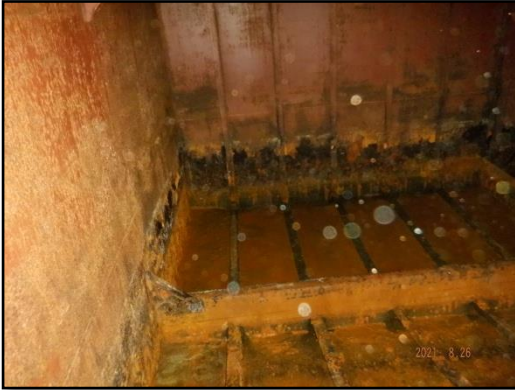
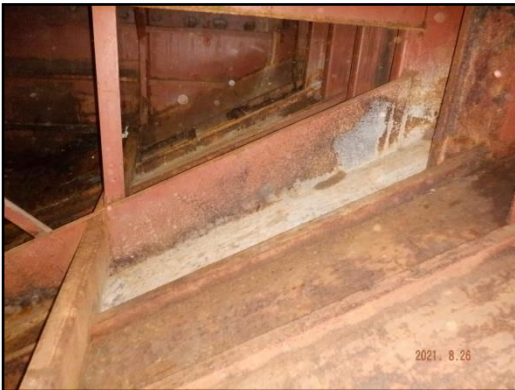
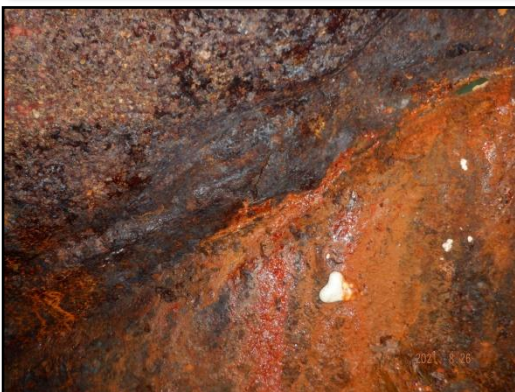
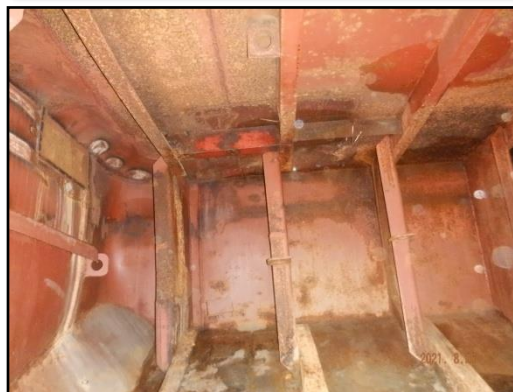
### Void S6

- 14" x 21" with 3" coaming
- 8 bronze bolts & nuts – \*\*\*1 bolt is broken
- Gasket in good condition
- Cover in good condition

- Deck ~80%
- Side shell ~20%
- Bulkhead ~60%
- Hull ~30%

- Bay 2 SS-LF set-over moderate

- Moderate rust

- \*\*\*Bay 6 B-P to SS-P has a hole (Old damage filled with foam)
