Condition & Valuation Survey Report

Accommodation Barge - Hotel Pacific

Re: Revised Survey of Hotel Pacific

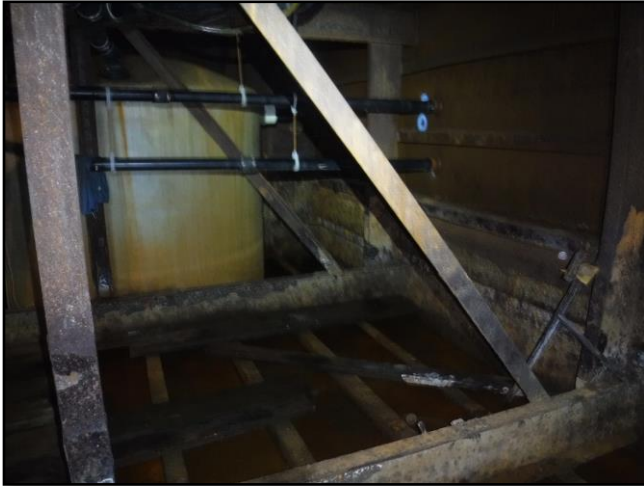
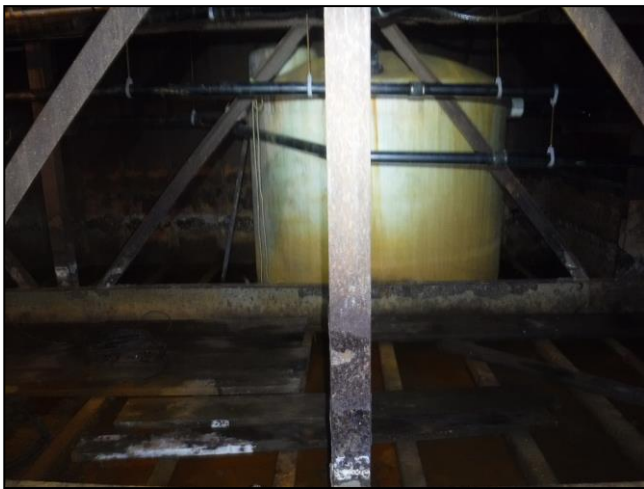
Void Port 3

- Stairs in good condition

- Deck ~50%
- Side shells ~30%
- Bulkheads ~30%
- Hull ~10%

- Good condition

- SS-P set in light

- Good condition
- Cut out to allow access to Starboard 3

- ~4" water

- Fresh water tank
- Small cut outs to Port 2

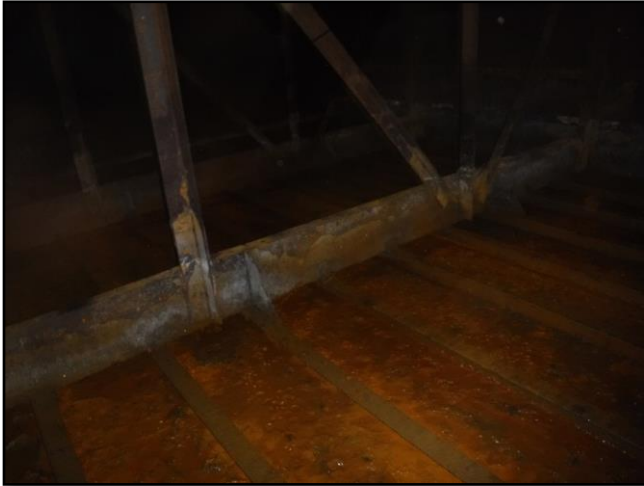
Void Starboard 3

- Good condition

- Deck ~10%
- Side shells ~15%
- Bulkheads ~30%
- Hull 0%

- Bay 1 set in light

- Good condition
- Cut out to allow access to Port 3

- Moderate rust
- Not set up

- Black water tank
- Small cut outs to Starboard 2
