RE: Examination of Tadano Boom Truck Crane

Product ID: 35-7-3207

Date: March 10, 2025

Technical Report

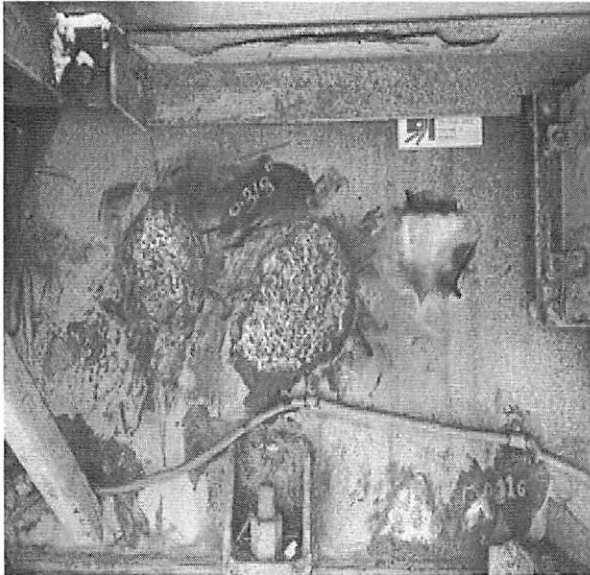
<u>COMPONENTS</u>	<u>DATE COMPLETED</u>	<u>INSPECTOR</u>	<u>RESULT</u>
Front Stabilizer	3/10/2025	JORDANG	NO DEFECT NOTED
Outriggers (4x)	3/10/2025	JORDANG	NO DEFECT NOTED
Mainframe	3/10/2025	JORDANG	DEFECT NOTED
Corrosion/Material loss/ pitting on subframe between front and rear outrigger on both the sub frame and truck frame rail approximately 1/16" to 3/32 material loss noted fro mcursory thickness tests			
Turret	3/10/2025	JORDANG	NO DEFECT NOTED
Winch Weldment	3/10/2025	JORDANG	NO DEFECT NOTED
Boom Butt Section	3/10/2025	JORDANG	NO DEFECT NOTED
First Boom Intermediate Section	3/10/2025	JORDANG	NO DEFECT NOTED
Second Boom Intermediate Section	3/10/2025	JORDANG	NO DEFECT NOTED
Boom Tip Section	3/10/2025	JORDANG	NO DEFECT NOTED
Swing Away Jib Butt section	3/10/2025	JORDANG	NO DEFECT NOTED
Swing away Jib stinger tip section	3/10/2025	JORDANG	NO DEFECT NOTED
Sheaves	3/10/2025	JORDANG	NO DEFECT NOTED
32-Ton SWL Load Block and Hook (S/N: 291078), (P/N: 9128-96)	3/10/2025	JORDANG	NO DEFECT NOTED

- 1) Material loss on frame rail was noted to be approximately 1/16"
- 2) Material loss on localized areas on Subframe was approximately 1/16"

Corrosion sub frame passenger side

It is recommended that truck frame rails and subframe be cleaned of all oxidation and scale to clean steel for further examinations to determine material losses

- 1) Localized area on subframe by driverside tie down area to be repaired by weld filling and grinding smooth using sterling weld procedure WP2
- 2) it is recommended that subframe and frame be blasted and repainted to prevent further deterioration

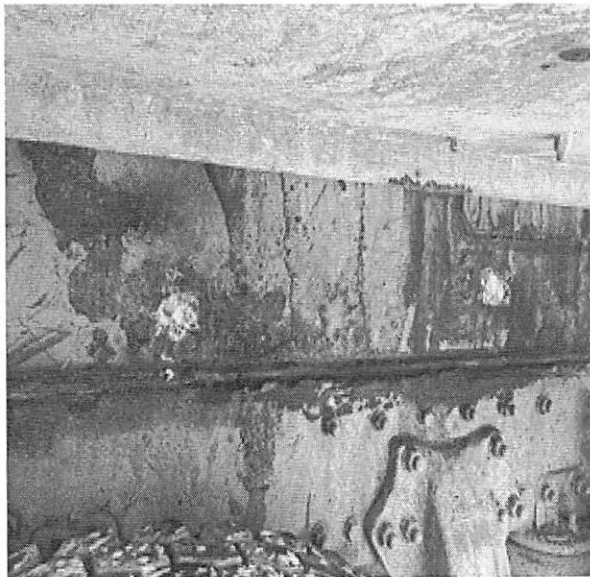
Corrosion passenger side

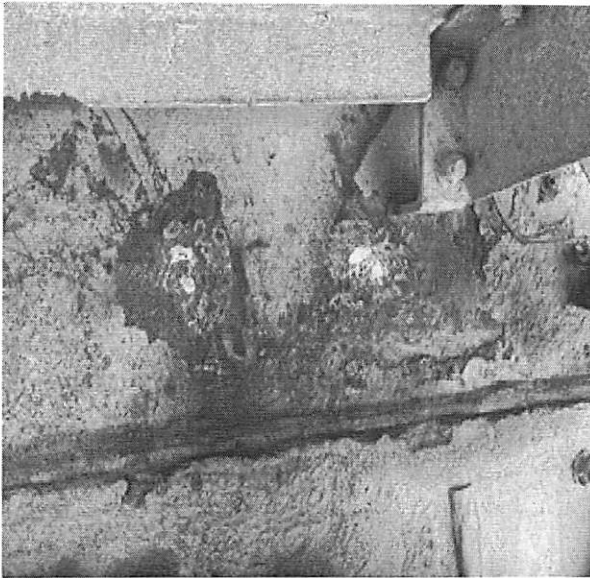
Corrosion passenger side

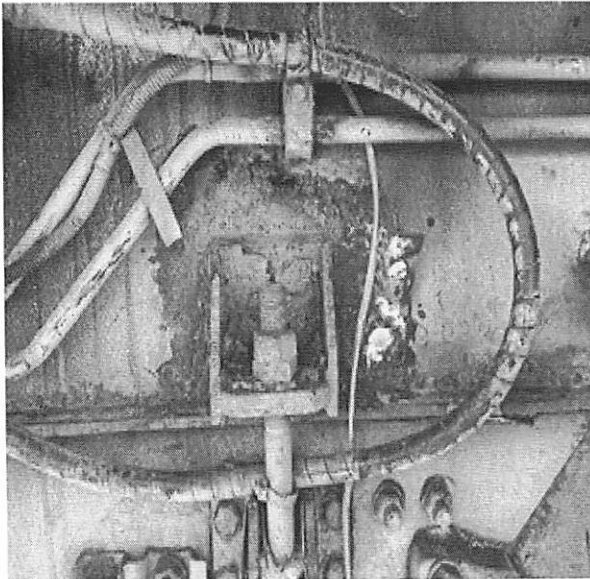
with the exception of a localized area on the driverside tie down which was 3/32"

Corrosion Driverside
