HEAVY EQUIPMENT REPAIRS

# SERVICE REPORT

**Job:** 4000HR service

| Asset A-170089 Skid Steer | | | |

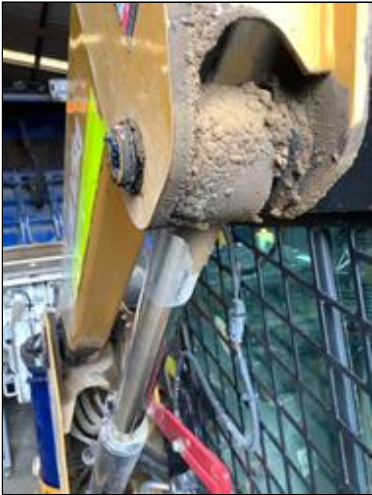
| Defect D-2344 for A-170089 | | | Status: New |

| Boom Cylinders Movement & Condition | OPERATIONAL-SIGNS OF WEAR |

| ... — Boom Cylinders Movement & Condition | | | |

Excessive wear on barrel and rod end of boom cylinders on both sides

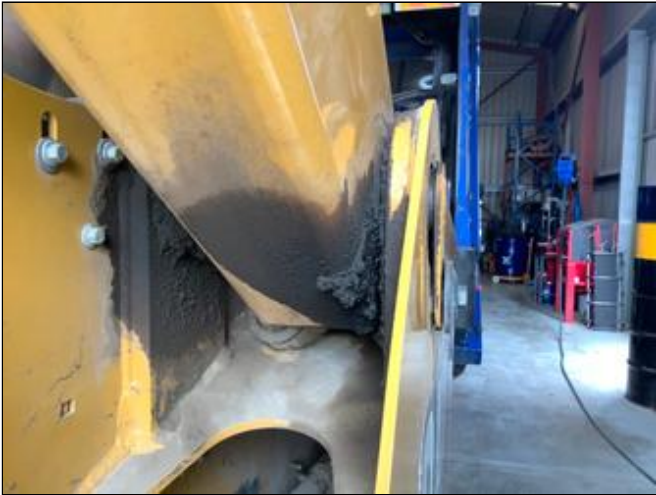
| Defect D-2345 for A-170089 | | | Status: New |

| Boom Pin Movement | OPERATIONAL-SIGNS OF WEAR |

| ... — Boom Pin Movement | | | |

Boom pin has wear on both ends

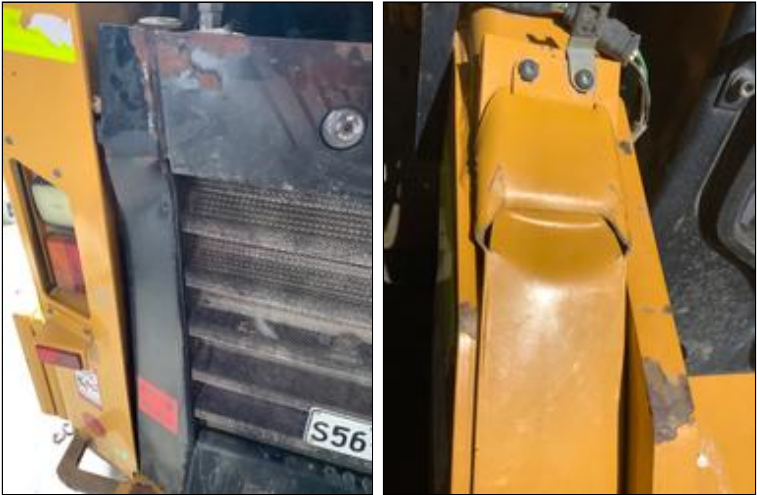
... — Chassis & Frame Cracks/Loose Bolts

| Chassis & Frame Cracks/Loose Bolts | OPERATIONAL-SIGNS OF WEAR |

Dent on right boom cylinder and left side of engine bay door

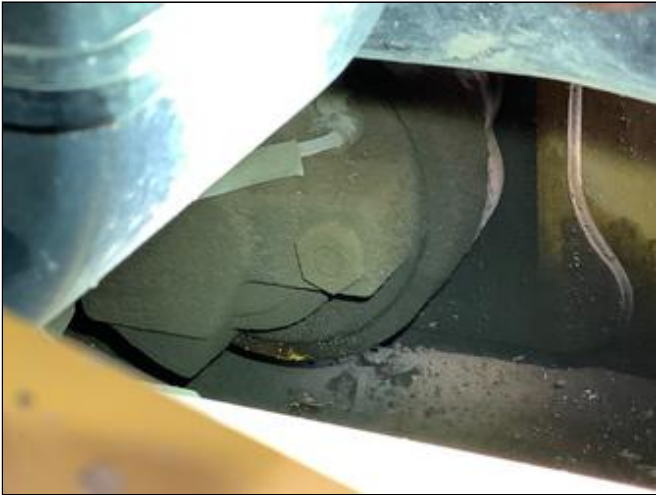
.. — Final Drive/Duo Seal Oil Levels & Leaks

| . | Answer |
|---|---|
| Final Drive/Duo Seal Oil Levels & Leaks | OPERATIONAL-SIGNS OF WEAR |

Both duos leaking/weeping

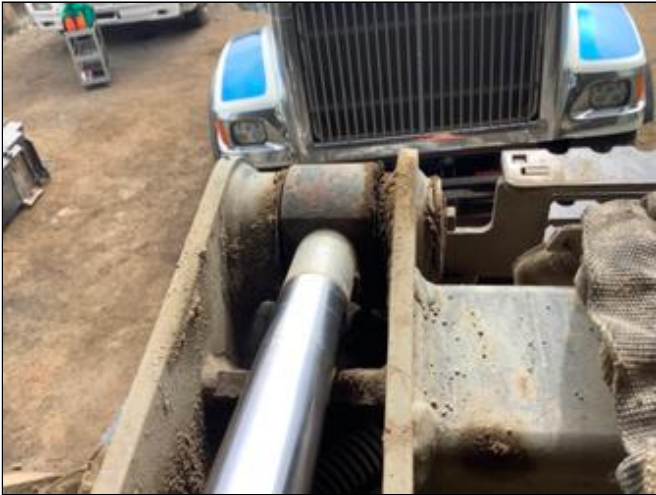
| Defect D-2343 for A-170089 | | | Status: New |

| Tilt Cylinder/s Movement & Condition | OPERATIONAL-SIGNS OF WEAR |

| ... — Tilt Cylinder/s Movement & Condition | | | |

Excessive wear on barrel and rod end of tilt cylinder on both sides

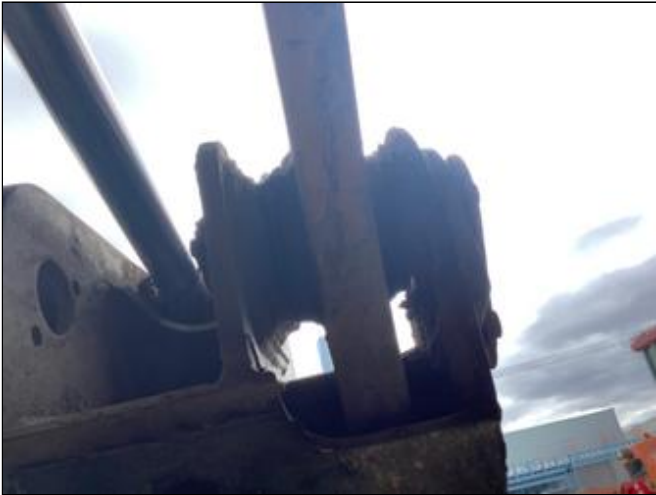
| Defect D-2346 for A-170089 | | | Status: New |

| Tilt Linkage Movement | OPERATIONAL-SIGNS OF WEAR |

| ... — Tilt Linkage Movement | | | |

Tilt link has wear on both sides

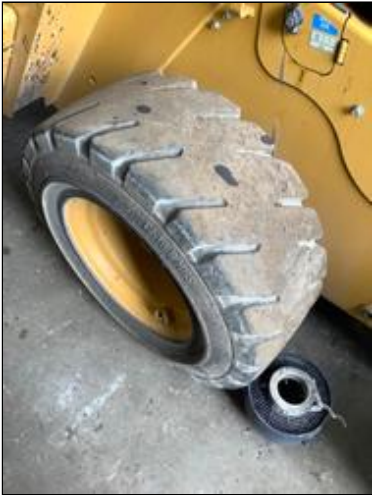
... — Tyre/Rim Condition & Pressure

| Tyre/Rim Condition & Pressure | OPERATIONAL-SIGNS OF WEAR |

Rear tyres low on tread

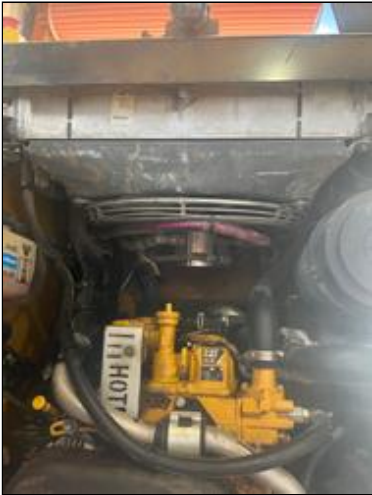
Job Images

**Customer Instruction:** 4000HR service  
Replace Broken Fan Shroud

Removed hydraulic radiator fan Unbolted fan shroud Installed new fan should Refitted fan - zip tied cables/lines out of way Packed up
