# SERVICE REPORT

**Job:** 500HR Service

| Asset A-184337 Skid Steer | | | |
| Make | CAT | Model number | 246D |

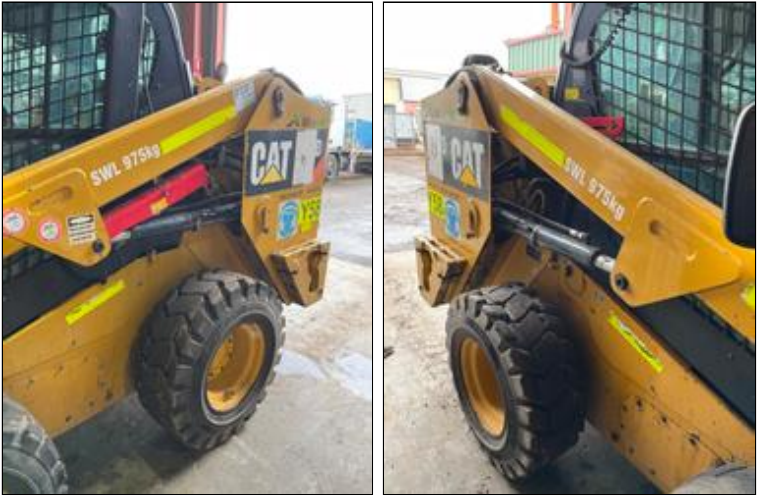
... — Boom Cylinders Movement & Condition

| . | Answer |
|---|---|
| Boom Cylinders Movement & Condition | OPERATIONAL-SIGNS OF WEAR |

Boom cylinders have movement in pins and both ends

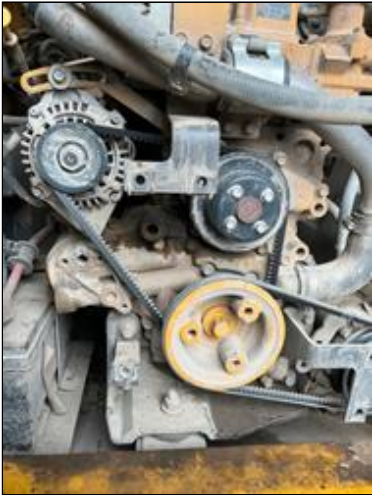
.. — Coolant Level, Leaks & Radiator Cleanliness

| . | Answer |
|---|---|
| Coolant Level, Leaks & Radiator Cleanliness | OPERATIONAL-SIGNS OF WEAR |

Water pump weeping - getting worse

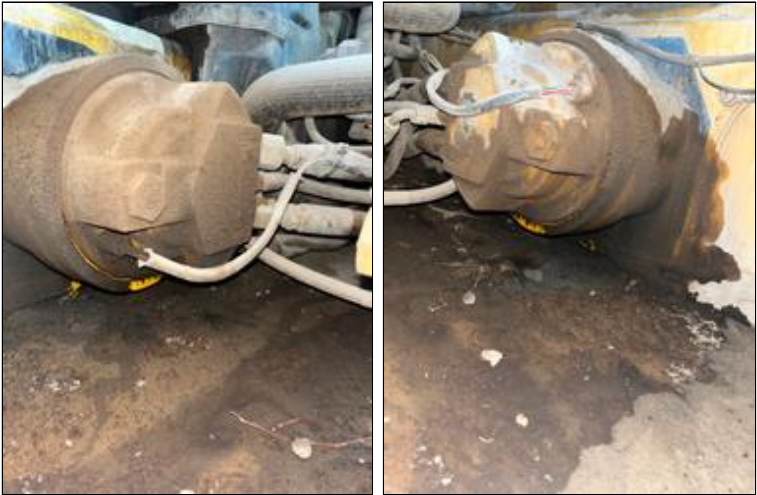
.. — Final Drive/Duo Seal Oil Levels & Leaks

| . | Answer |
|---|---|
| Final Drive/Duo Seal Oil Levels & Leaks | OPERATIONAL-SIGNS OF WEAR |

Both front final drives are weeping - getting worse

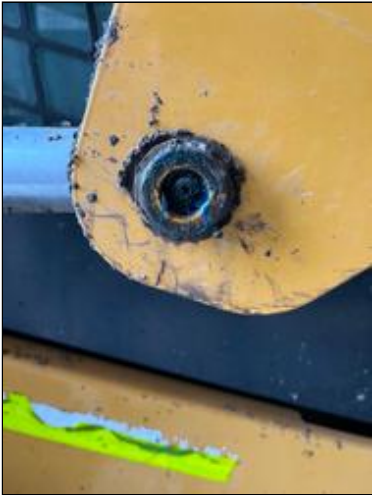
. — Grease System Operation & Condition

| | Answer |
|---|---|
| Grease System Operation & Condition | CRITICAL-NEEDS REPAIR |

Grease nipple snapped off RHS boom cylinder - rod end

Removed and replaced grease nipple

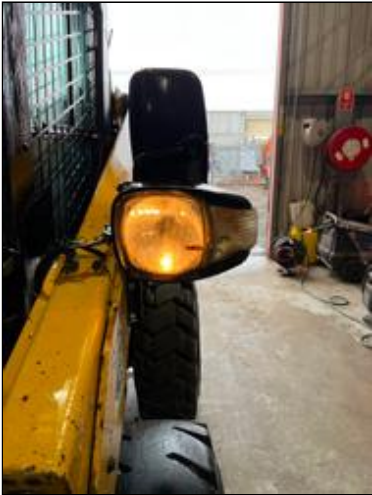
. — Head Lights, Tail Lights & Work Lights

| | Answer |
|---|---|
| Head Lights, Tail Lights & Work Lights | CRITICAL-NEEDS REPAIR |

LHS front head light does not work

Removed blown head light and replaced with new one

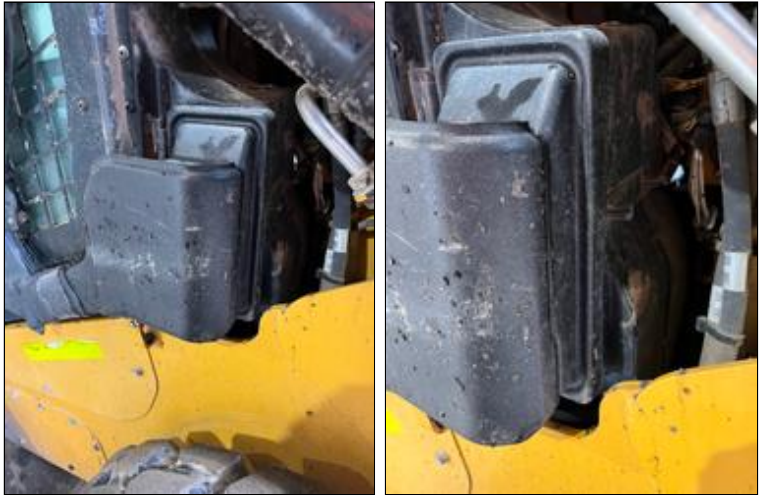
| . — HVAC System Including Filters | | | |

| | Answer |
|---|---|
| HVAC System Including Filters | OPERATIONAL-SIGNS OF WEAR |

External filter housing missing locking tab

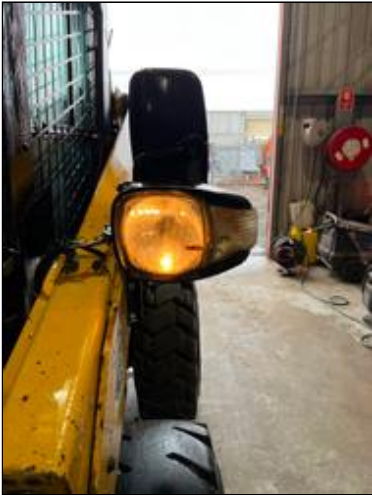
. — Indicators & Hazard Lights

Carried out 500HR service Filters replaced: engine, fuel, outer air Oils replaced: engine oil Noted all faults found Diagnosed LHS indicator not working, found open circuit in harness and a pre existing by pass wire

| | Answer |
|---|---|
| Indicators & Hazard Lights | CRITICAL-NEEDS REPAIR |

LHS front indicator does not work

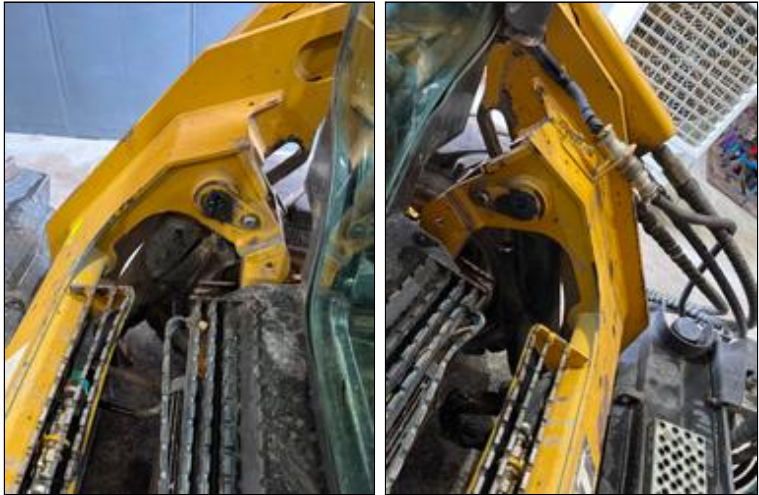
| ... — Tilt Cylinder/s Movement & Condition | | | |

| . | Answer |
|---|---|
| Tilt Cylinder/s Movement & Condition | OPERATIONAL-SIGNS OF WEAR |

Both tilt cylinders have movement in pins at both ends

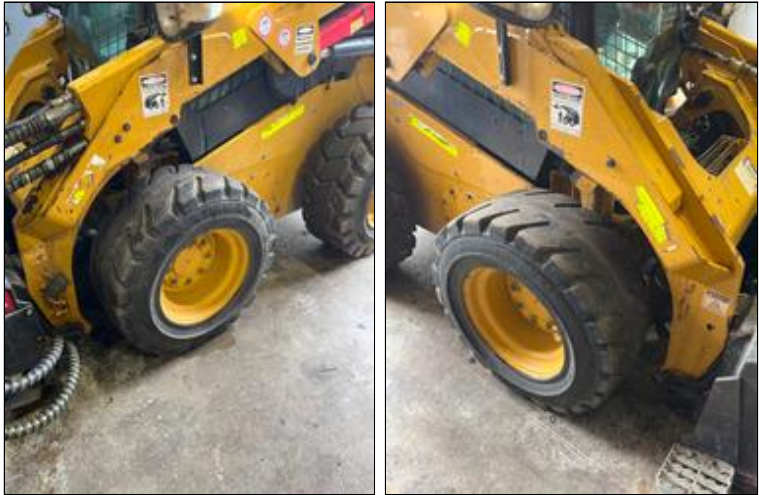
... — Tyre/Rim Condition & Pressure

| . | Answer |
|---|---|
| Tyre/Rim Condition & Pressure | OPERATIONAL-SIGNS OF WEAR |

Both front tyres are low on tread
