REPAIR REPORT

AT744 – CAT 740 – B1P01666 – 18058 Hours

The following is a report on the damage and repairs to Articulated Dump Truck 744 for Garraway Group, Douglas Mine Site, VIC

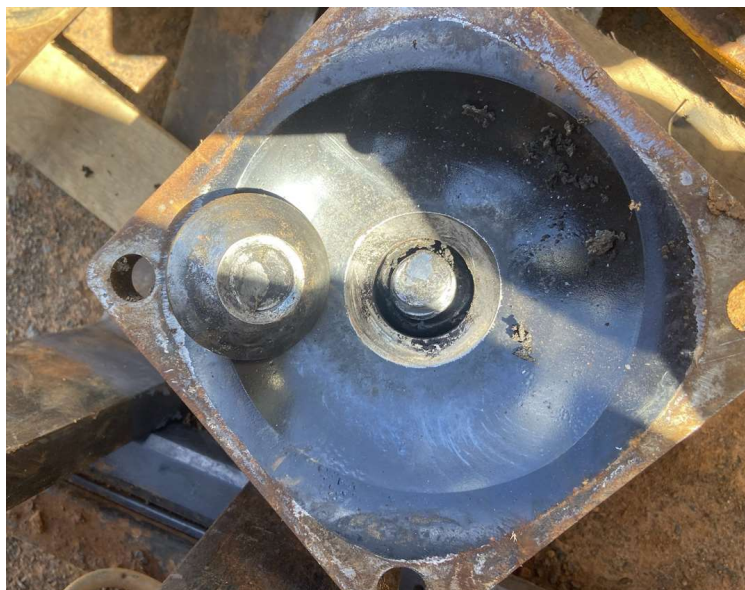
- P3. 212mm Center bolt broken, see photo below.
- P4. 210mm Center bolt intact, stretched.
- P5. 210mm Center bolt intact, stretched.
- P6. 210mm Center bolt intact, stretched.

- All four suspension mounts have been replaced with new ones.
P3,P4,P5,P6

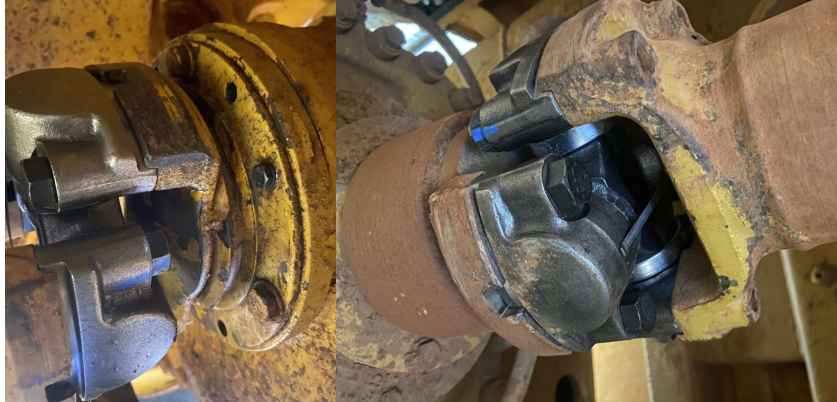
- Oil pooling in P3 wheel due leaking centre axle output yoke. Upon further inspection the centre axle track rod had contacted the drive shaft/yoke – damage to the seal.
- LH hose guide bracket has been bent.
- P3 had dirt pushed between the tyre bead and the rim bead ring, damaged the lock ring protector on the bead seat.
- Damage to the LH front of the tipping body.
- P1 guard had been pushed towards the wheel by the spilling load.

- Centre axle output yoke has had the bearings and seals replaced.
- Uni-joints were replaced on the driveshaft.

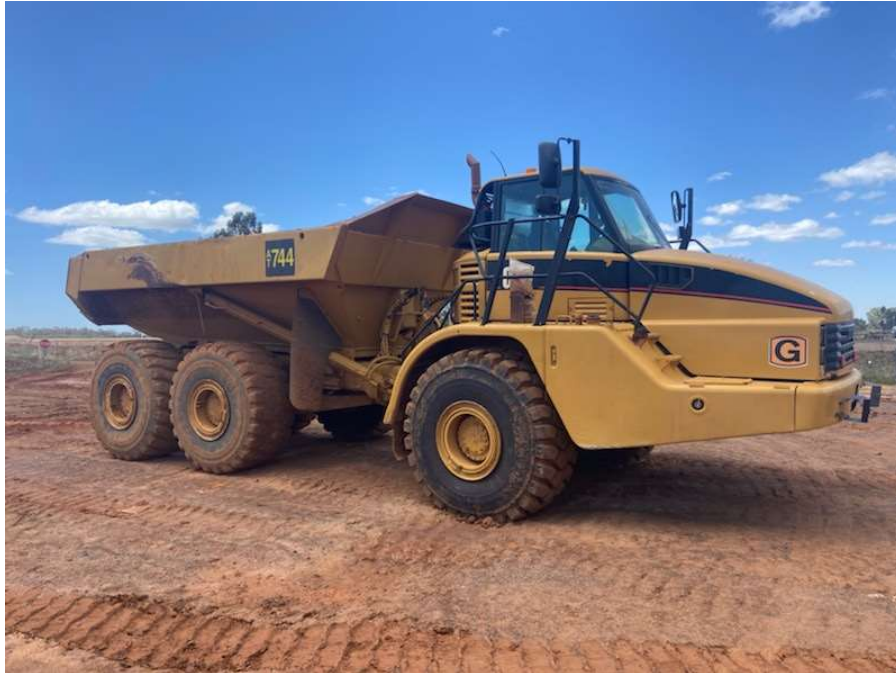
- AT744 now upright and back in working condition.
