**Re: Technical Assessment of Shipping Container Farm**

**Location:** Ritchie Bros. Auctioneers, 245 Taylor Park Drive, Unit 2, Lethbridge, Alberta

**Site Inspection Date:** July 8, 2026

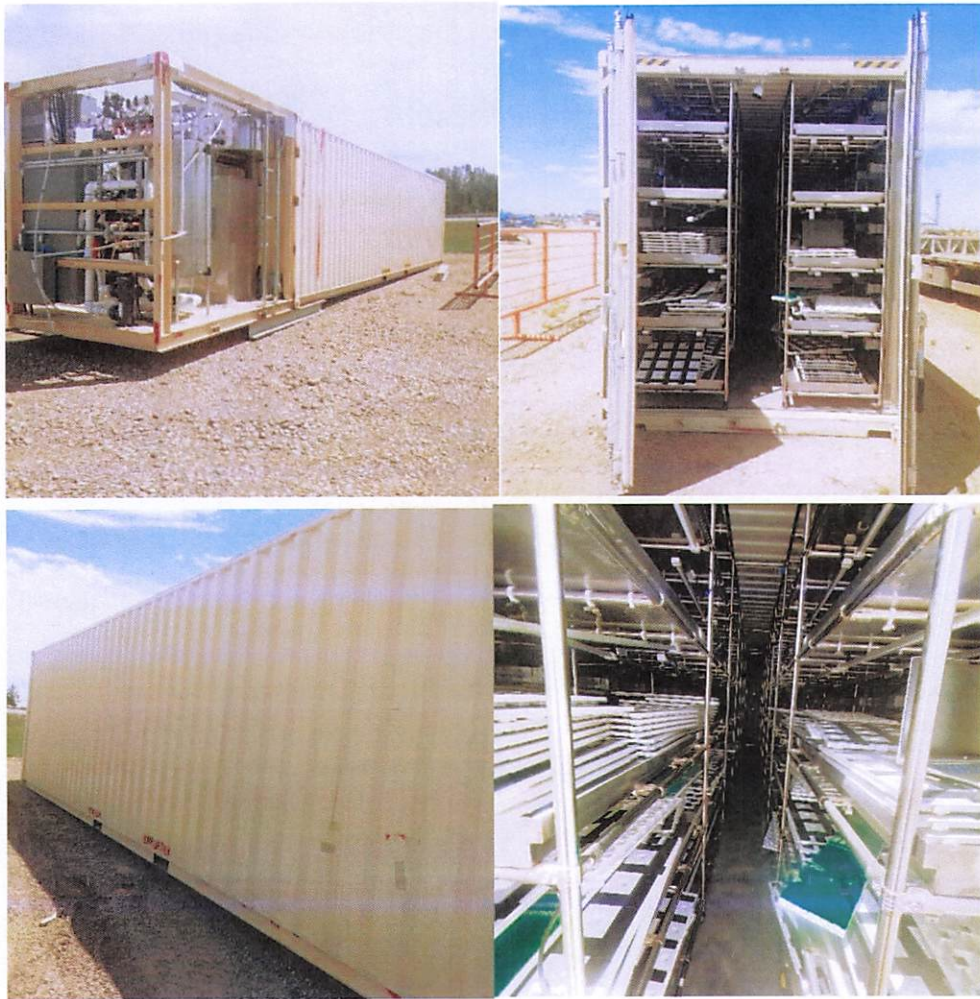
The growing shelves are constructed from custom-fabricated stainless steel flood trays extending the full length of the growing area. The trays are rigidly supported and appear to remain in good physical condition with no visible signs of distortion, corrosion, or leakage. The use of continuous stainless steel construction minimizes potential leak points while providing a durable and easily sanitized growing surface suitable for commercial food production.

The growing rafts appeared to be present and generally accounted for during the inspection. No significant physical damage was observed to the raft assemblies or growing channels. The growing aisle between production racks measures approximately 18 inches in width. While adequate for routine crop maintenance and harvesting, the relatively narrow aisle may restrict movement of personnel and equipment during servicing and cleaning operations.

Overall, the growing infrastructure remains one of the strongest aspects of the recovered asset. The extensive use of stainless steel construction, robust fabrication, and improved plant spacing provides a durable production platform with an expected service life well beyond many commercially available container farming systems. However, due to the design, the container is not suitable for use outdoors.

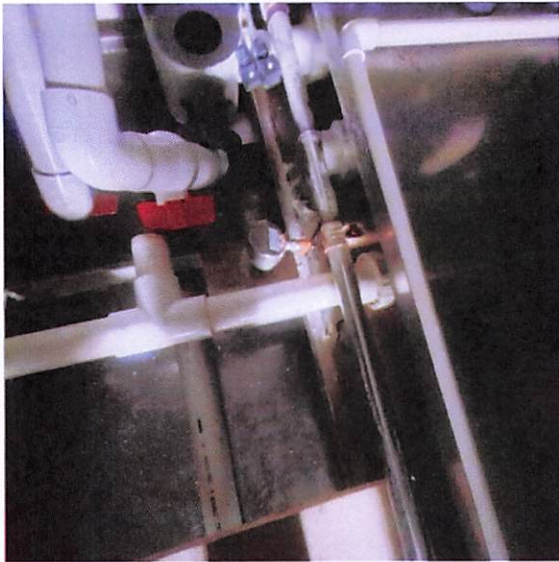
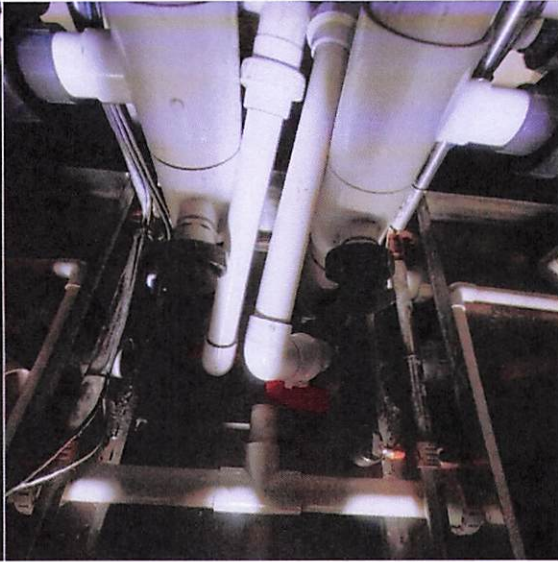
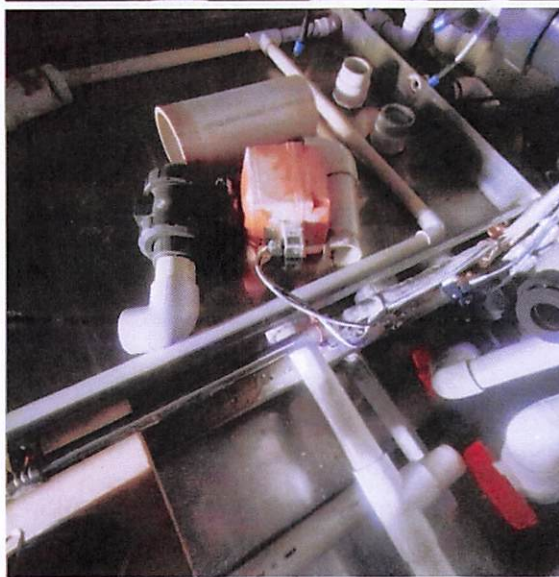
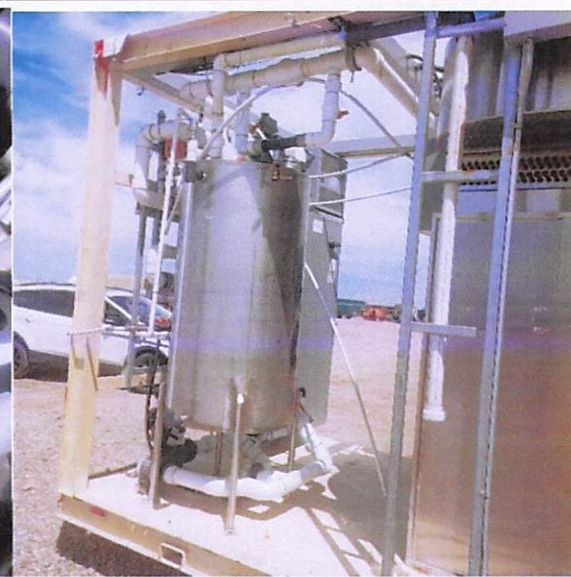
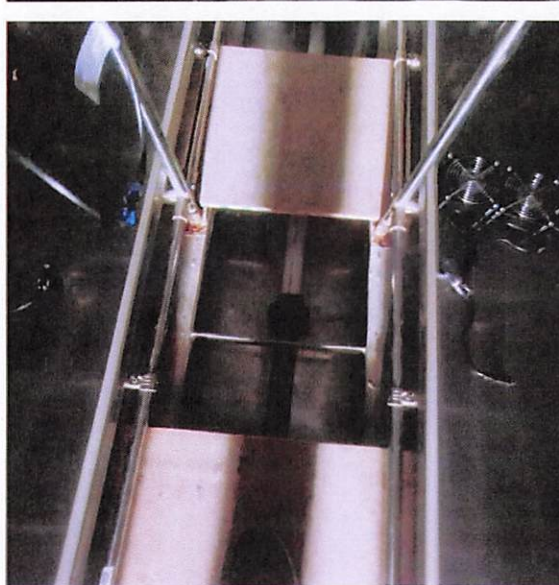
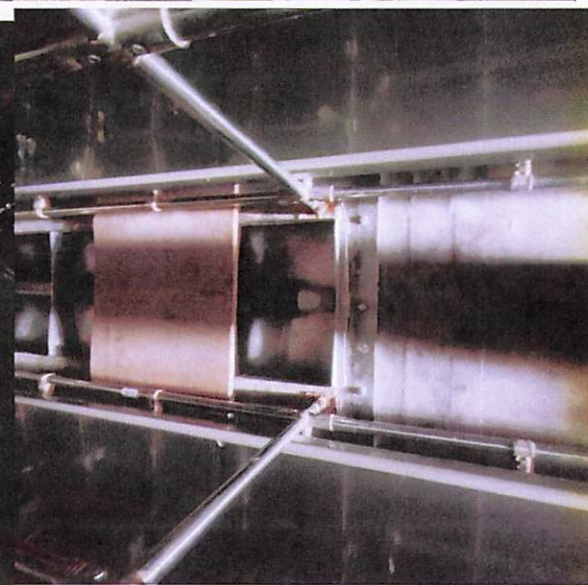
The primary nutrient reservoir is constructed from stainless steel and remains in good physical condition. The tank exhibits no visible signs of structural damage, significant corrosion, or leakage. The use of stainless steel for the nutrient reservoir is considered an excellent design feature, providing superior corrosion resistance, ease of sanitation, and long service life in comparison to plastic or painted steel tanks.

routed to allow access for maintenance and servicing. However there are areas where the plumbing is disassembled, missing part so pipes, unions, perhaps instrumentation such as valves and sensors.

The most significant deficiency identified within the nutrient delivery system is the absence of the primary circulation pump located beneath the nutrient reservoir. Based on the installed piping configuration and connection sizes, this pump is estimated to have been approximately 5 horsepower or greater and would have served as the primary circulation pump supplying nutrient solution throughout the growing system. Based on the sophistication of the remaining control equipment, it is also likely that the pump was equipped with Ethernet or industrial communications for integration with the control system.

Without replacement of the primary circulation pump, adding the missing valves and plumbing section the nutrient delivery system is not capable of operating.

Several brass fittings were observed within portions of the PEX plumbing network. While brass fittings are commonly used in potable water systems, they are generally not recommended within recirculating hydroponic systems due to the potential for trace metal leaching into nutrient solutions over extended periods of operation. Although this does not represent an immediate operational concern, replacement with stainless steel or food-grade polymer fittings would be considered best practice during refurbishment.

During the inspection, it was also observed that several floor access panels located at the rear of the container were missing. These panels are intended to provide safe access over the drain tank and associated plumbing located beneath the floor. In their current condition, the exposed openings present a potential safety hazard to personnel and increase the likelihood of tools, growing media, plant material, or other debris falling into the drain tank

and process piping. Replacement of the missing floor panels should be considered a priority before the facility is returned to service to restore a safe working surface and protect the underlying process equipment.

| Item | Deficiency | Recommendation | Priority |
|---|---|---|---|
| Nutrient Delivery | Main circulation pump missing beneath nutrient reservoir. | Supply, install and commission replacement pump. | High |

| <b>Item</b> | <b>Deficiency</b> | <b>Recommendation</b> | <b>Priority</b> |
|---|---|---|---|
| Floor Panels | Floor access panels over the drain tank are missing. | Fabricate and install replacement floor panels to restore a safe walking surface. | High |

| Item | Deficiency | Recommendation | Priority |
|---|---|---|---|
| Plumbing Materials | Brass fittings observed within portions of the nutrient system. | Replace with stainless steel or food-grade polymer fittings during refurbishment. | Low |

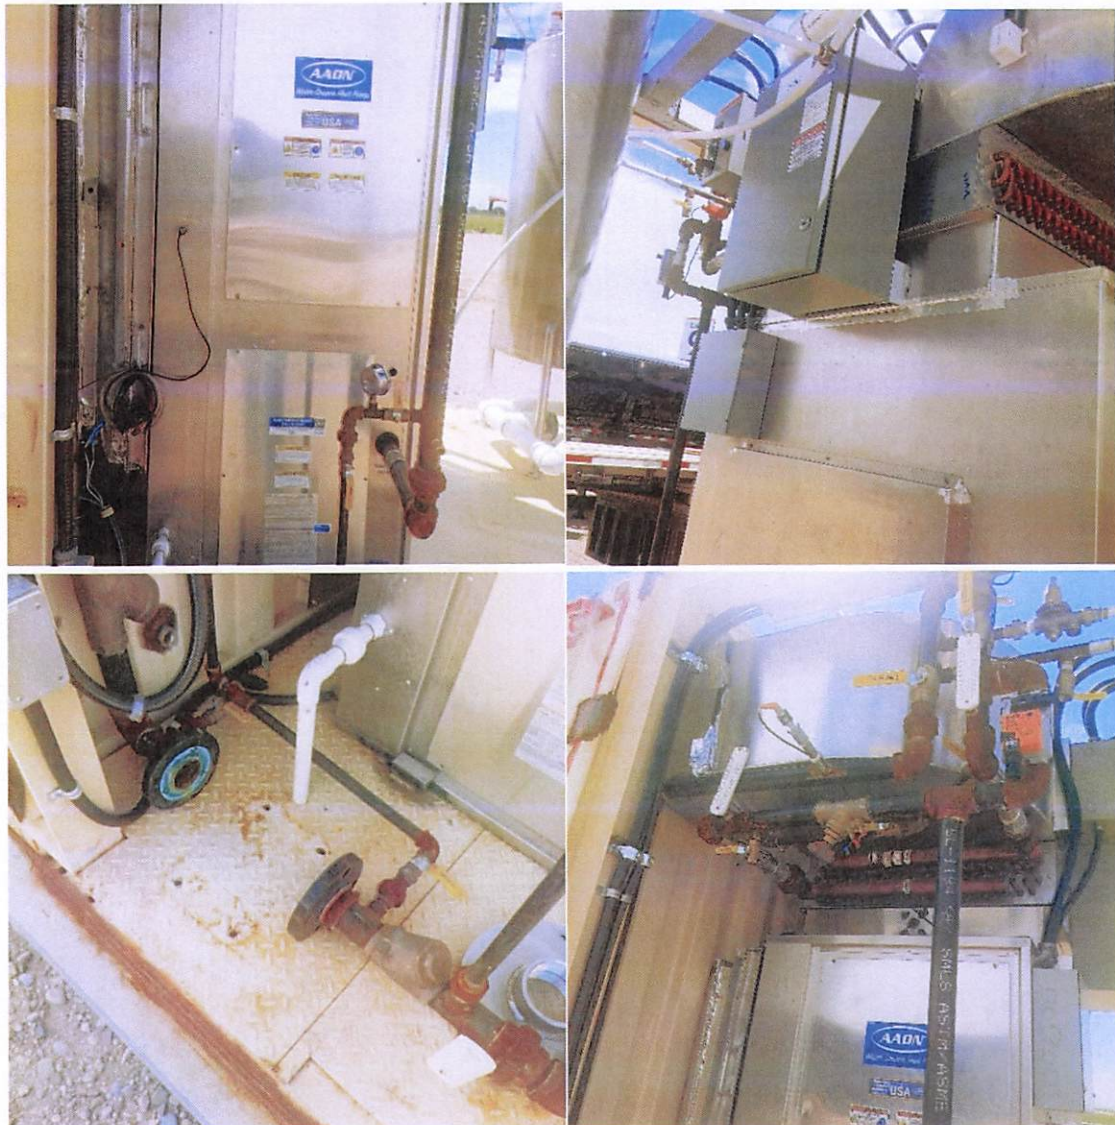
The HVAC equipment appears to remain largely intact and in good physical condition. The air handling equipment, ductwork, piping, and associated mechanical components exhibited no obvious signs of significant physical damage during the visual inspection. Surface corrosion was observed on portions of the carbon steel piping and fittings; however, this appears to be cosmetic in nature and consistent with normal exposure to moisture. No evidence of significant corrosion or structural deterioration was observed.

The most significant deficiency identified during the inspection is the absence of the primary HVAC circulation pump responsible for transferring heat from the HVAC system to the process water. Without this pump, the environmental control system cannot reject heat from the growing enclosure and is therefore incapable of maintaining proper operating temperatures. Replacement of this component will be required before the facility can be recommissioned.

Several environmental monitoring devices that would typically be used to measure growing conditions, including air temperature, relative humidity, and other environmental parameters, appear to be missing from the growing chamber. These sensors are required to provide feedback to the control system and maintain stable environmental conditions. Replacement and calibration of these sensors will be necessary before automatic environmental control can be achieved.

| Item | Deficiency | Recommendation | Priority |
|---|---|---|---|
| HVAC System | Primary liquid cooling circulation pump missing. | Supply and install replacement pump. Commission cooling loop. | High |

| <b>Item</b> | <b>Deficiency</b> | <b>Recommendation</b> | <b>Priority</b> |
|---|---|---|---|
| Environmental Sensors | Several environmental sensors are missing. | Supply, install and calibrate replacement sensors. | High |

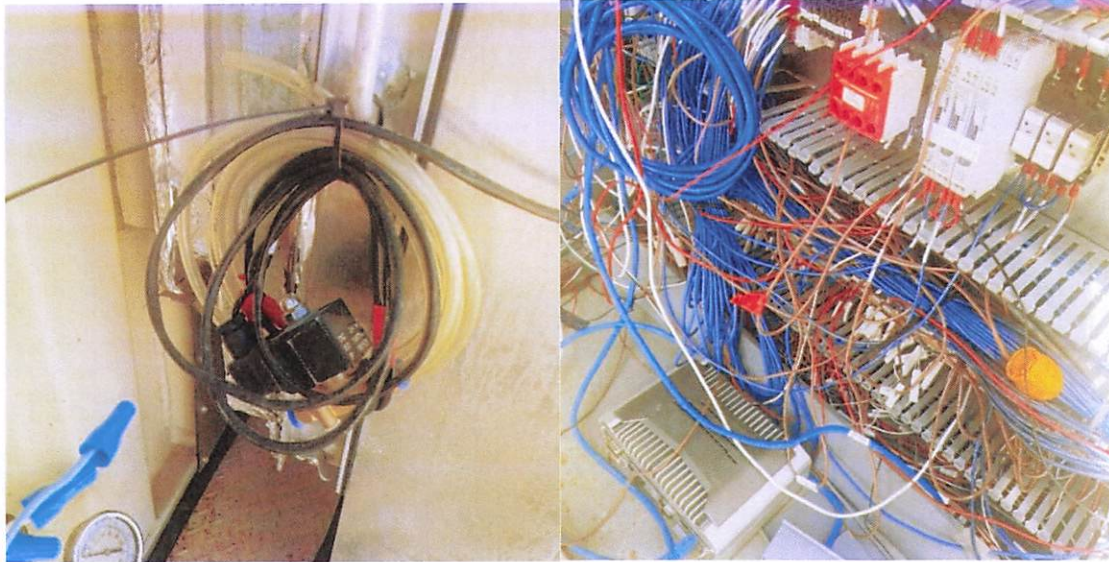
The primary electrical control panels remain installed and most internal components appear physically intact. Two industrial Variable Frequency Drives (VFDs) remain installed within the main control enclosure and represent a significant portion of the remaining equipment value. However, several electrical enclosures exhibit cosmetic damage and should be repaired or replaced prior to recommissioning.

Numerous field modifications appear to have been made after the original construction of the system. Wiring associated with instrumentation and process controls appears to have been altered, with several circuits appearing incomplete or disconnected. Flow and pressure monitoring devices were observed without complete field wiring, making it difficult to determine the intended operation of portions of the control system.

The overall condition of the field wiring is considered a significant concern. Although portions of the panel wiring remain neat and professionally assembled, undocumented modifications throughout the system substantially increase the complexity of troubleshooting and recommissioning. Prior to placing the facility back into service, all field wiring should be verified against newly developed electrical drawings, and all circuits should undergo continuity testing, insulation resistance testing, and functional verification.

Another consideration for future operation is that a significant portion of the equipment labeling, electrical identification, and control panel markings are provided in French. While this may have been appropriate for the original installation, replacement labeling in English is recommended to improve maintainability, simplify troubleshooting, and ensure consistency with industry practices in Western Canada.

| Item | Deficiency | Recommendation | Priority |
|---|---|---|---|
| Electrical Identification | Much of the electrical equipment is labeled in French. | Replace or supplement labeling with English identification. | Medium |
| Electrical Enclosures | Minor cosmetic damage observed on selected electrical enclosures and junction boxes. | Repair or replace damaged enclosure components as required. | Low |
