# Work Order

CAT RM350-B RECLAIMER

# Road Reclaimer / Soil Stabilizer TA1

Inspection Number	22994282	Customer No	2969545903
Serial Number	AXW00279	Customer Name	SILVERADO SITE SERVICES LTD
Make	CATERPILLAR	Completed On	2025-05-30 11:28:09 AM
Model	RM-350B	Inspector	Ben Pospisil
Equipment Family	RECLAIMER & STABILIZER (SRSR)	PDF Generated On	2025-05-30
SMU	6711 Hours	Location	8426 116 St, Fort Saskatchewan, AB
Coordinates	625.768210886978, 53.7058246579766, -113.180653790676		
Technician	BP

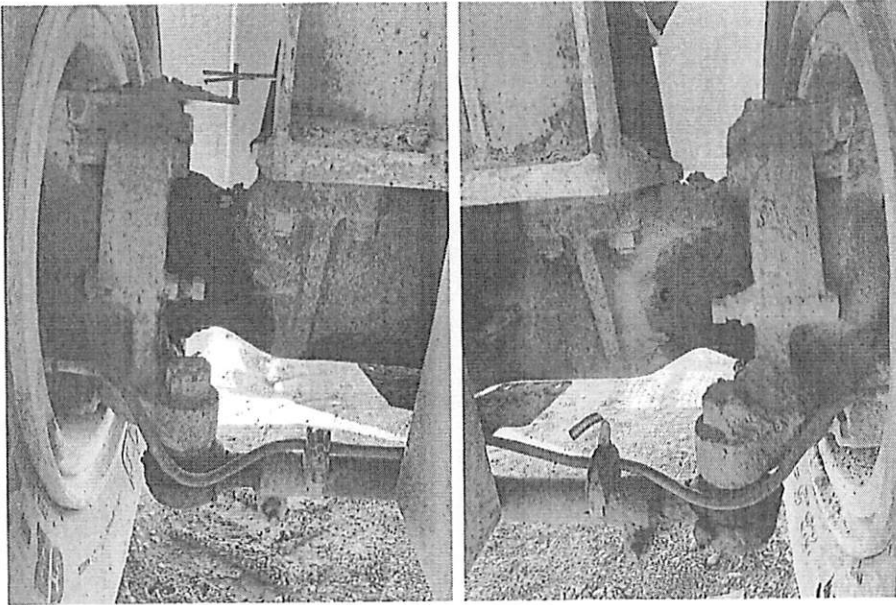
④ **2.2 Final Drives & Wheel Spindles** MONITOR  
 Comments: Axle seals sweating.

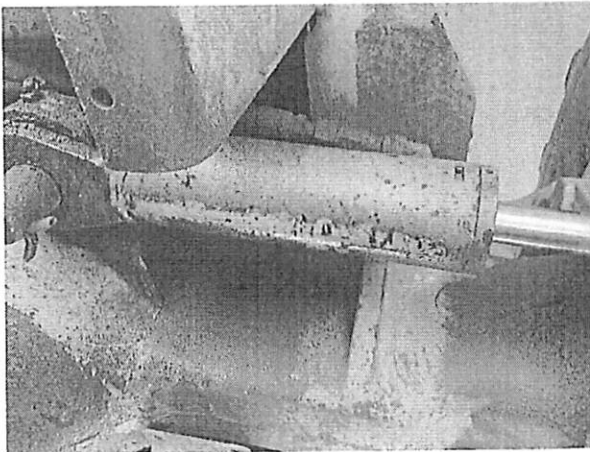
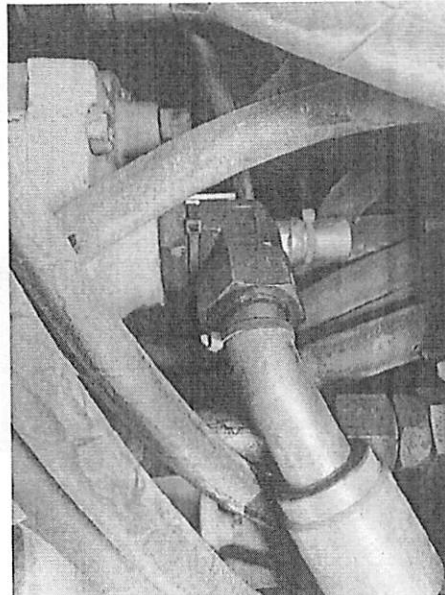
● 2.4 Steering Cylinders, Tie Rods & Linkages- MG

Comments: Hose off the trans charge pump is leaking washing down steering cylinder lines/cylinder.

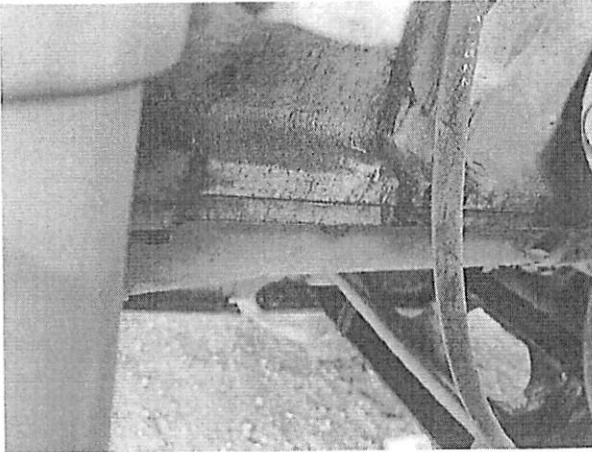
● 3.5 Engine Oil Pan

Comments: Small sweat LH side of engine

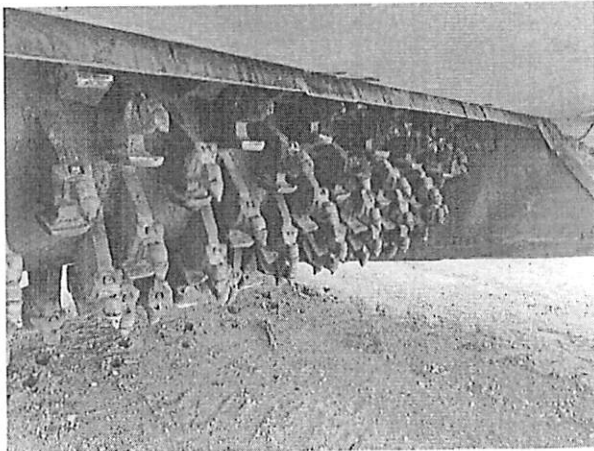
- 5.9 Rotor cutter bits

Comments: Appears there may be some bent on the rh side of rotor that have touched side of rotor hood.

Comments: Mix of new and worn

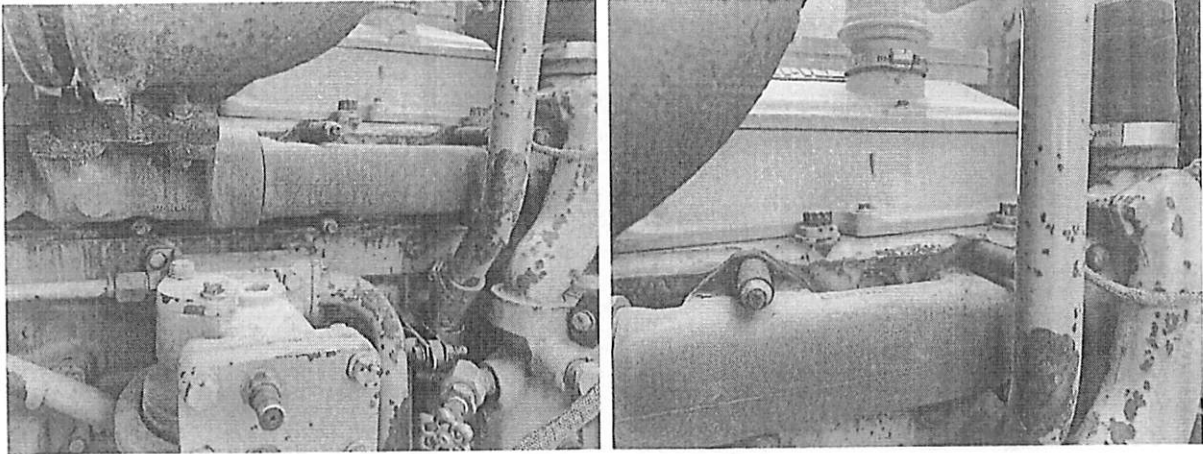
- 3.1 Cylinder Head and Valve Cover NORMAL

Comments: No leaks, all dry and tight.

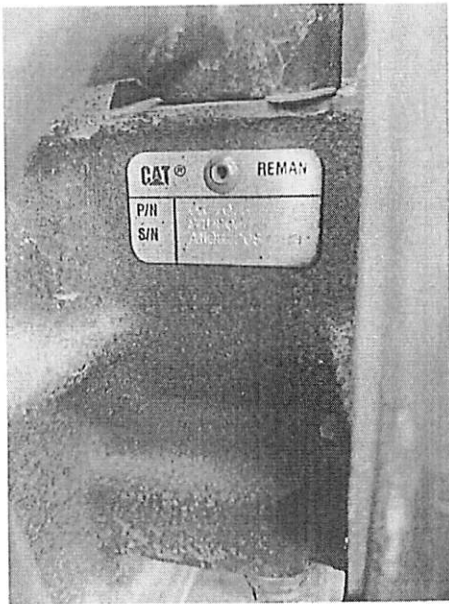
- 3.3 Turbocharger

Comments: Reman turbo

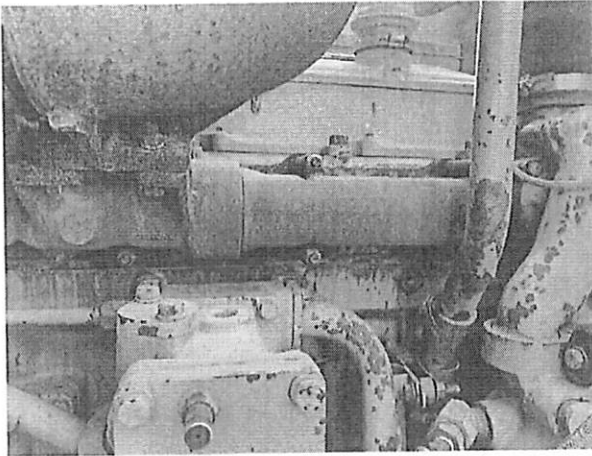
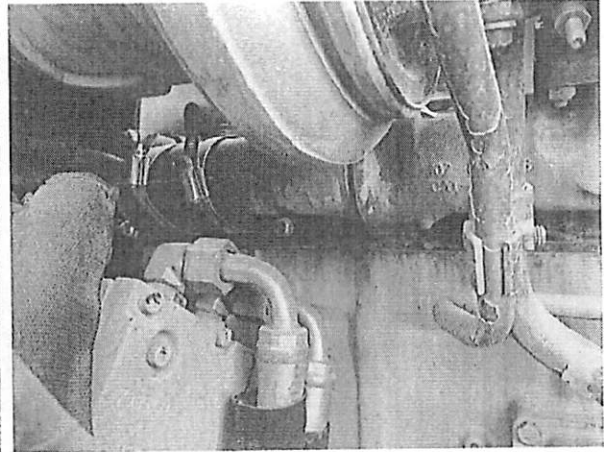
- 3.4 Exhaust Manifold

Comments: No evidence of leaks, all shields in place.

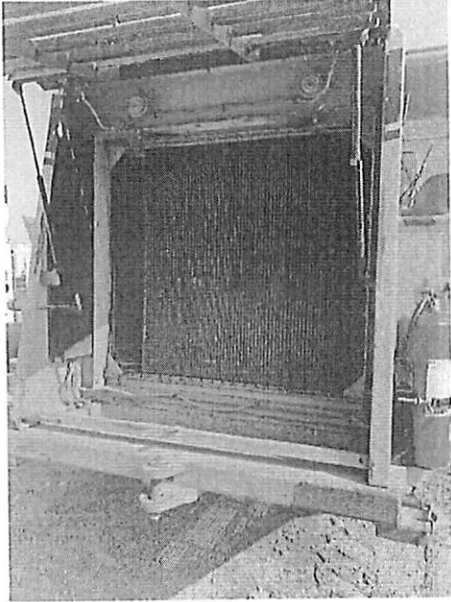
- **3.6 Pulleys, Belts, Compressor Clutch and Alternator** *NORMAL*  
Comments: Customer just replaced, all brand new.
- **3.7 Fuel Priming Pump** *NORMAL*  
Comments: Unit starts well & runs good.
- **3.8 Fuel Lines, Fuel Pump and Fuel Filter Base** *NORMAL*
- **3.9 Engine wiring harness** *NORMAL*
- **3.10 Upper and Lower Radiator Lines, Air Inlet Lines and Aftercooler Lines** *NORMAL*  
Comments: Customer just resealed rad & hoses
- **3.11 Radiator, Air Inlet, Oil Cooler & Aftercooler Lines** *NORMAL*
- **3.12 Cooling Fan, Fan Guard and Shroud** *NORMAL*
- **3.13 Radiator, Aftercooler, Oil Cooler & Condenser** *NORMAL*  
Comments: All resealed.

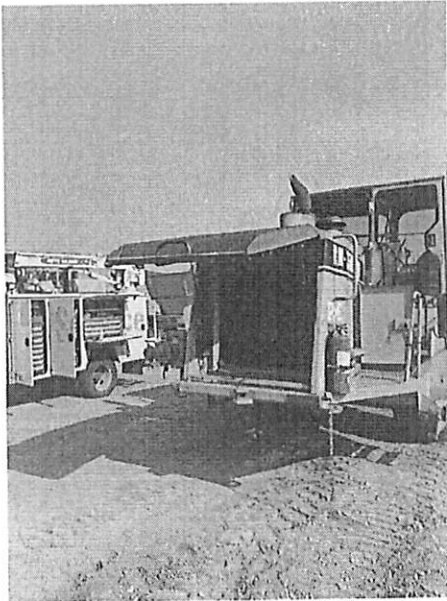
● **3.14 Hood and hood tilt cylinder**

Comments: Hood shocks replaced by customer.

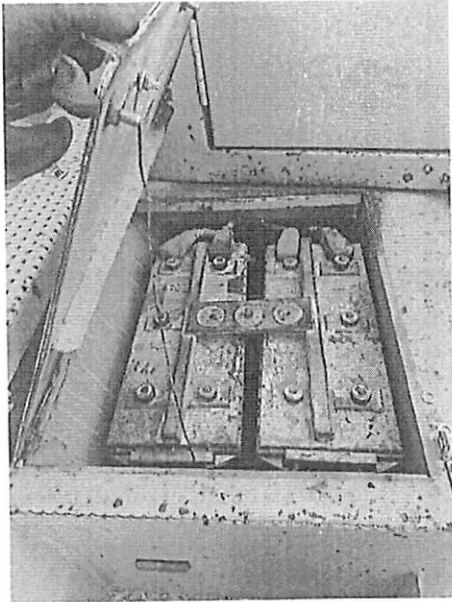
● **3.15 Battery & Cables**

Comments: Passed load test

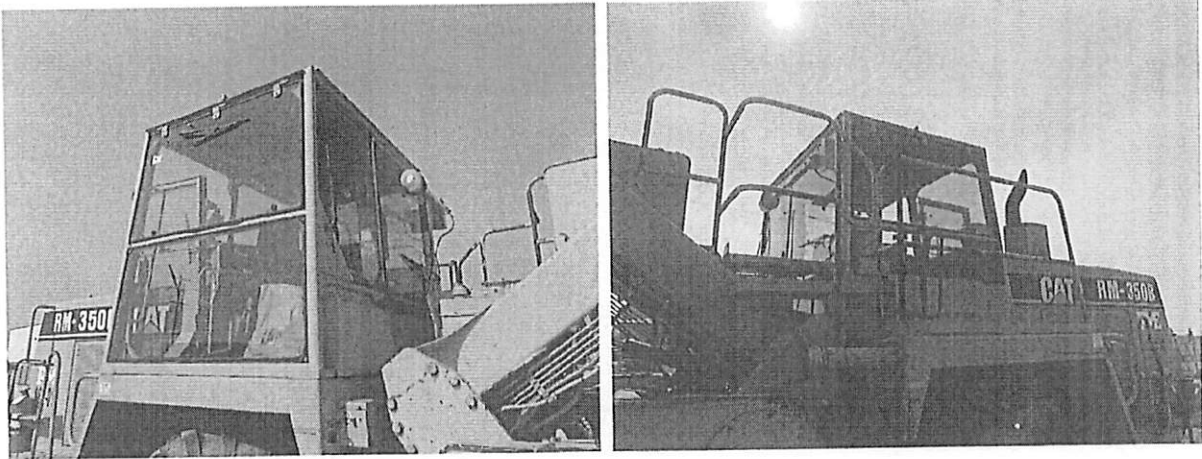
● **4.6 Cab Exterior**

Comments: All glass in place and free of cracks, RH window wiper motor missing

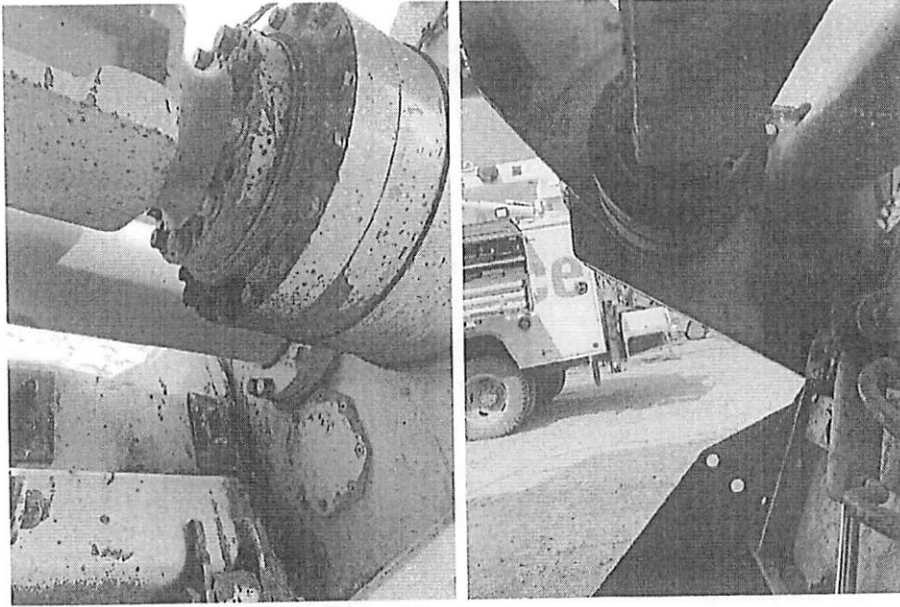
- **5.13 Rotor drive planetary** *NORMAL*

Comments: Left and right final drives appear to be sweating.

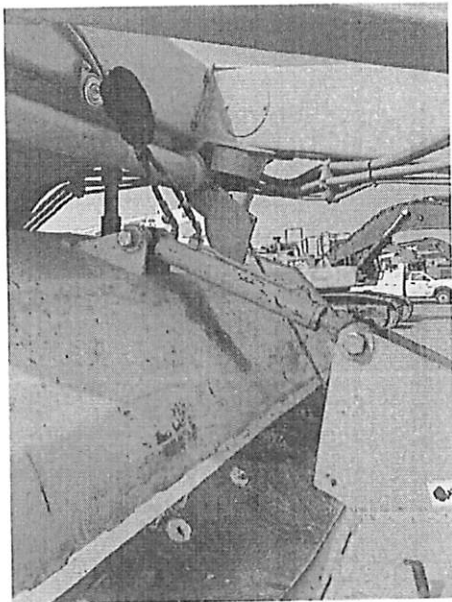
- 5.15 Mixing chamber rear door cylinder

Comments: Functions, no leaks
