Condition & Valuation Survey Report

HM 166

Re: Survey of Barge HM 166

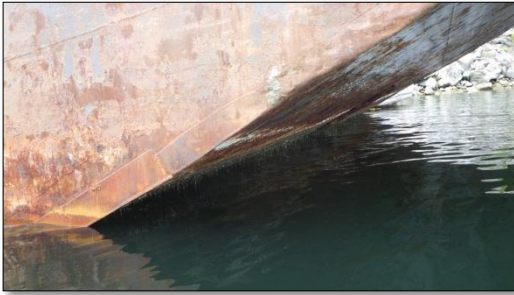
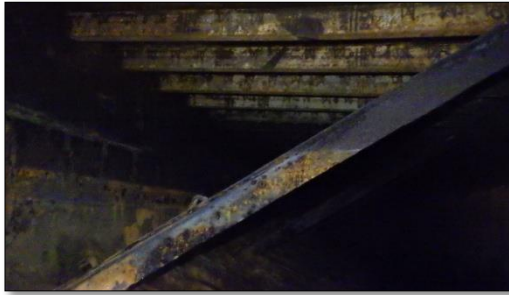
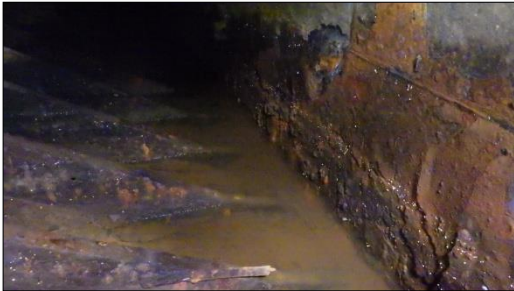
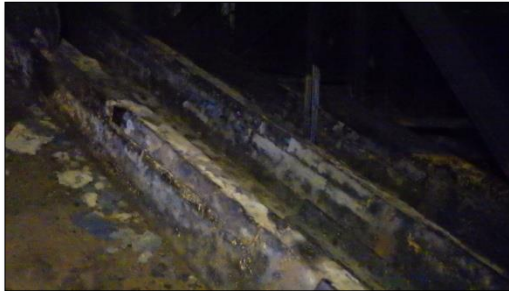
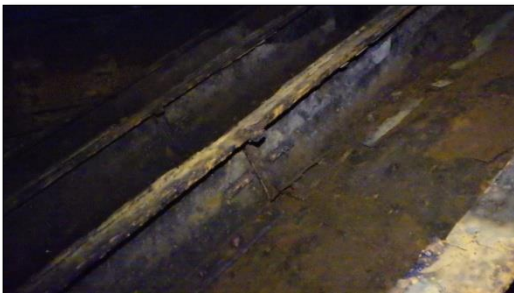
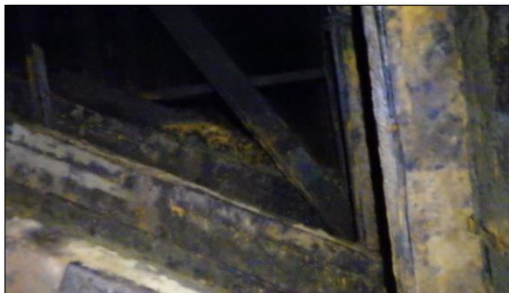
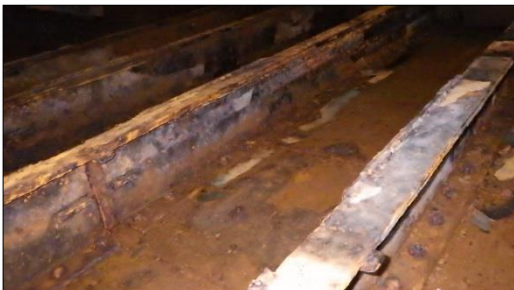
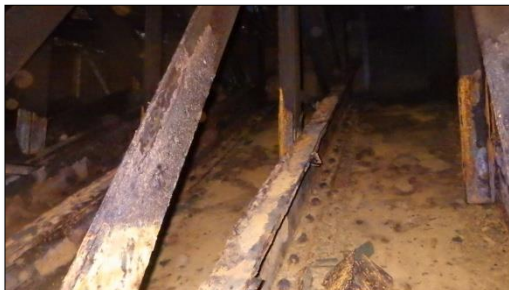
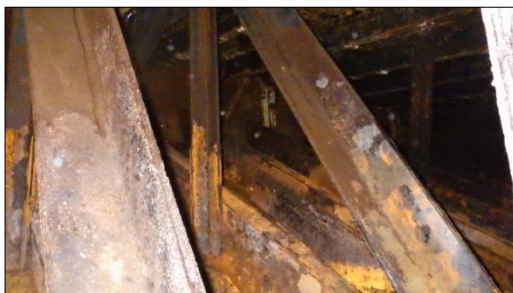
Void Bow 1

- Deck 0%
- Side shells 0%
- Bulkheads 0%
- Hull 0%

- ~10% wasted

- BH to H-P moderate wasting

- External SS-P to rake B-P 4" x 4" angle welded

- 3" water

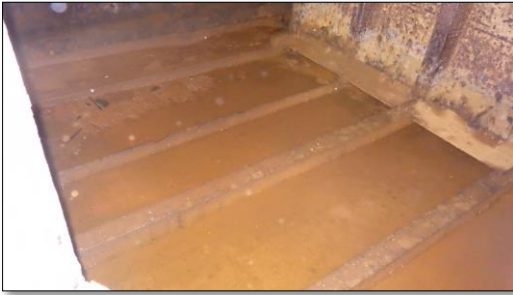
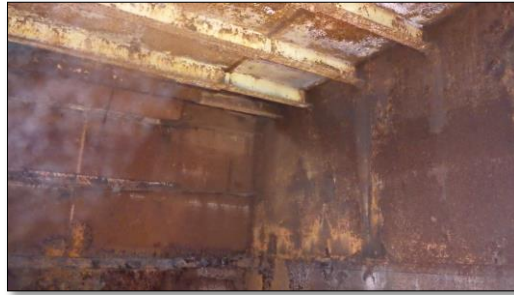
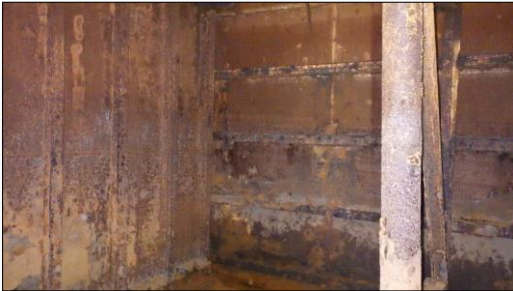
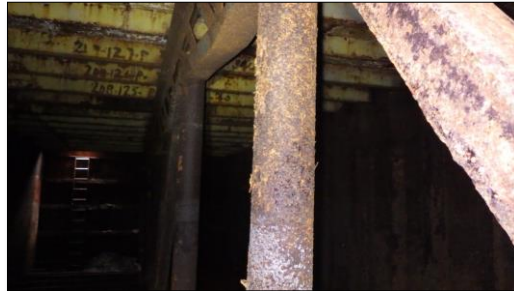
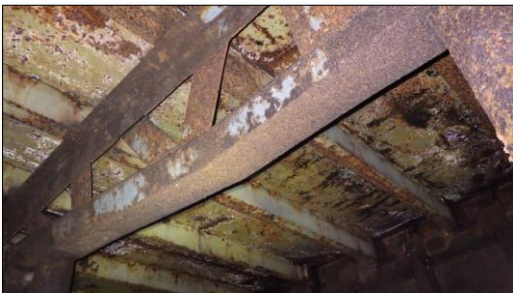
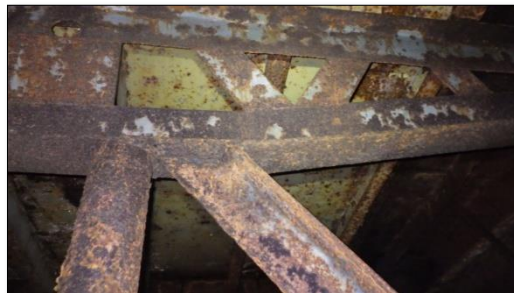
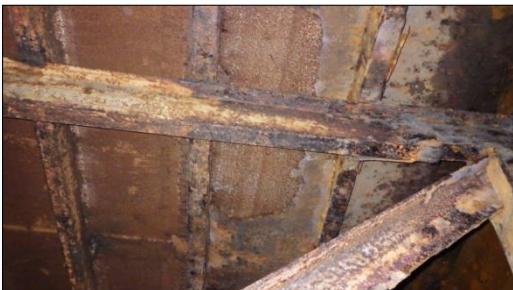
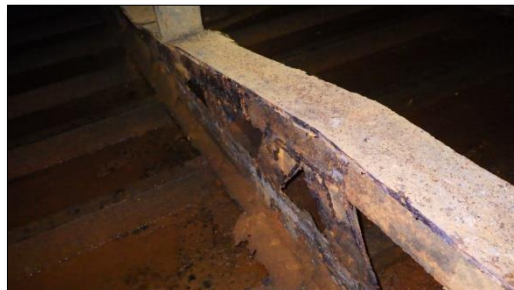
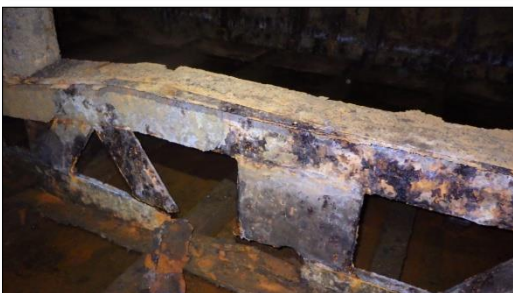
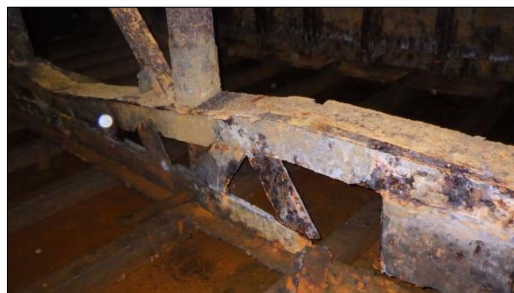
Void 2

- Deck ~20%
- Side shells ~30%
- Bulkheads ~20%
- Hull 0%

- D-LF set down light

- SS-LF ~20% wasted

- ~15% wasted

- **B-TG in Bay 3 100% wasted

- 2" water

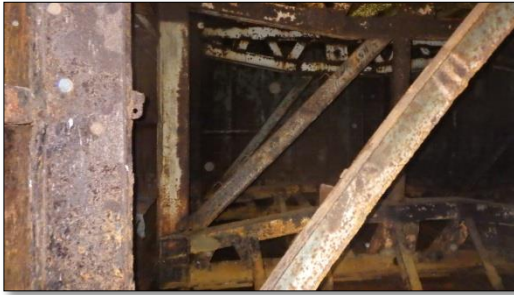
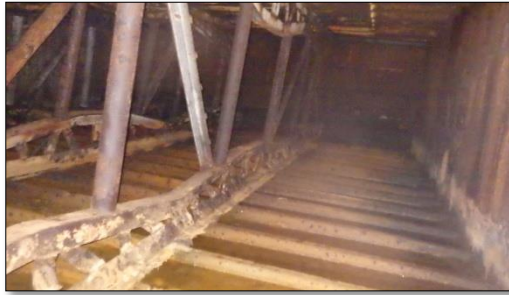
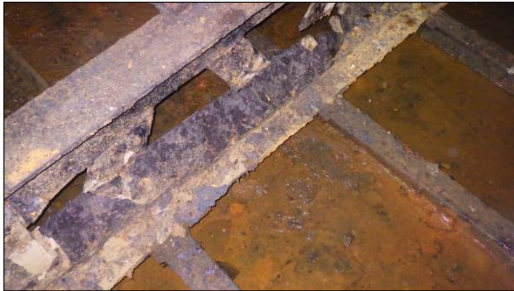
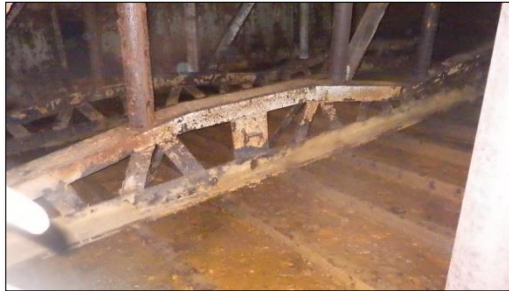
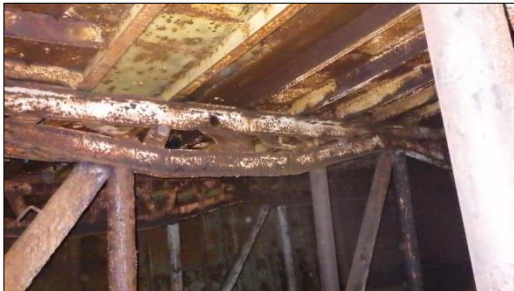
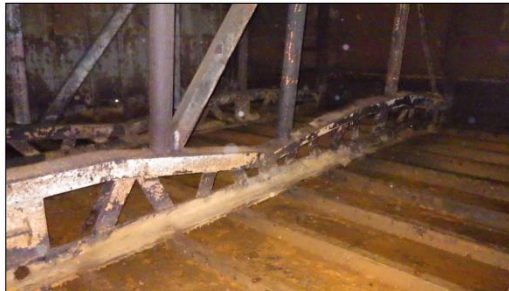
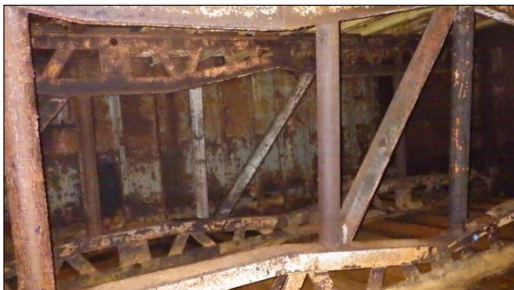
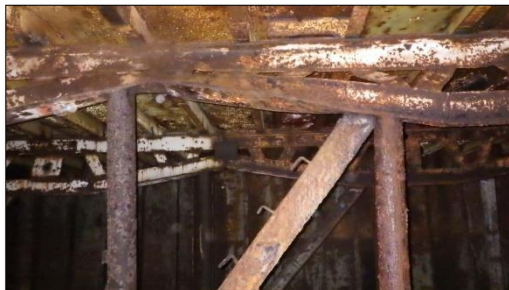
Void 3

- Deck ~20%
- Side shells ~30%
- Bulkheads ~20%
- Hull 0%

- D-TG set over moderate Bay 2

- ~20% wasted

- ~10% wasted

- B-TG set over moderate Bay 3

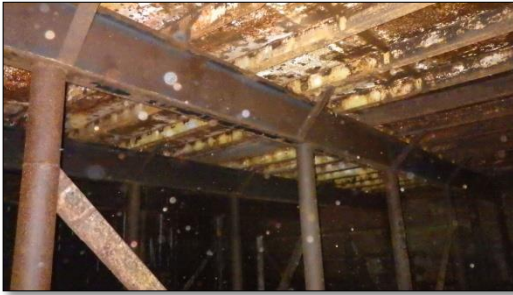
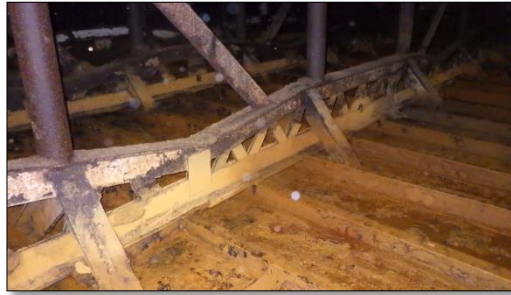
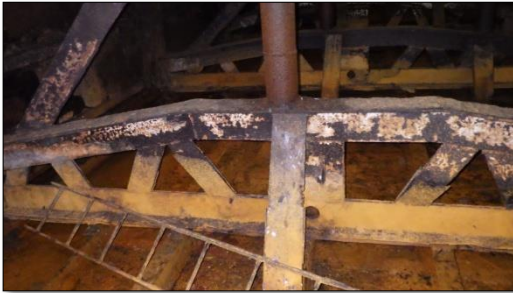
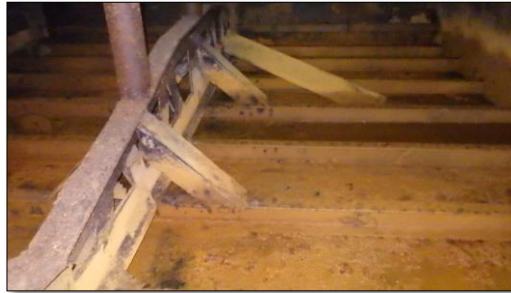
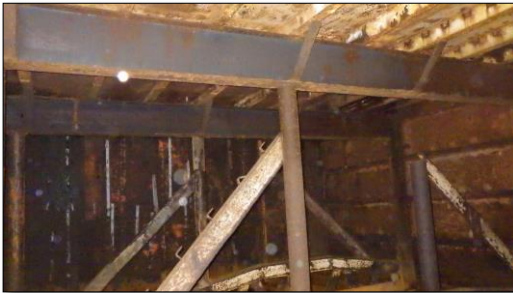
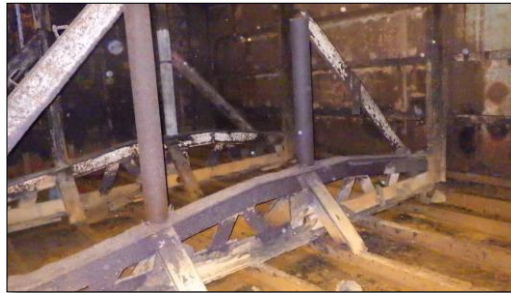
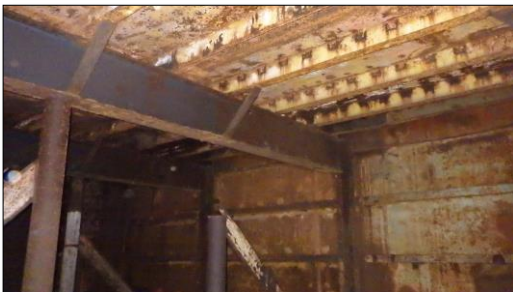
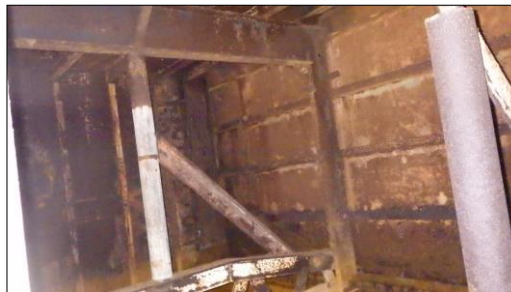
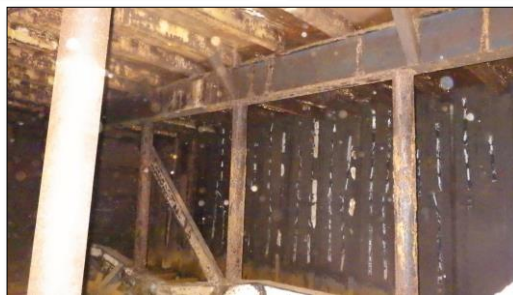
Void 4

- Deck ~20%
- Side shells ~30%
- Bulkheads ~20%
- Hull 0%

- D-TG truss replaced with I-beam

- ~10% wasted

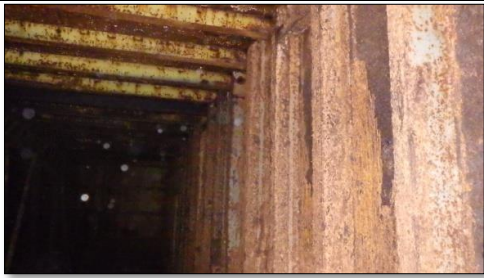
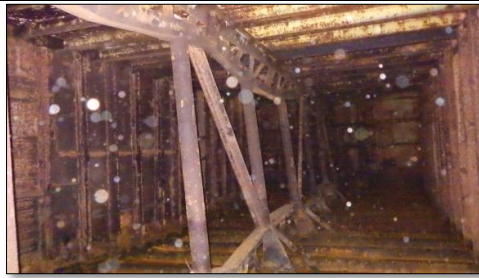
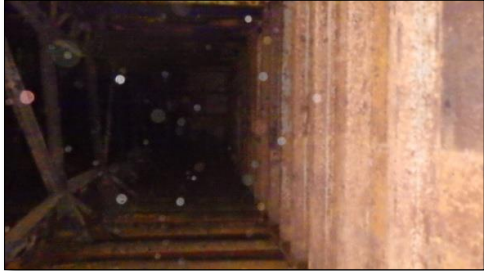
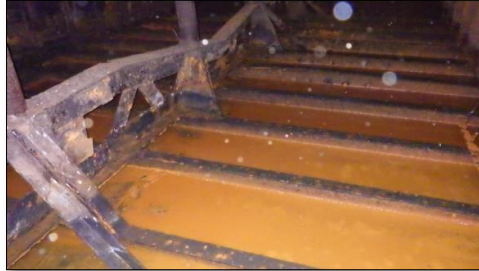
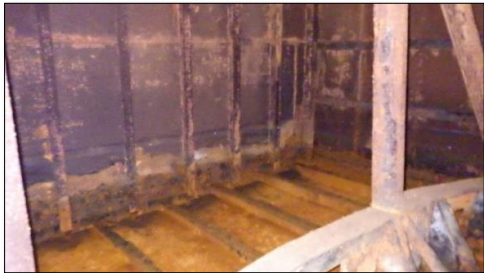
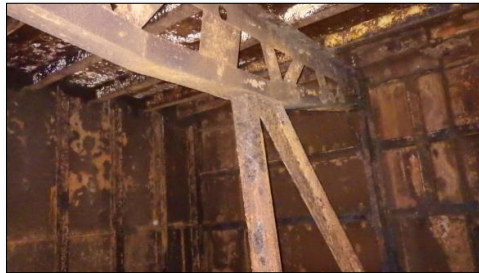
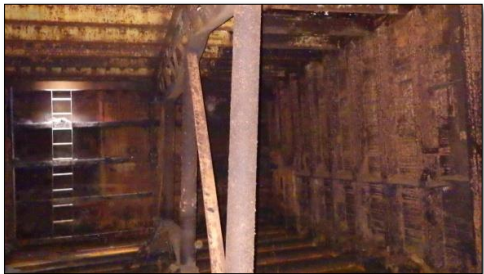
Void 5

- Deck ~20%
- Side shells ~30%
- Bulkheads ~20%
- Hull 0%

- D-P set down light

- ~30 % wasted at hatch

- ** BH plating 100% wasted to Void 6 on port side

- B-TG set over light

- 3" water in void

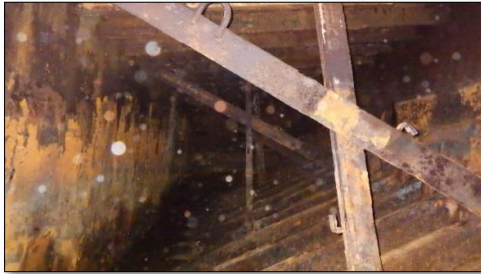
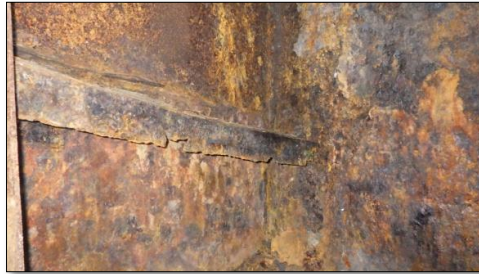
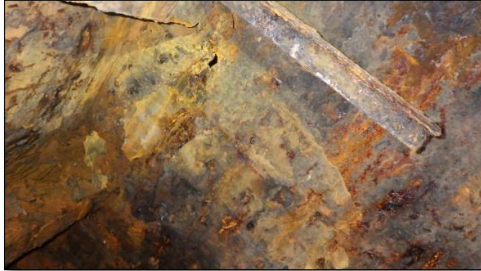
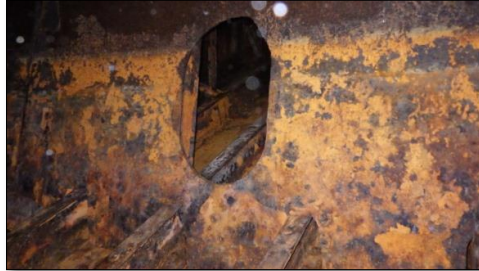
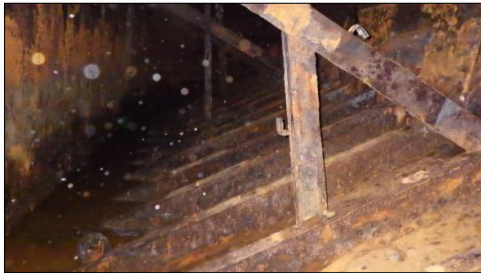
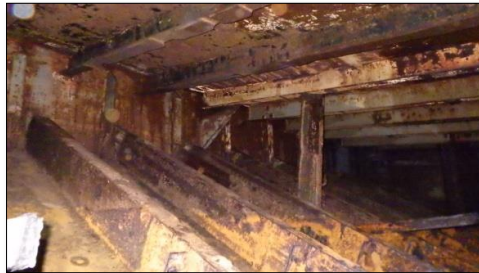
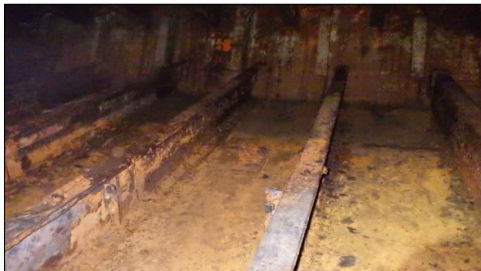
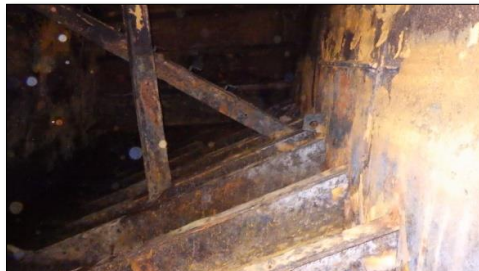
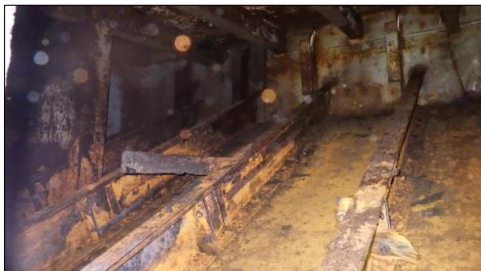
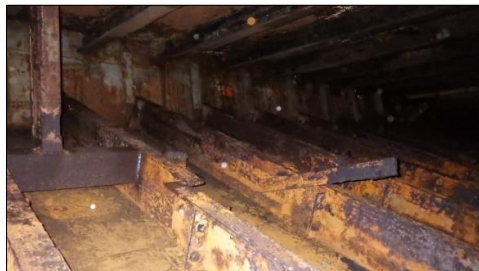
Void Stern 6

- Deck ~20%
- Side shells ~30%
- Bulkheads ~20%
- Hull 0%

- ~20% wasted

- **SS-LF ~70% wasted at ladder

- **BH plating 100% wasted to Void 5 on port side

- ~30% wasted

- 2" water in void
