∞xtime Automobile Status Report

2014 Ram 5500

Multi-Point Inspection Form

Additional Service Recommendations

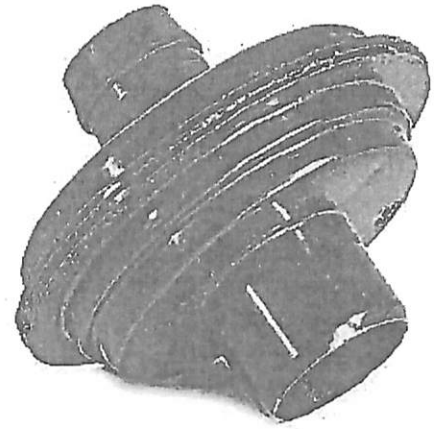
Filters - Crankcase Filter: PERFORM SERVICE LIGHT IS ON. CCV FILTER FILTER REQUIRES REPLACEMENT

If the crankcase filter is damaged or clogged, the expanding gasses will be trapped inside of the crank case until the pressure builds to the point where the gases will escape from the easiest point, which could cause an oil leak.

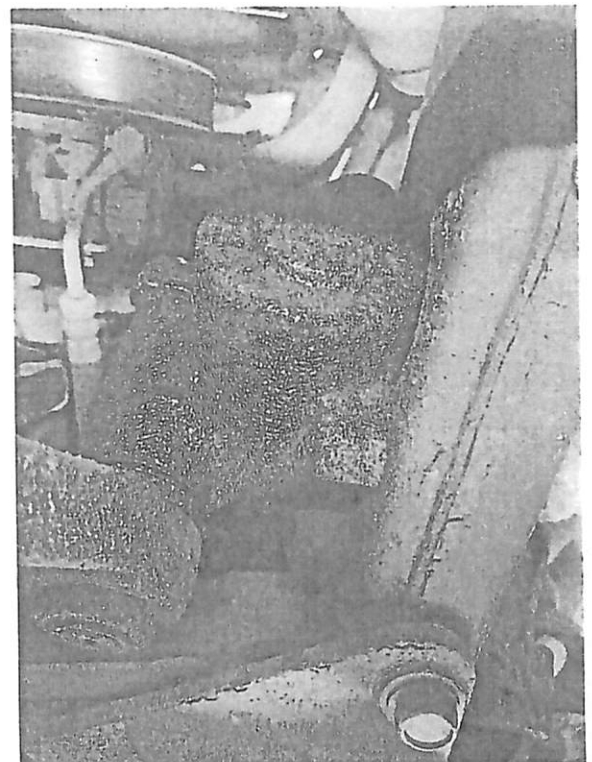
Steering Gearbox Replacement

Steering Gearbox Replacement: POWER STEERING LEAK FROM STEERING GEAR

If not replaced, a worn steering gearbox will allow excess 'play' in the steering that could make it not respond as quickly as it should.
