RITCHIE BROS.
TRUCK PLANET

Item #12289695 - 2011 Mack CXU613 6x4 Transfer Set

Inspection Report

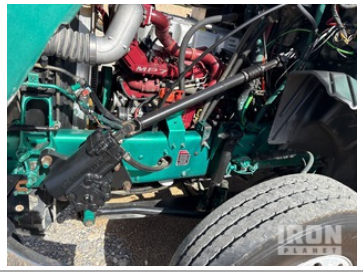
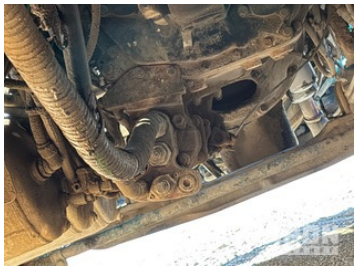
Item	Assessment	Photo
Emissions Information	2010 US EPA Label	
Engine #1		
Engine #2		
Engine #3		
Engine #4		
Emission Label		
A/C Compressor	Operational	
Blow-by (subjective visual observation)	No noticeable vapor or pressure	
Starter	Operational

Air Compressor	Operational	
Fuel System	Operational	
Exhaust System		
Diesel Particulate Filter		
Radiator	★★★☆	
Oil Leaks	No dripping leaks	
Fuel Leaks	No dripping leaks	
Cooling System Leaks	No dripping leaks	
Engine - Left Side

Engine - Right Side		
DEF / AdBlue Tank		
Limited Function Check	The engine started and ran.
