Report Number:	INST – 037
Report Date:	24.08.2021

Elevating Work Platform

MAJOR EXAMINATION

Model: 1930ES

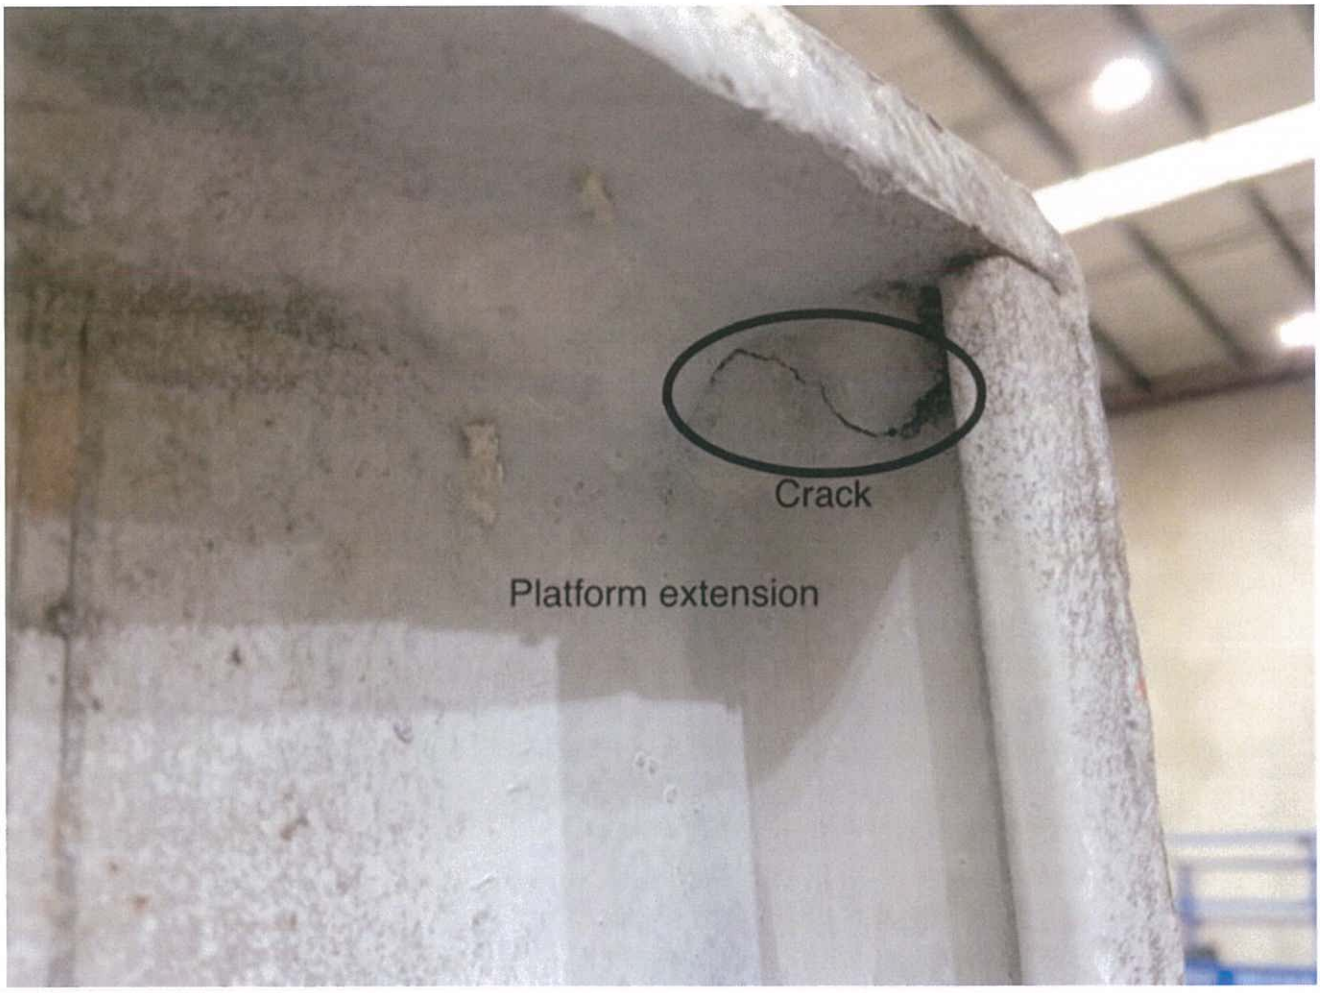
Photo 9

Item No.	Item to be checked	Initial (Pass / Fail)	Final (Pass / Fail)	Notes
9.	STRUCTURAL CONDITION			
9.1	Structural free from deformation	Pass	Pass	
9.2	Critical areas free of cracks	Fail	Pass	Platform extension deck repaired by Robert Lange Engineering
9.3	Corrosion absent and surface condition protected	Pass	Pass	
9.4	Platform condition and guardrails adequate	Pass	Pass	
9.5	Platform gates self-closing and latching	Pass	Pass	
9.6	Platform floor condition adequate	Fail	Pass	Platform extension deck repaired by Robert Lange Engineering
9.7	Travel rests satisfactory (boom type MEWPs)	N/A	N/A	
9.8	Personnel access adequate and slip resistant	Pass	Pass

- 100% of Platform Structure welds ****2 x Cracklike indications detected in platform extension. (Refer photo 8-9)*****

Description	Amount
Repair 9 off Aluminium Scissor Lift Floors Labour only Purchase Order:Dave - 4/08/2021	750.00
