Report Number:	INST – 017
Report Date:	11.08.2021

Elevating Work Platform

MAJOR EXAMINATION

Model: 1930ES

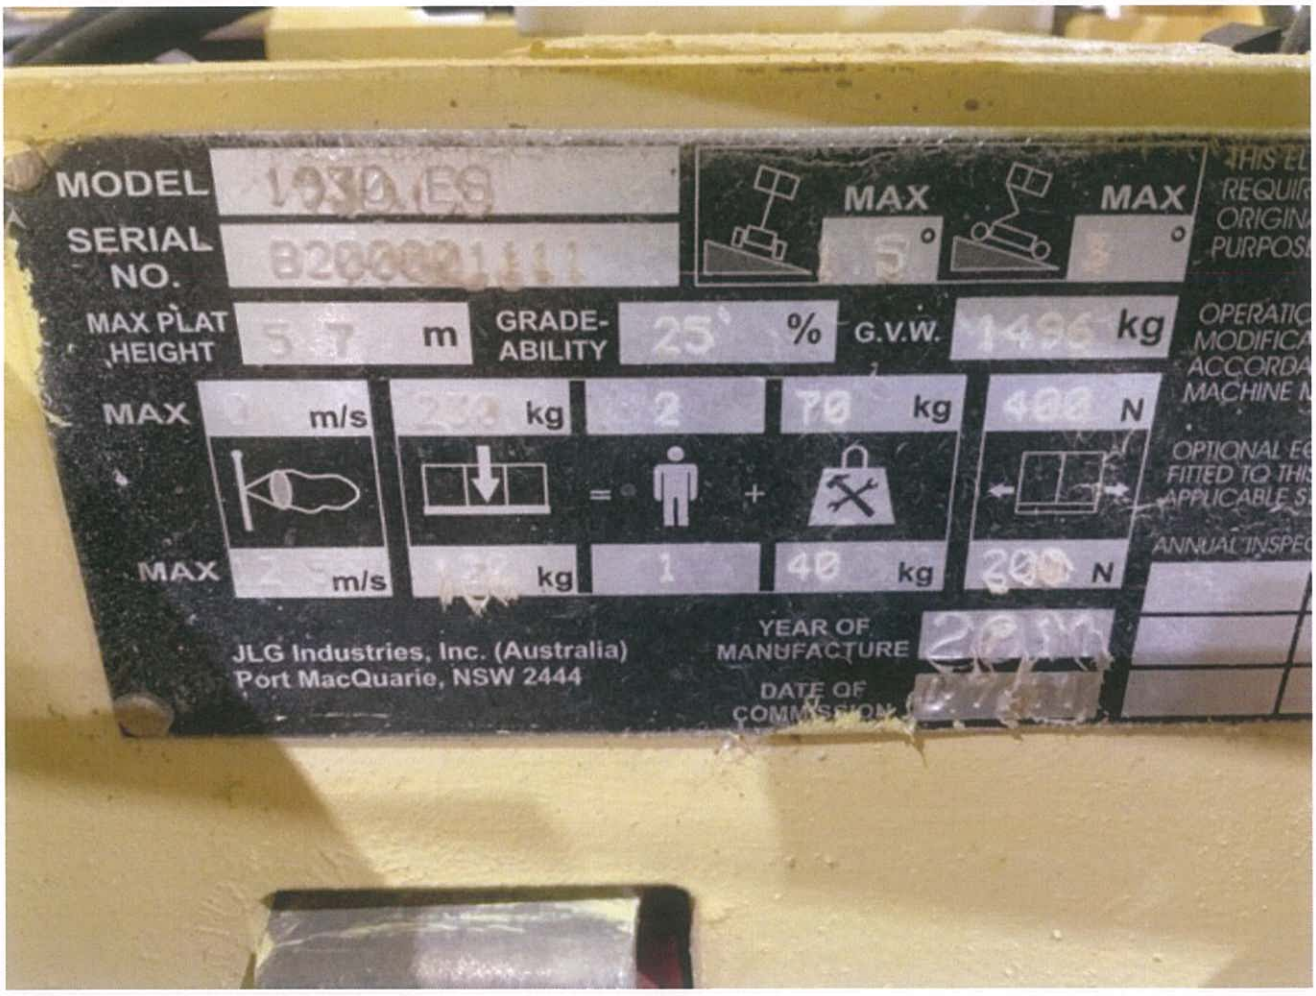
Photo 2

Make:	JLG (Refer photo 1)
Model:	1930-ES
Serial No.:	B200001111 (Refer photo 2)
D.O.M.:	2011
Hours:	659 as indicated (Refer photo 3)
Klms:	N/A
Reg. No.:	N/A
Asset No.:	Unit: 1111
