Report Number:	INST – 015
Report Date:	19.08.2021

Elevating Work Platform

MAJOR EXAMINATION

Model: 1930ES

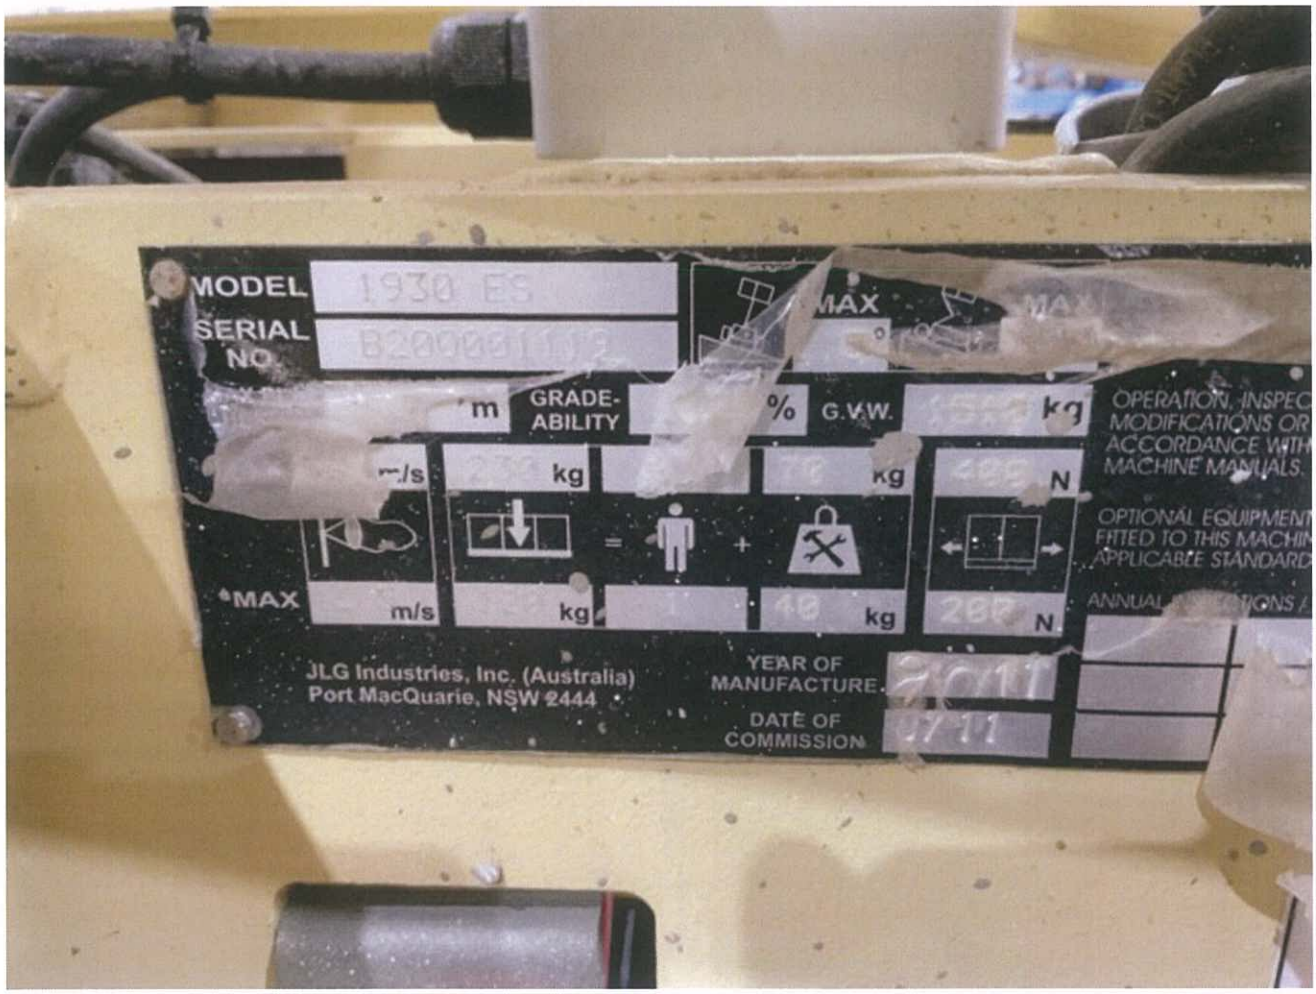
Photo 2

Make:	JLG (Refer photo 1)
Model:	1930-ES
Serial No.:	B200001119 (Refer photo 2)
D.O.M.:	2011
Hours:	624 as indicated (Refer photo 3)
Klms:	N/A
Reg. No.:	N/A
Asset No.:	Unit: 1119

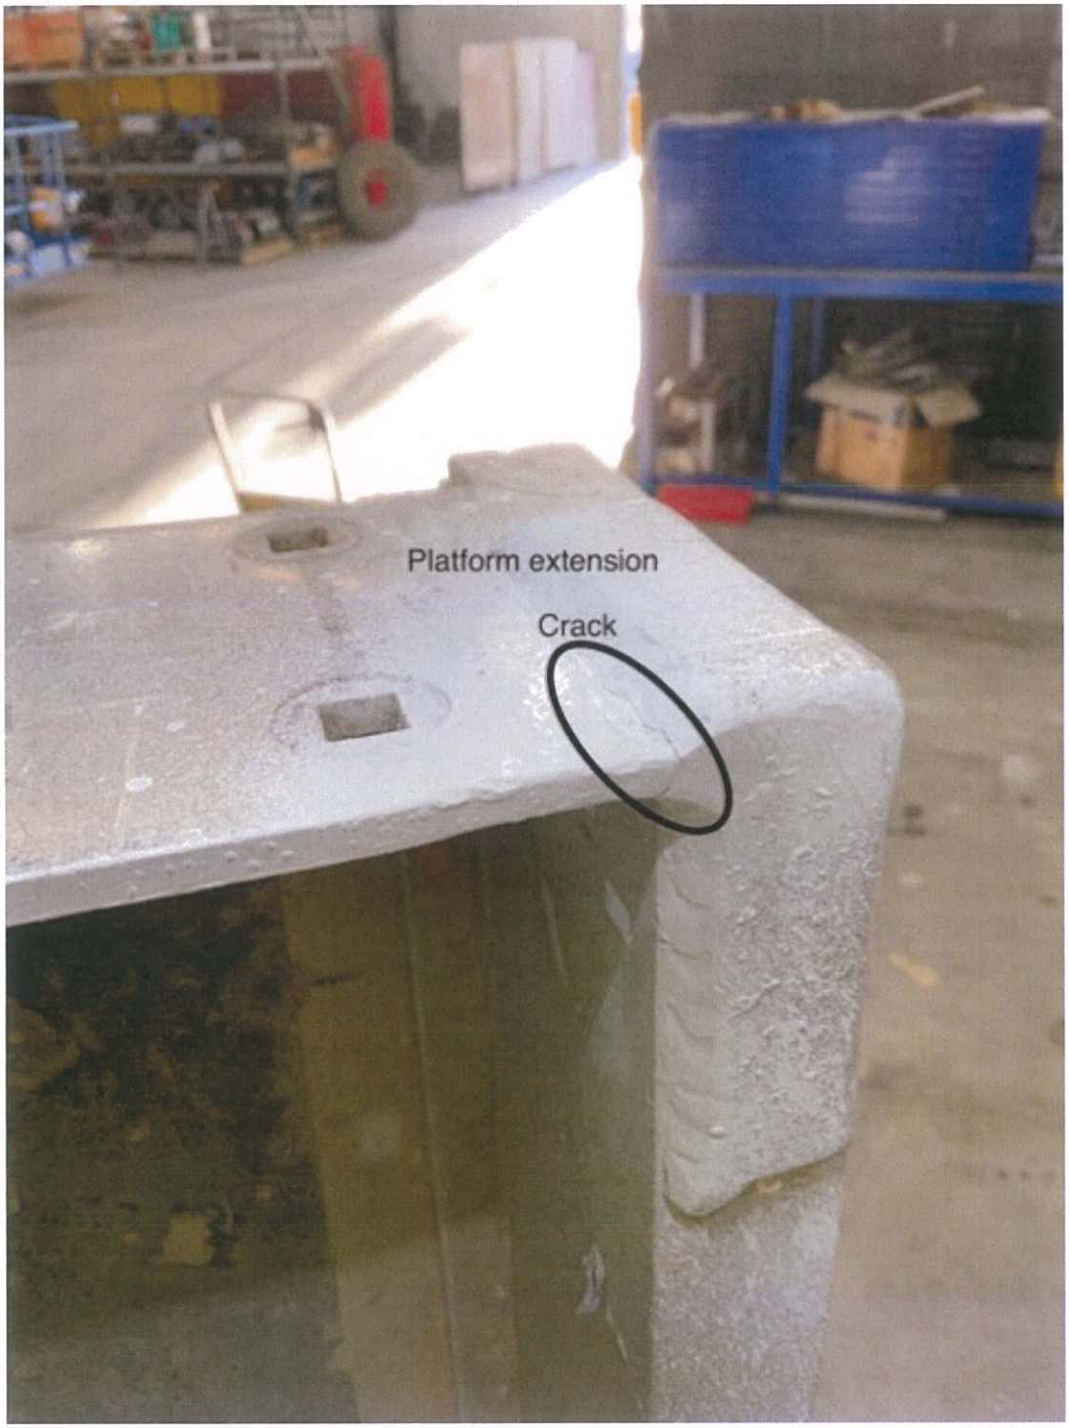
Photo 8

- 100% of Platform Structure welds ****2 x Cracklike indications detected in platform extension. (Refer photo 7-8) Lack of fusion & porosity detected in platform extension. (Refer photo 9)****

Item No.	Item to be checked	Initial (Pass / Fail)	Final (Pass / Fail)	Notes
9.	**STRUCTURAL CONDITION**			
9.1	Structural free from deformation	**Pass**	**Pass**	
9.2	Critical areas free of cracks	**Fail**	**Pass**	**Platform extension deck repaired by Andar Engineering**
9.3	Corrosion absent and surface condition protected	**Pass**	**Pass**	
9.4	Platform condition and guardrails adequate	**Pass**	**Pass**	
9.5	Platform gates self-closing and latching	**Pass**	**Pass**	
9.6	Platform floor condition adequate	**Fail**	**Pass**	**Platform extension deck repaired by Andar Engineering**
9.7	Travel rests satisfactory (boom type MEWPs)	**N/A**	**N/A**	
9.8	Personnel access adequate and slip resistant	**Pass**	**Pass**
