Report Number:	INST – 041
Report Date:	09.09.2021

Elevating Work Platform

MAJOR EXAMINATION

Model: 1930ES

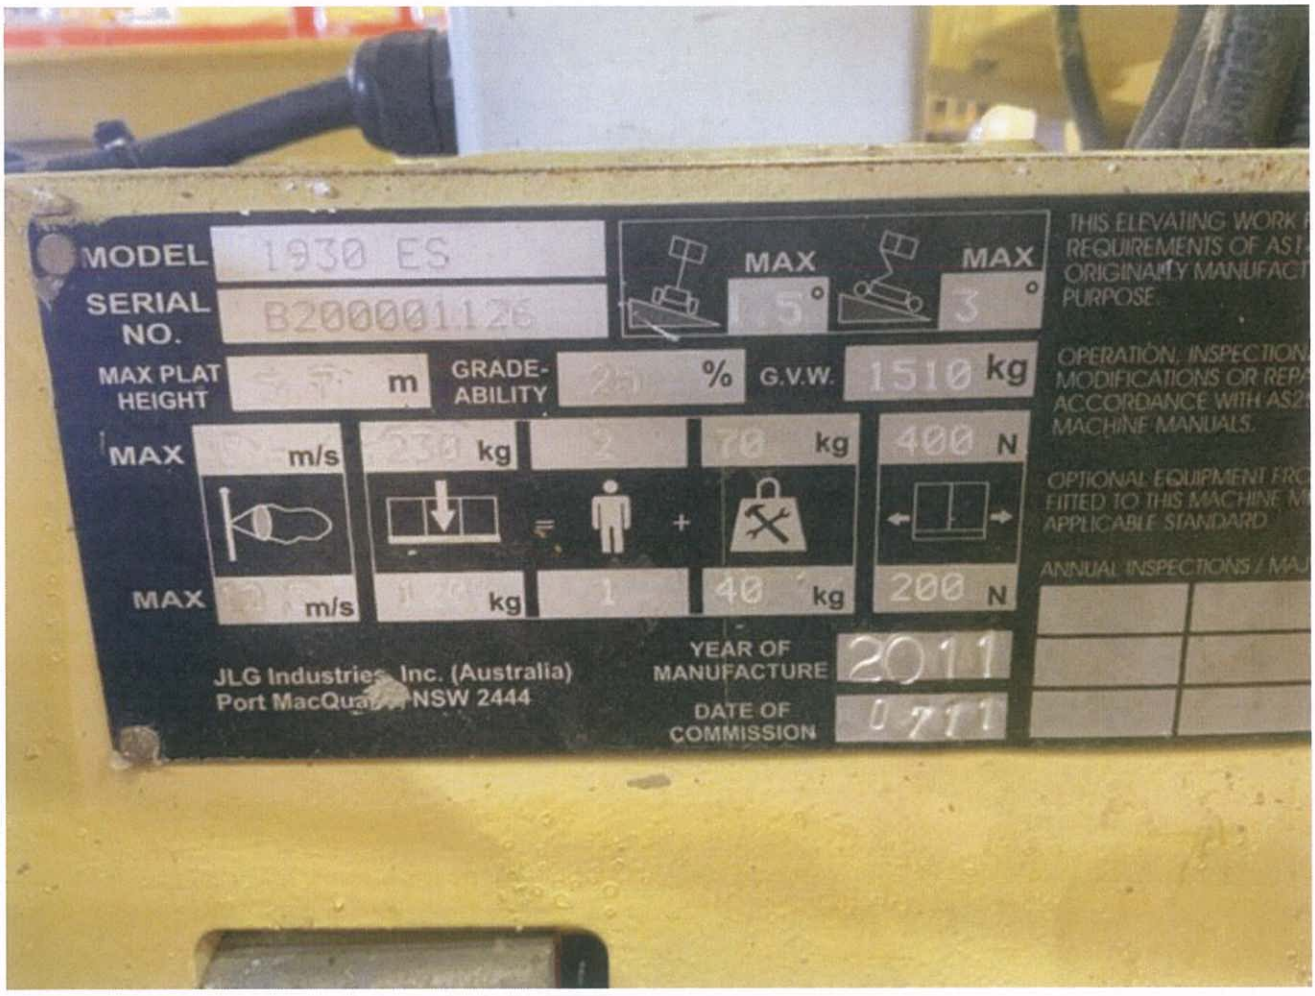
Photo 2

Make:	JLG (Refer photo 1)
Model:	1930-ES
Serial No.:	B200001126 (Refer photo 2)
D.O.M.:	2011
Hours:	524 as indicated (Refer photo 3)
Klms:	N/A
Reg. No.:	N/A
Asset No.:	Unit: 1126
