Report Number:	INST – 020
Report Date:	12.08.2021

Elevating Work Platform

MAJOR EXAMINATION

Model: 1930ES

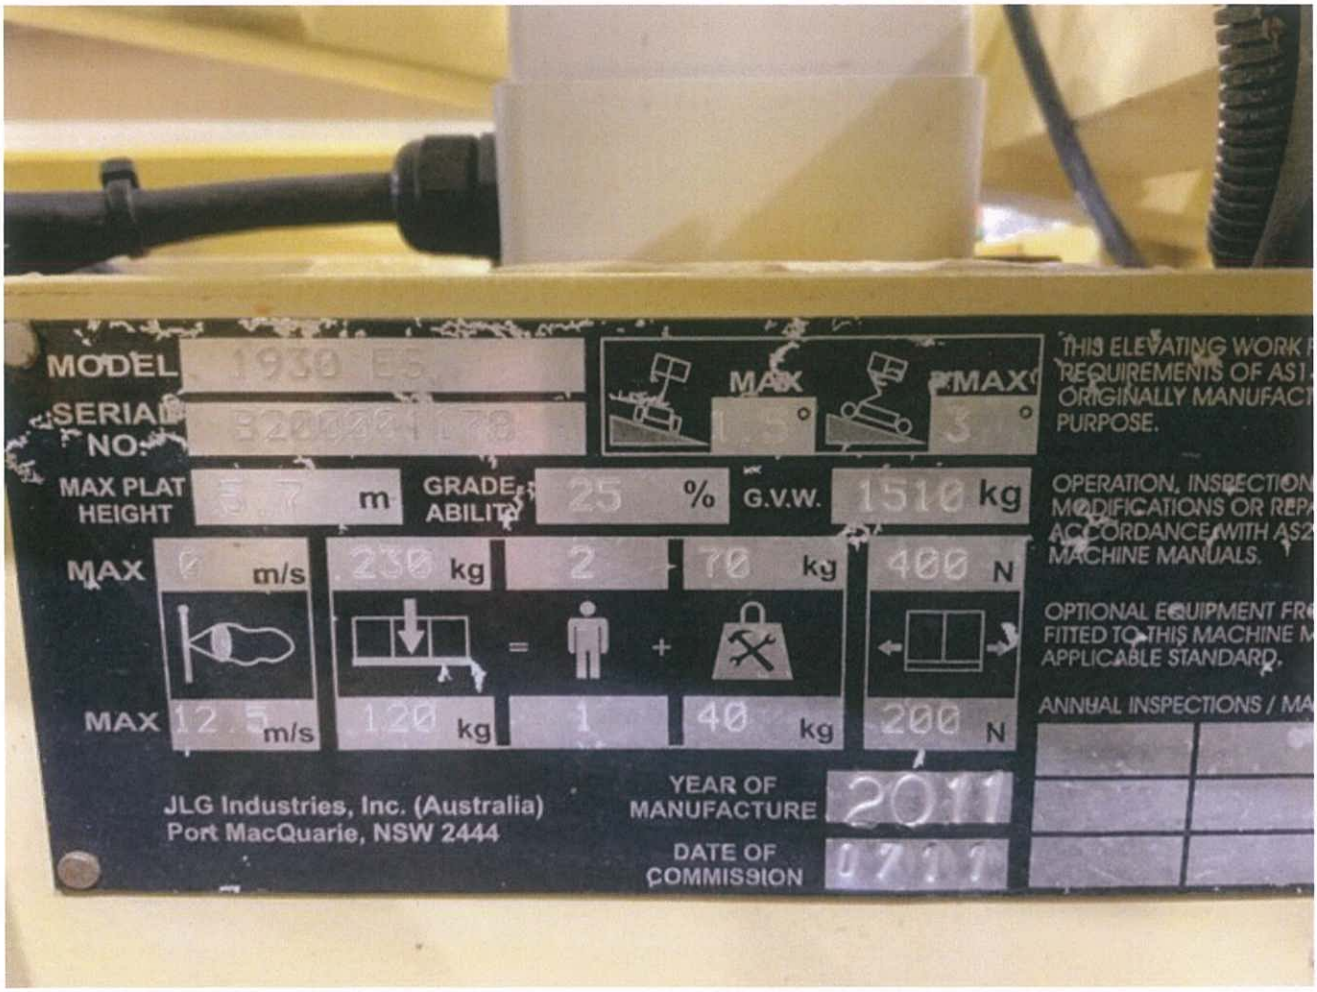
Photo 2

Make:	JLG (Refer photo 1)
Model:	1930-ES
Serial No.:	B200001178 (Refer photo 2)
D.O.M.:	2011
Hours:	595 as indicated (Refer photo 3)
Klms:	N/A
Reg. No.:	N/A
Asset No.:	Unit: 1178

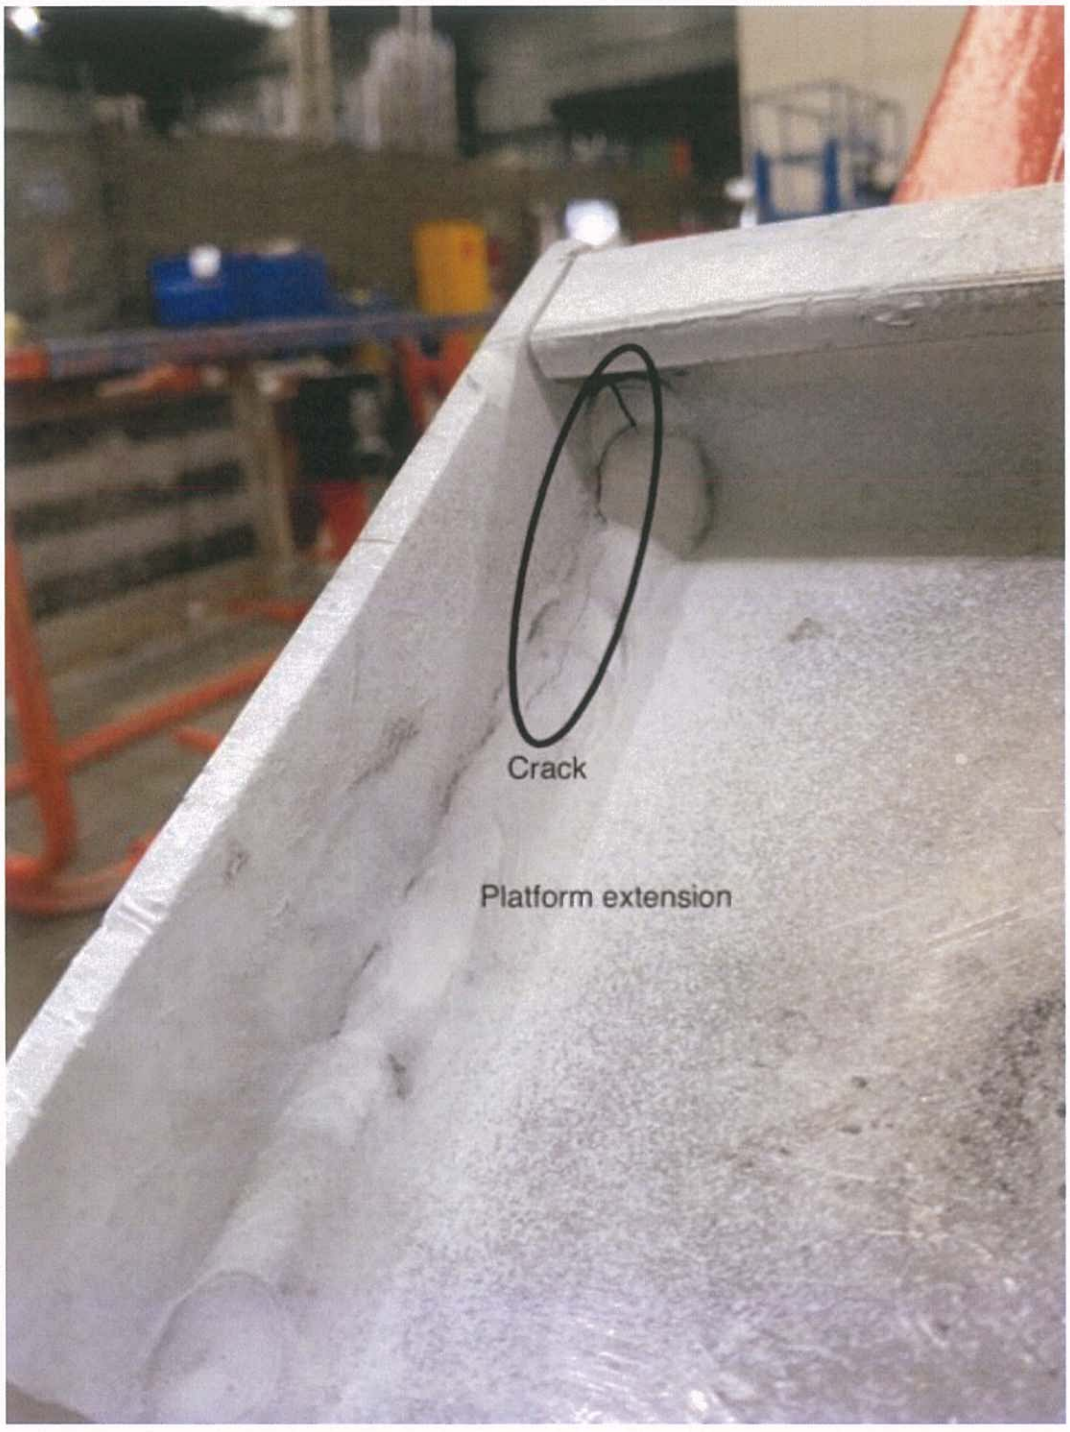
Photo 8

- 100% of Platform Structure welds ****2 x Cracklike indication detected in platform extension. (Refer photo 8-9)****

Item No.	Item to be checked	Initial (Pass / Fail)	Final (Pass / Fail)	Notes
9.	STRUCTURAL CONDITION			
9.1	Structural free from deformation	Pass	Pass	
9.2	Critical areas free of cracks	Fail	Pass	Platform Extension Deck repaired by Andar Engineering
9.3	Corrosion absent and surface condition protected	Pass	Pass	
9.4	Platform condition and guardrails adequate	Pass	Pass	
9.5	Platform gates self-closing and latching	Pass	Pass	
9.6	Platform floor condition adequate	Fail	Pass	Platform Extension Deck repaired by Andar Engineering
9.7	Travel rests satisfactory (boom type MEWPs)	N/A	N/A	
9.8	Personnel access adequate and slip resistant	Pass	Pass
