Report Number:	INST – 021
Report Date:	12.08.21

Elevating Work Platform

MAJOR EXAMINATION

Model: 1930ES

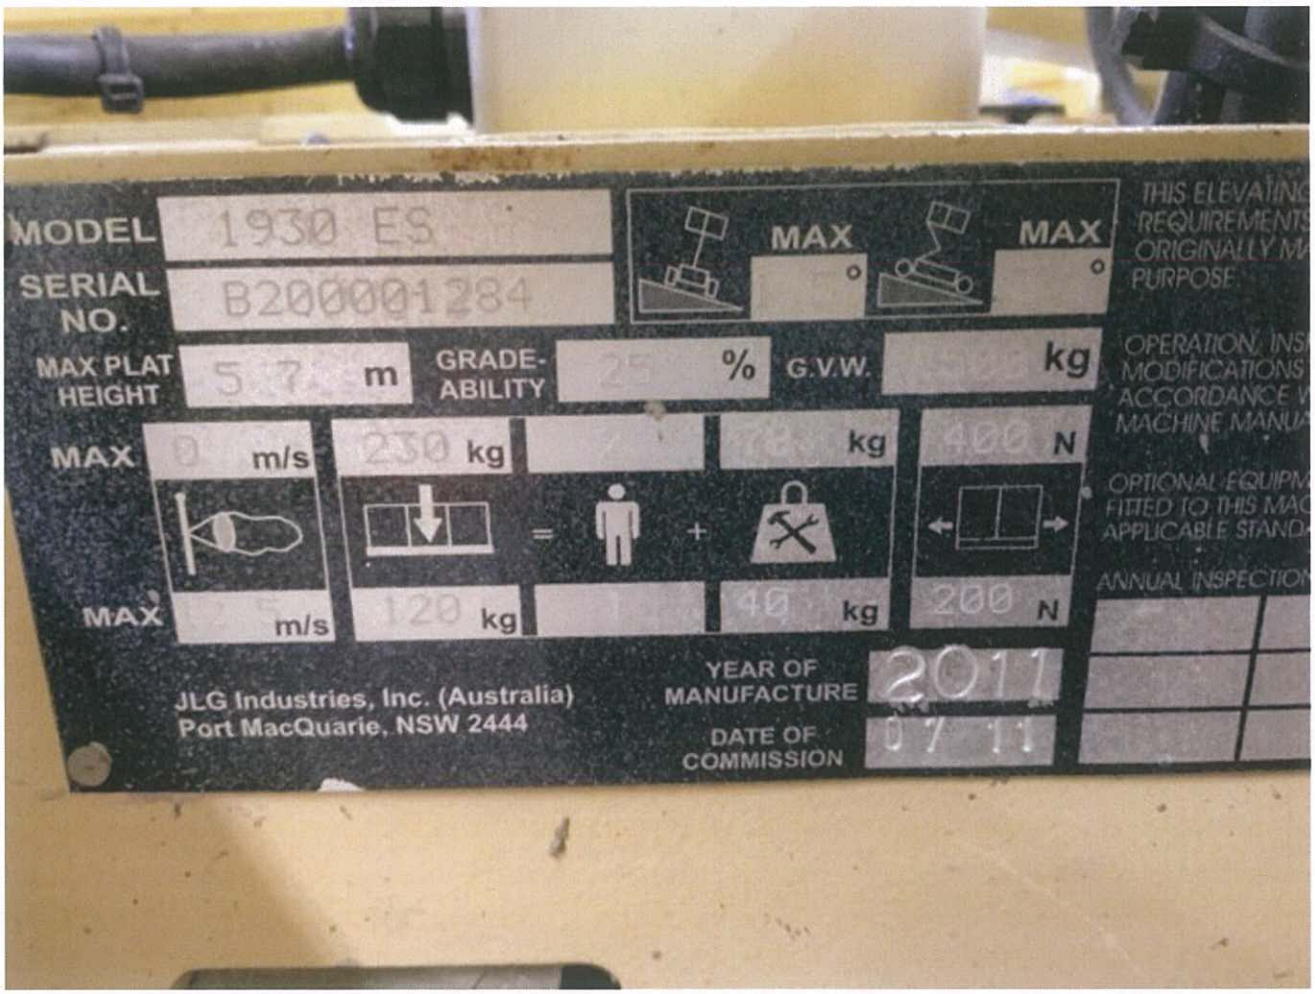
Photo 2

Make:	JLG (Refer photo 1)
Model:	1930-ES
Serial No.:	B200001284 (Refer photo 2)
D.O.M.:	2011
Hours:	596 as indicated (Refer photo 3)
Klms:	N/A
Reg. No.:	N/A
Asset No.:	Unit: 1284
