Report Number:	INST – 151
Report Date:	16.08.2022

Elevating Work Platform

MAJOR EXAMINATION

Manufacturer: JLG

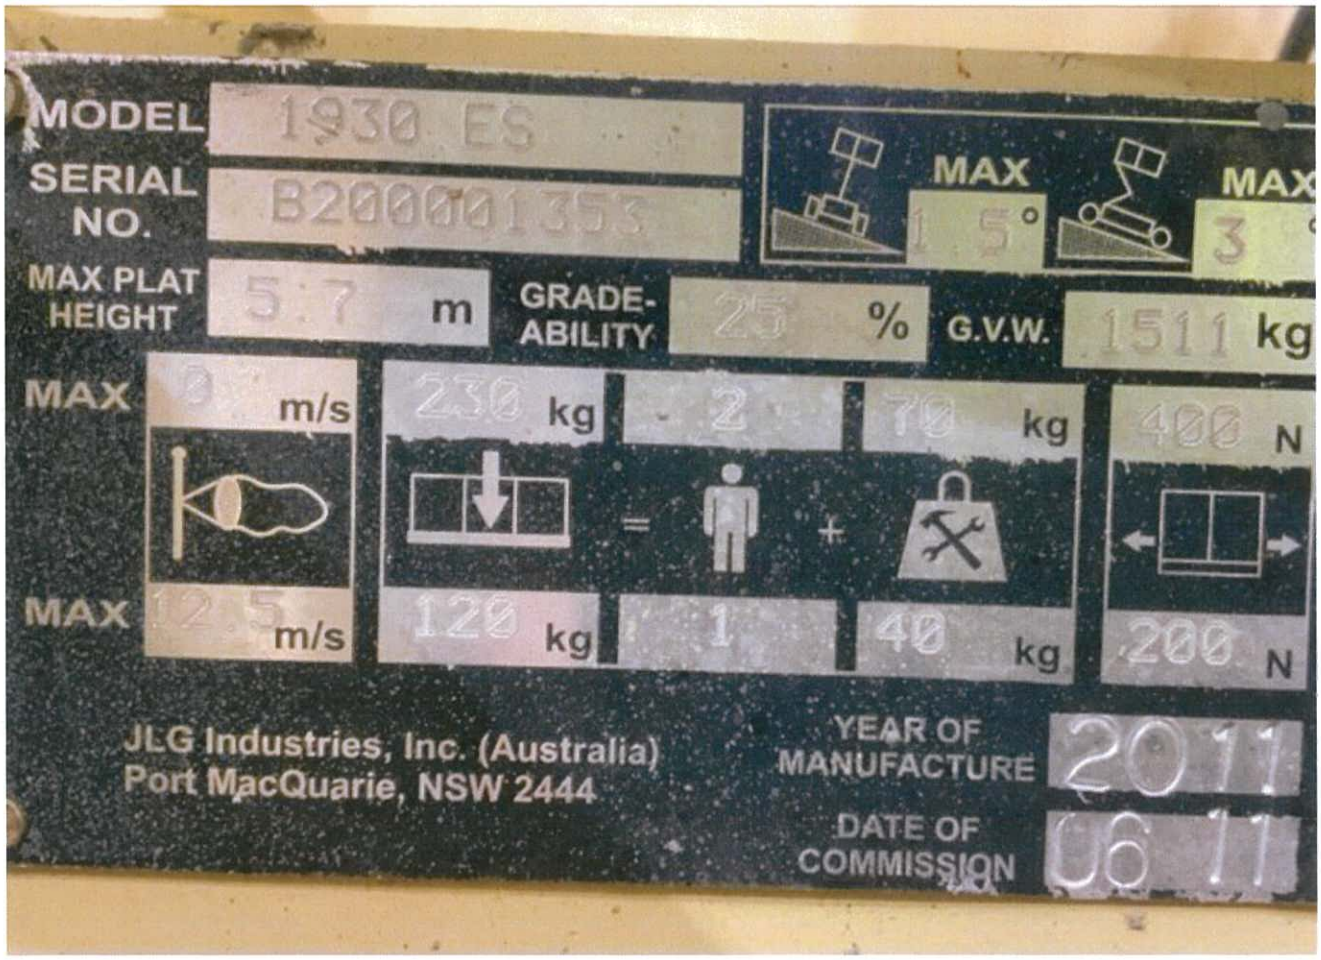
Photo 2

Make:	JLG (Refer photo 1)
Model:	1930 ES
Serial No.:	B200001353 (Refer photo 2)
D.O.M.:	2011
Hours:	557 as indicated (Refer photo 3)
KIms:	N/A
Reg. No.:	N/A
Asset No.:	Unit: 1353
