Report Number:	INST – 204
Report Date:	11/07/2023

Elevating Work Platform

MAJOR EXAMINATION

NON-DESTRUCTIVE TEST REPORT

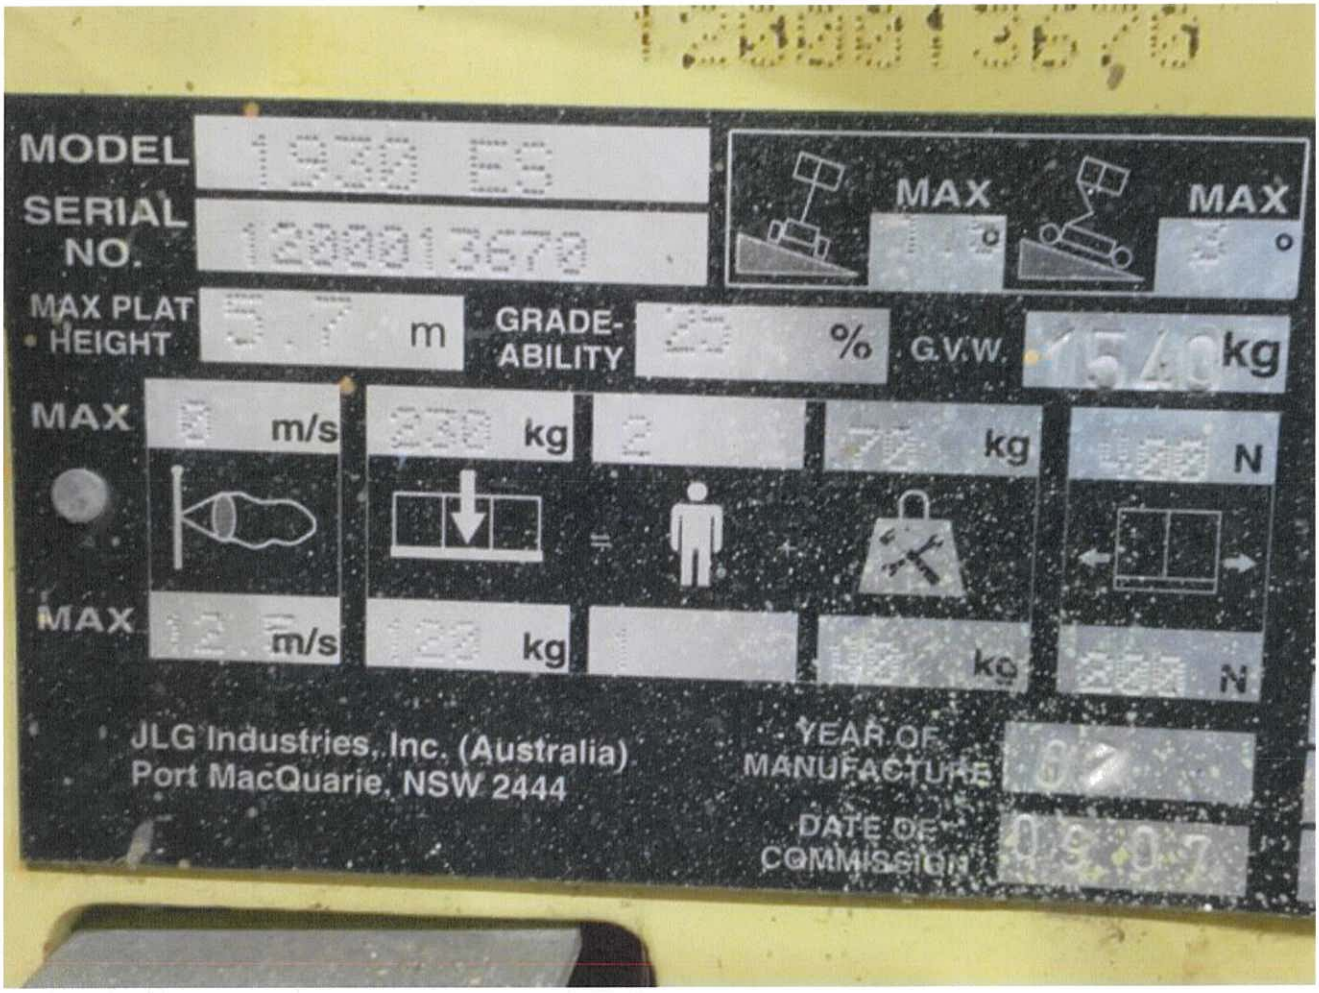
Photo 1

Make:	JLG (Refer photo 1)
Model:	1930-ES
Serial No.:	1200013760 (Refer photo 2)
D.O.M.:	09/07
Hours:	as indicated (Refer photo 3)
Klms:	N/A
Reg. No.:	N/A
Asset No.:	Unit: 13760
