Report Number:	INST – 184
Report Date:	06.02.2023

Elevating Work Platform

MAJOR EXAMINATION

Model: 1930ES

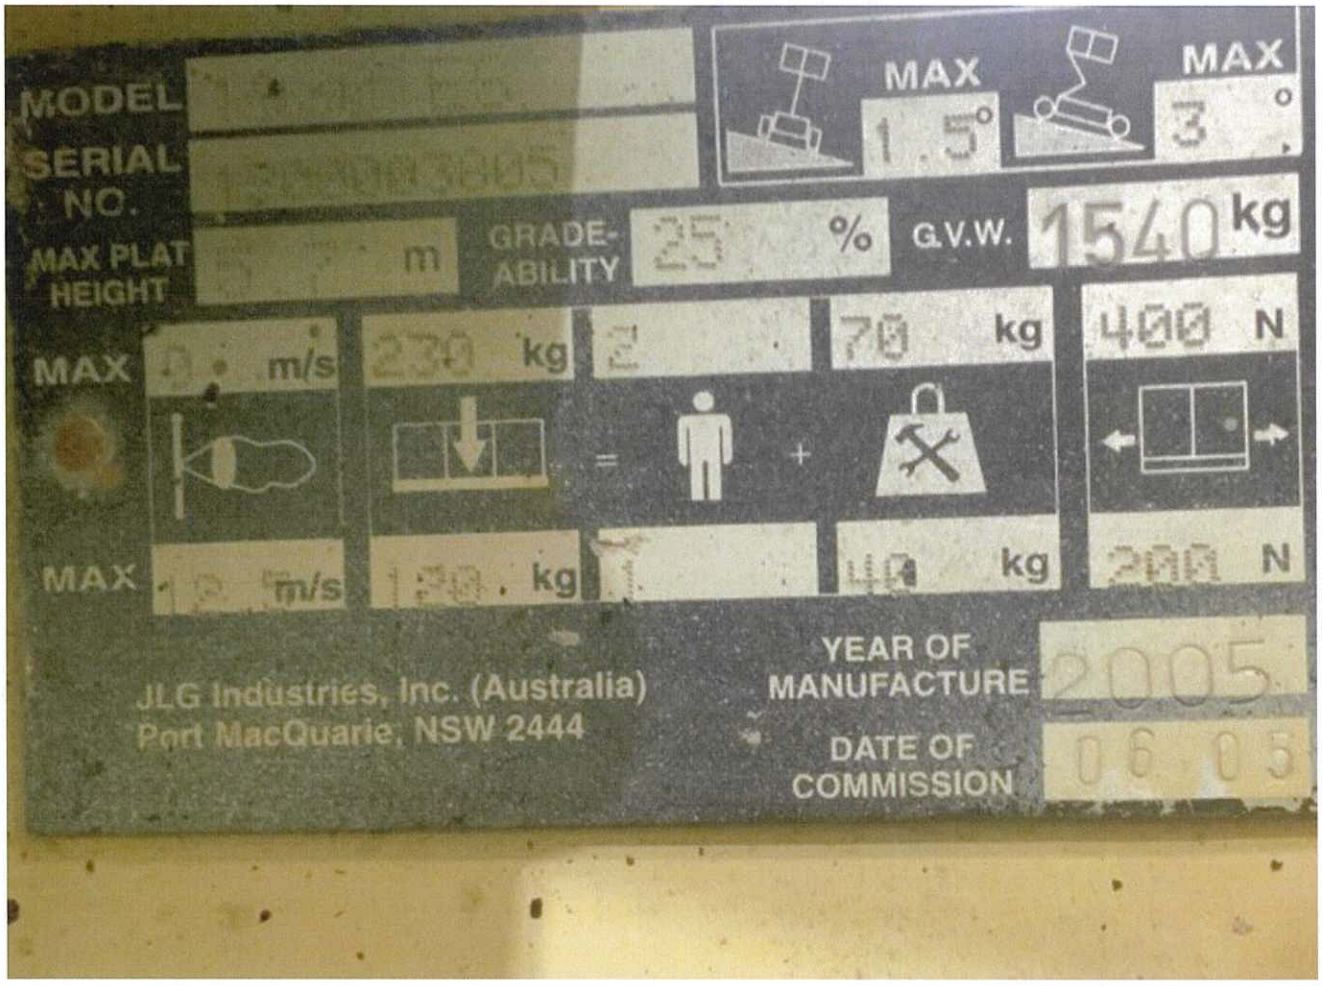
Photo 2

Make:	JLG (Refer photo 1)
Model:	1930-ES
Serial No.:	1200003805 (Refer photo 2)
D.O.M.:	2005
Hours:	883 as indicated (Refer photo 3)
Klms:	N/A
Reg. No.:	N/A
Asset No.:	Unit: 3805

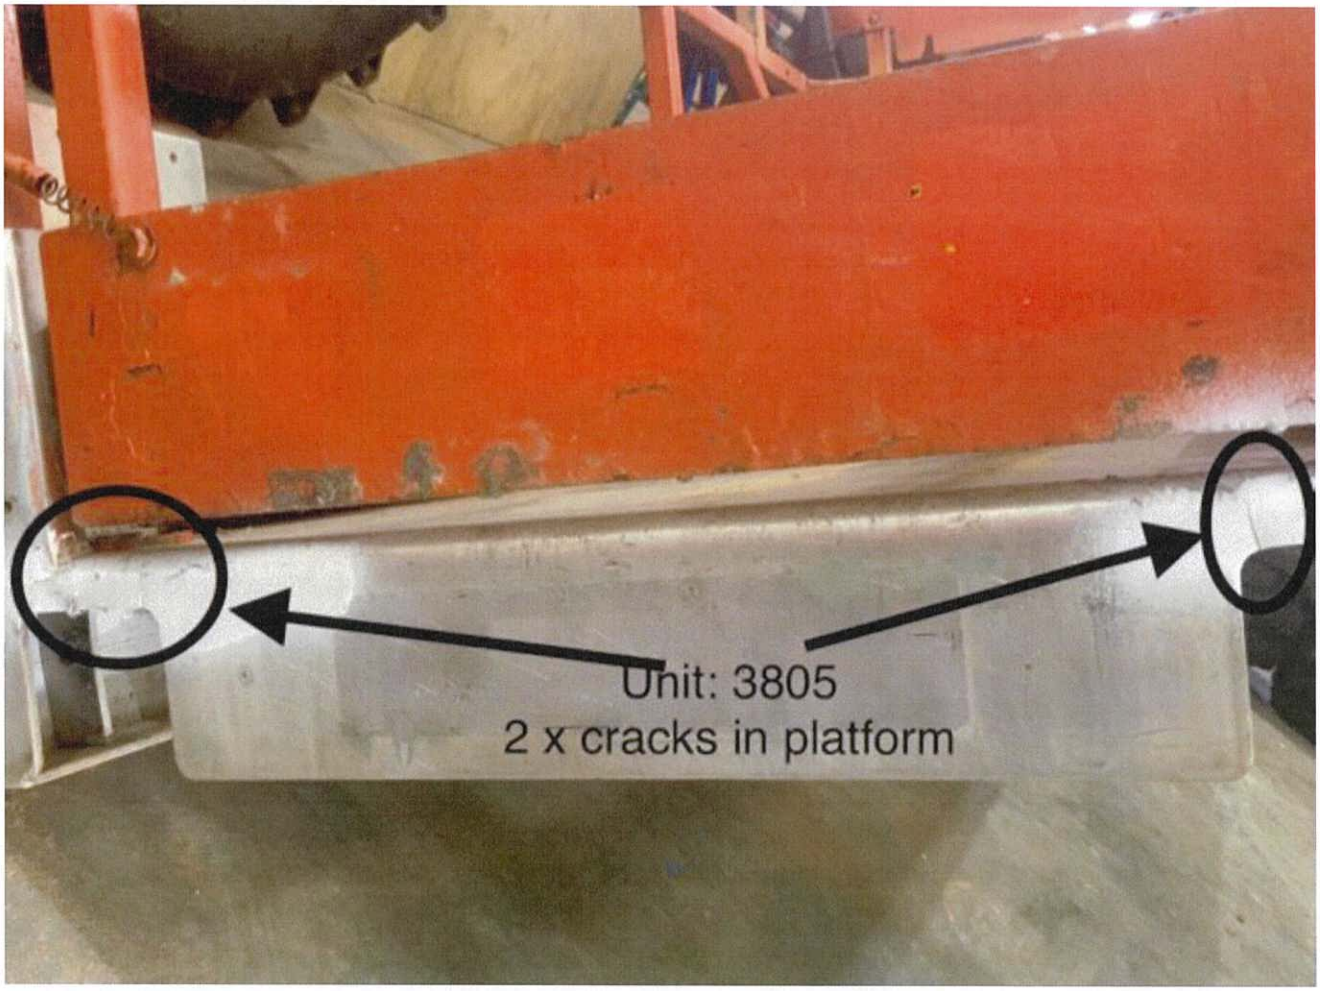
Photo 6

- 100% of Platform Structure welds ***Cracks detected at both ends of platform floor. Areas marked. (Refer photo 6-7)***

Item No.	Item to be checked	Initial (Pass / Fail)	Final (Pass / Fail)	Notes
9.	STRUCTURAL CONDITION			
9.1	Structural free from deformation	Pass	Pass	
9.2	Critical areas free of cracks	Pass	Pass	
9.3	Corrosion absent and surface condition protected	Pass	Pass	
9.4	Platform condition and guardrails adequate	Fail	Pass	Repairs carried out by Andar Engineering
9.5	Platform gates self-closing and latching	Pass	Pass	
9.6	Platform floor condition adequate	Fail	Pass	Repairs carried out by Andar Engineering
9.7	Travel rests satisfactory (boom type MEWPs)	N/A	N/A	
9.8	Personnel access adequate and slip resistant	Pass	Pass
