Report Number:	INST – 169
Report Date:	03.10.2022

Elevating Work Platform

MAJOR EXAMINATION

Model: 1930ES

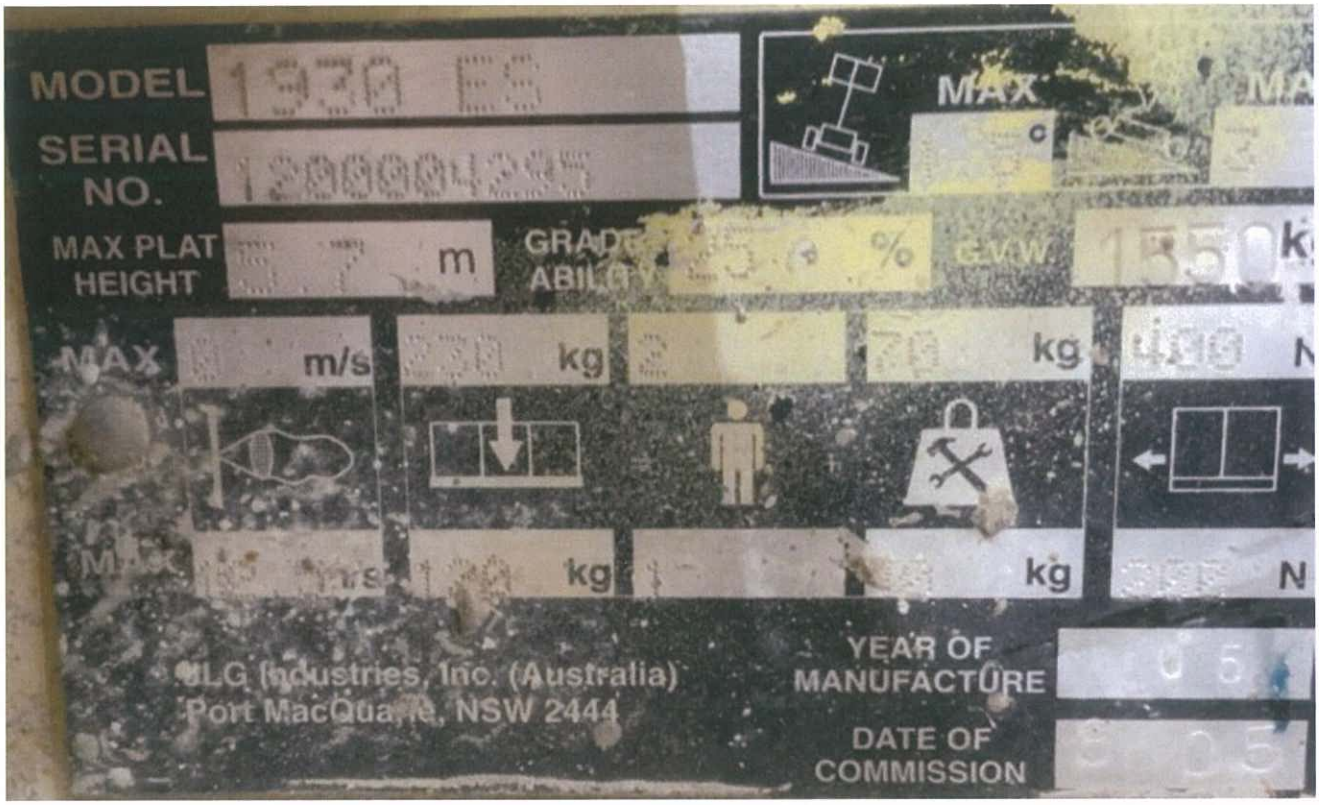
Photo 2

Make:	JLG (Refer photo 1)
Model:	1930-ES
Serial No.:	1200004295 (Refer photo 2)
D.O.M.:	2005
Hours:	529 as indicated (Refer photo 3)
KIms:	N/A
Reg. No.:	N/A
Asset No.:	Unit: 4295

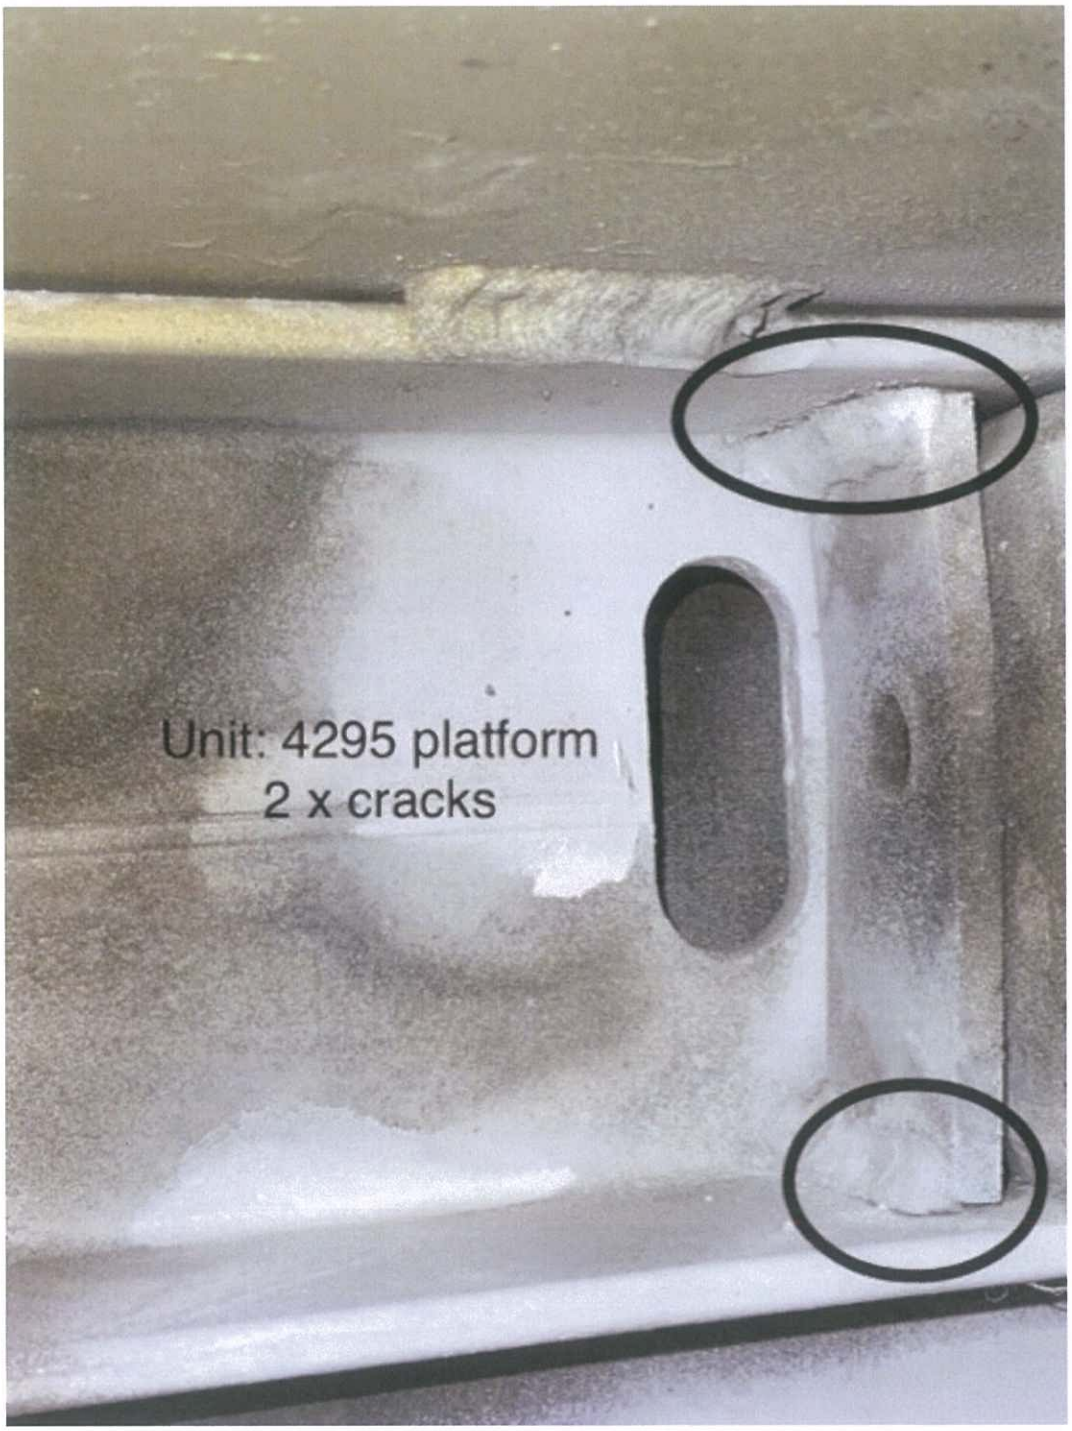
Photo 8

- 100% of Platform Structure welds ***3 x cracks detected in platform floor. (Refer photo 7-9)***

Description	Amount
Supply 4 off Ally Propeller Plates - Small - Type 1 Supply 4 off Ally Propeller Plates - Small - Type 2 Supply 4 off Ally Propeller Plates - Big	2,720.00
Material & Labour	
Repair 2 off Small Aluminium Scissor Lift Decks	280.00
Labour only	
Repair 2 off Large Aluminium Scissor Lift Decks	320.00
Labour only	
Purchase Order:Dave - 7/09/2022	
Repair 1 off Small Aluminium Scissor Lift Deck with Straps	150.00
Labour only	
Repair 1 off Large Aluminium Scissor Lift Deck with Straps	150.00
Labour only	
Purchase Order:Dave - 12/09/2022
