Report Number:	INST – 163
Report Date:	05.09.2022

Elevating Work Platform

MAJOR EXAMINATION

Model: 2646ES

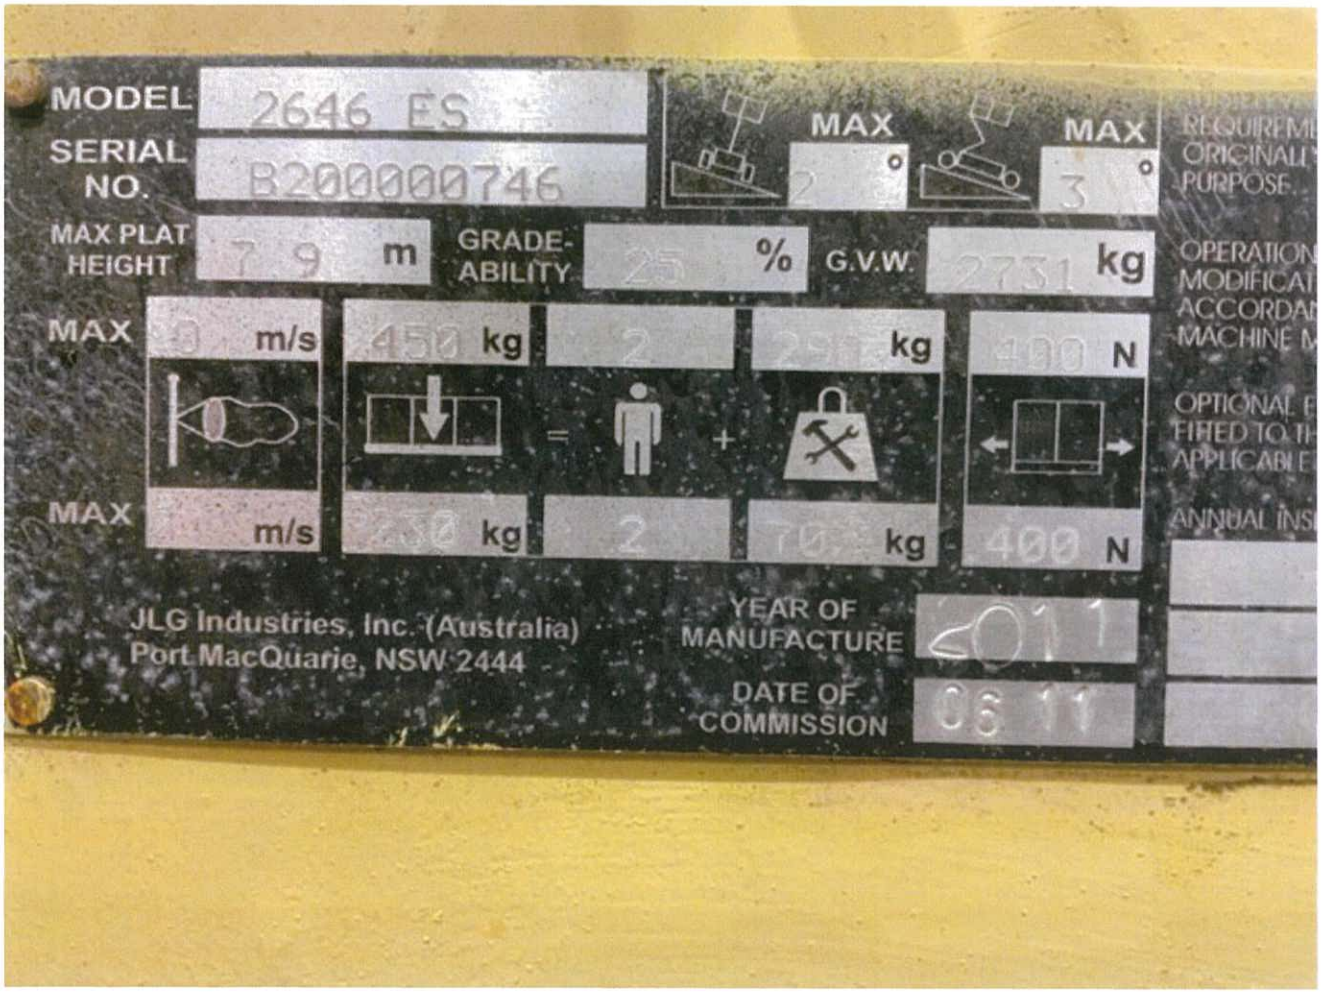
Photo 2

Make:	JLG (Refer photo 1)
Model:	2646-ES
Serial No.:	B200000746 (Refer photo 2)
D.O.M.:	2011
Hours:	Not Stated
Klms:	N/A
Reg. No.:	N/A
Asset No.:	Unit: 746

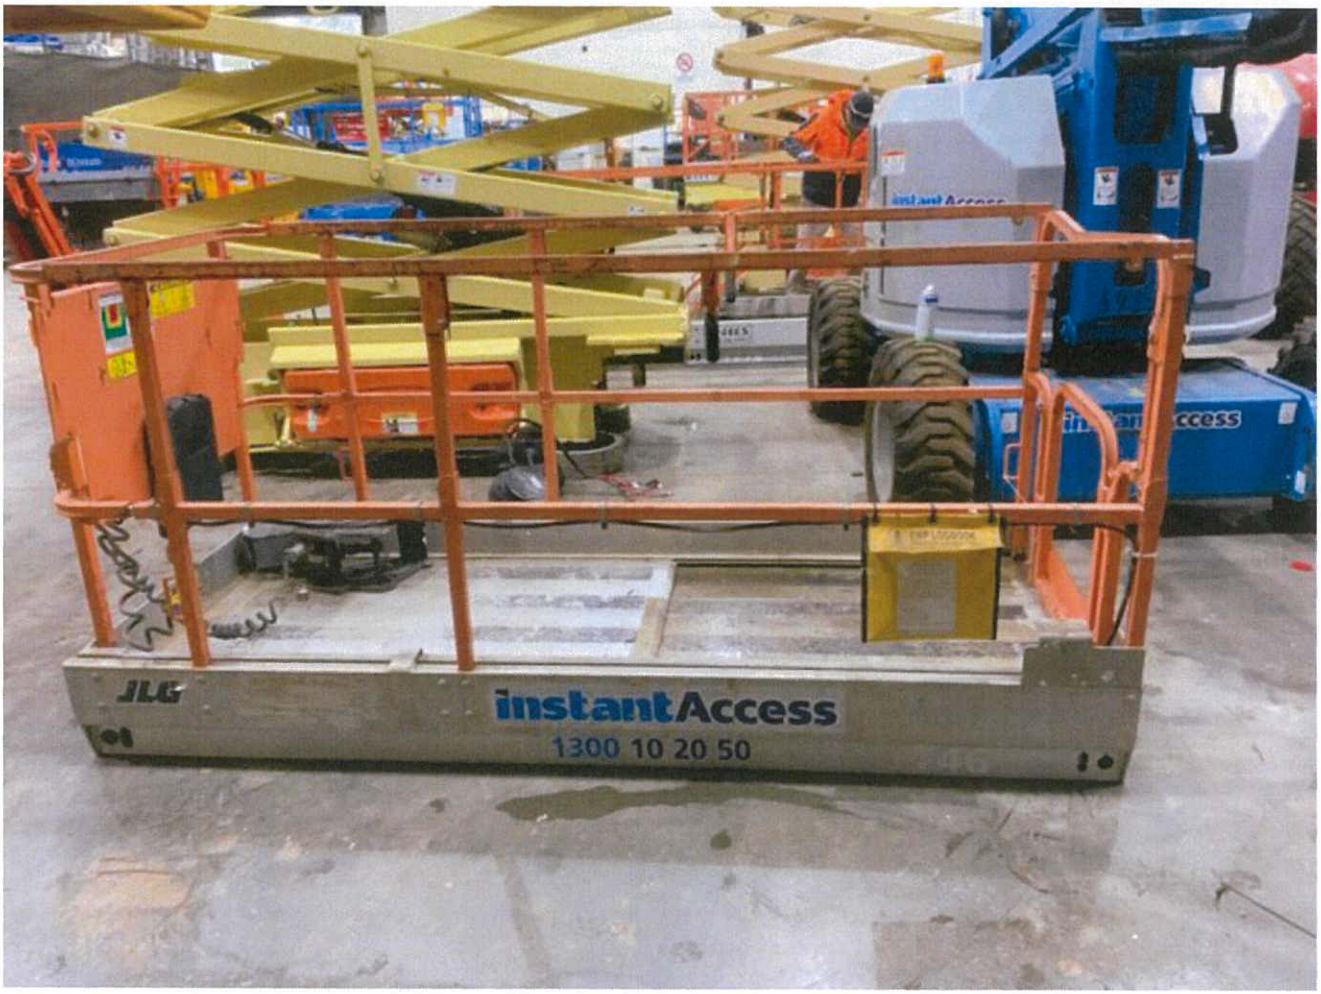
Photo 6

Nil fractures were detected at the time of inspection.
