Report Number:	INST – 080
Report Date:	10.02.2022

Elevating Work Platform

MAJOR EXAMINATION

Model: 2646ES

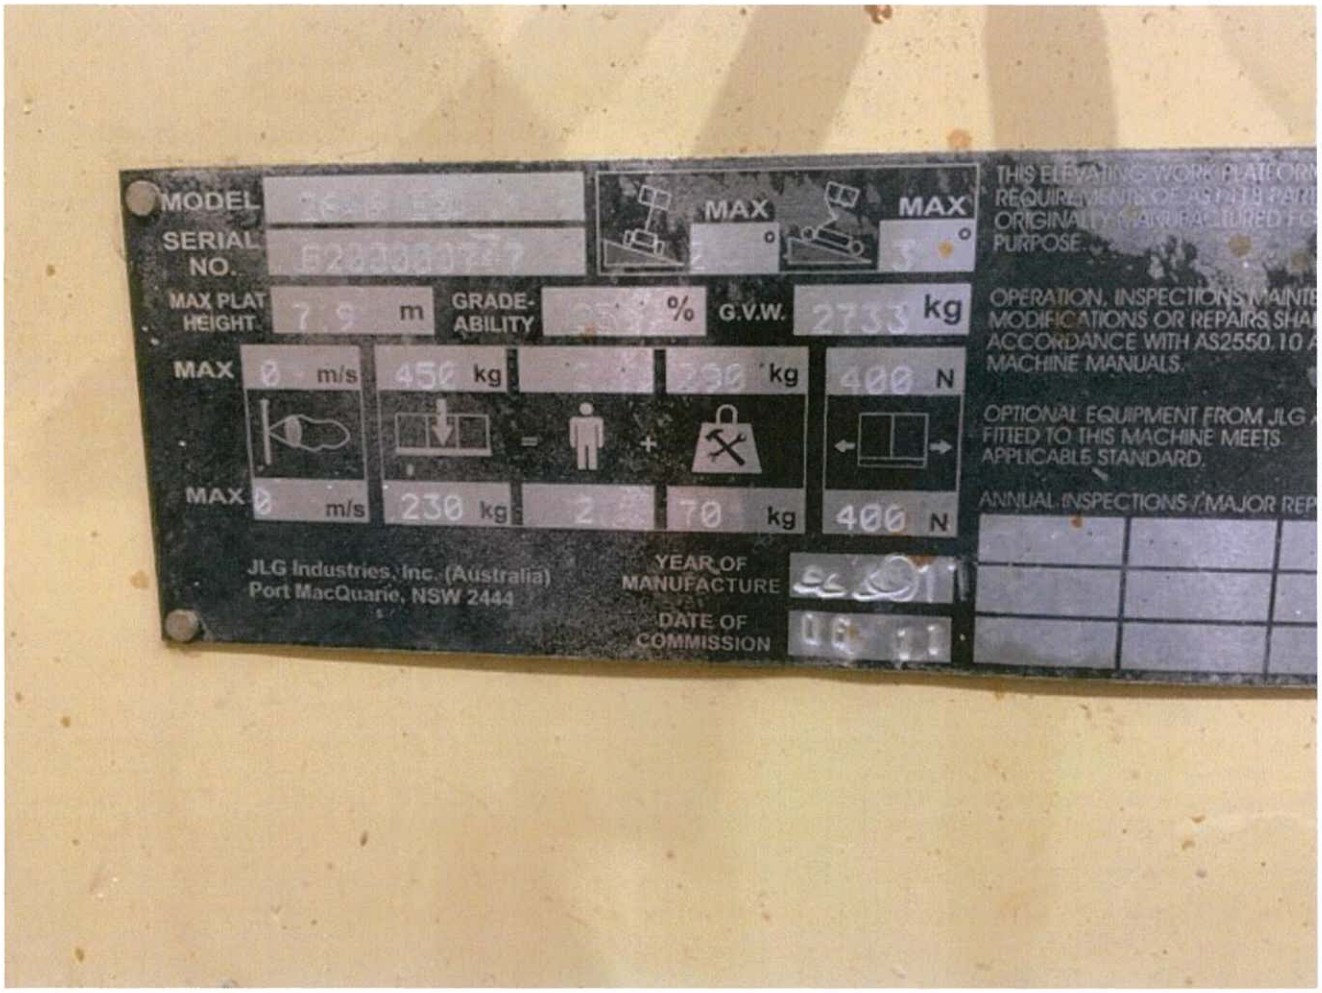
Photo 2

Make:	JLG (Refer photo 1)
Model:	2646-ES
Serial No.:	B200000747 (Refer photo 2)
D.O.M.:	2011
Hours:	670 as indicated (Refer photo 3)
Klms:	N/A
Reg. No.:	N/A
Asset No.:	Unit: 747

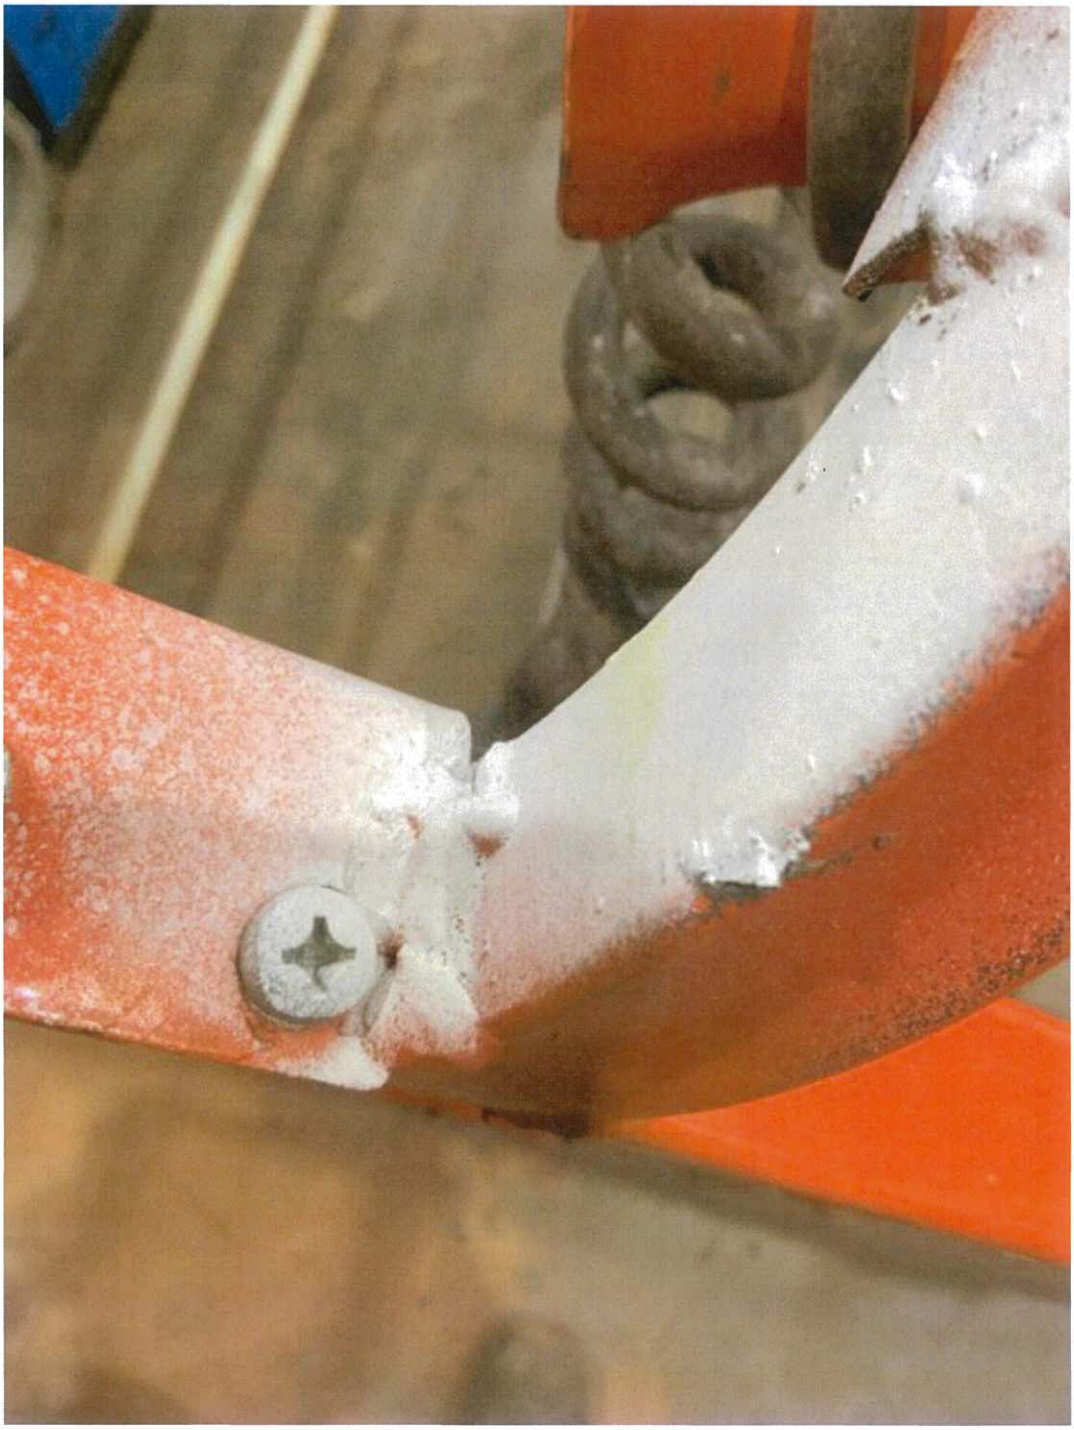
Photo 8

- 100% of Platform Structure welds ****Multiple cracks detected. Areas marked (Refer photo 7-9)****

- 100% of Safety Harness Attachment Point welds
REMEDIAL WORKS: Affected Areas ground back and rewelded. (Refer photo
