Report Number:	INST – 165
Report Date:	09.11.2022

Elevating Work Platform

MAJOR EXAMINATION

NON-DESTRUCTIVE TEST REPORT

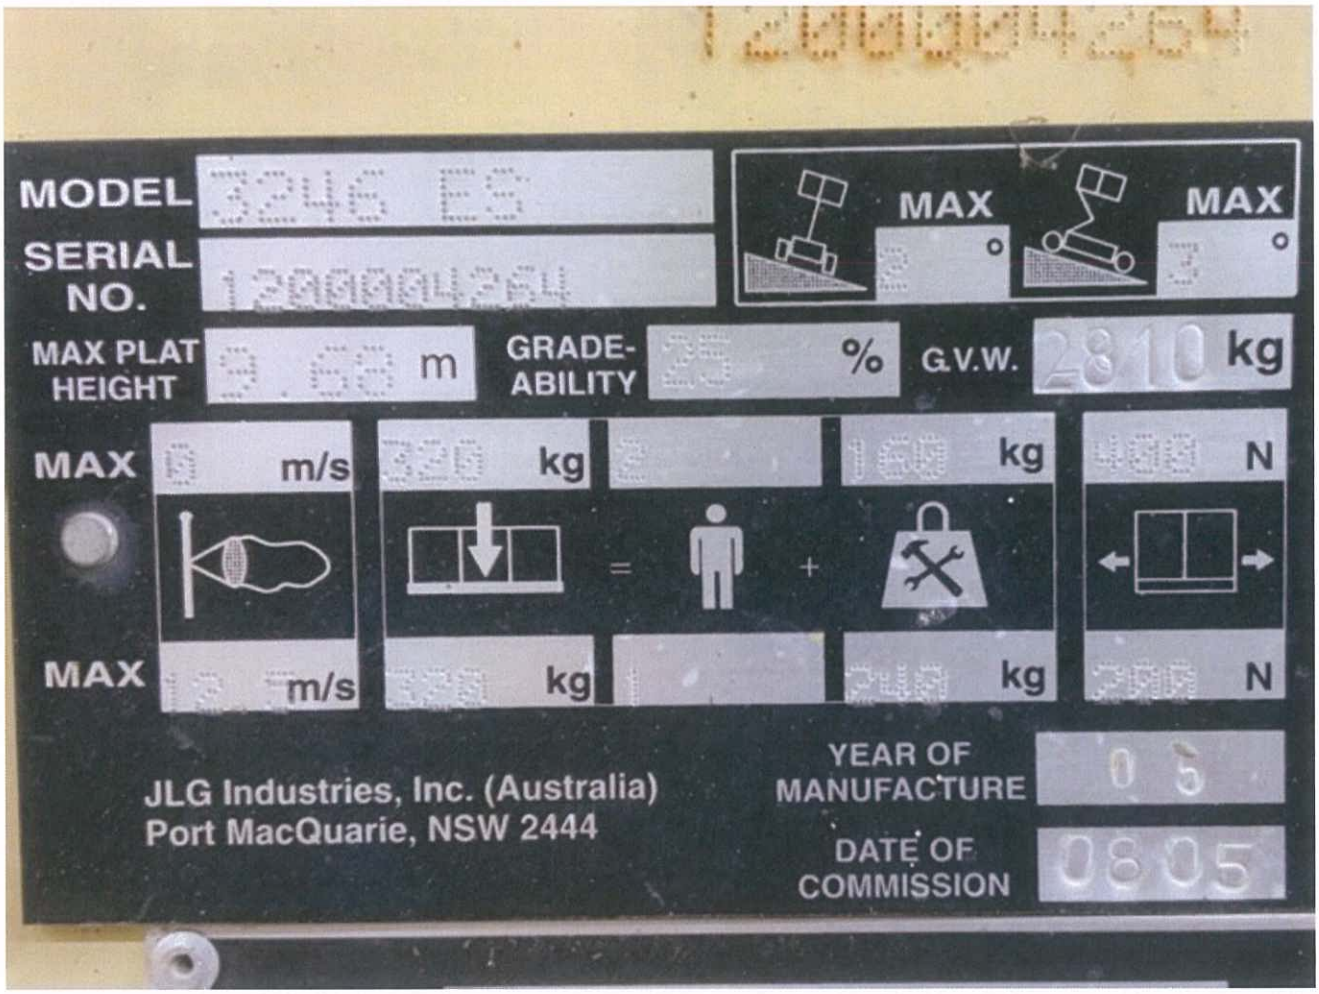
Photo 2

Make:	JLG (Refer photo 1)
Model:	3246-ES
Serial No.:	1200004264 (Refer photo 2)
D.O.M.:	2005
Hours:	495 as indicated (Refer photo 3)
Klms:	N/A
Reg. No.:	N/A
Asset No.:	Unit: 4264

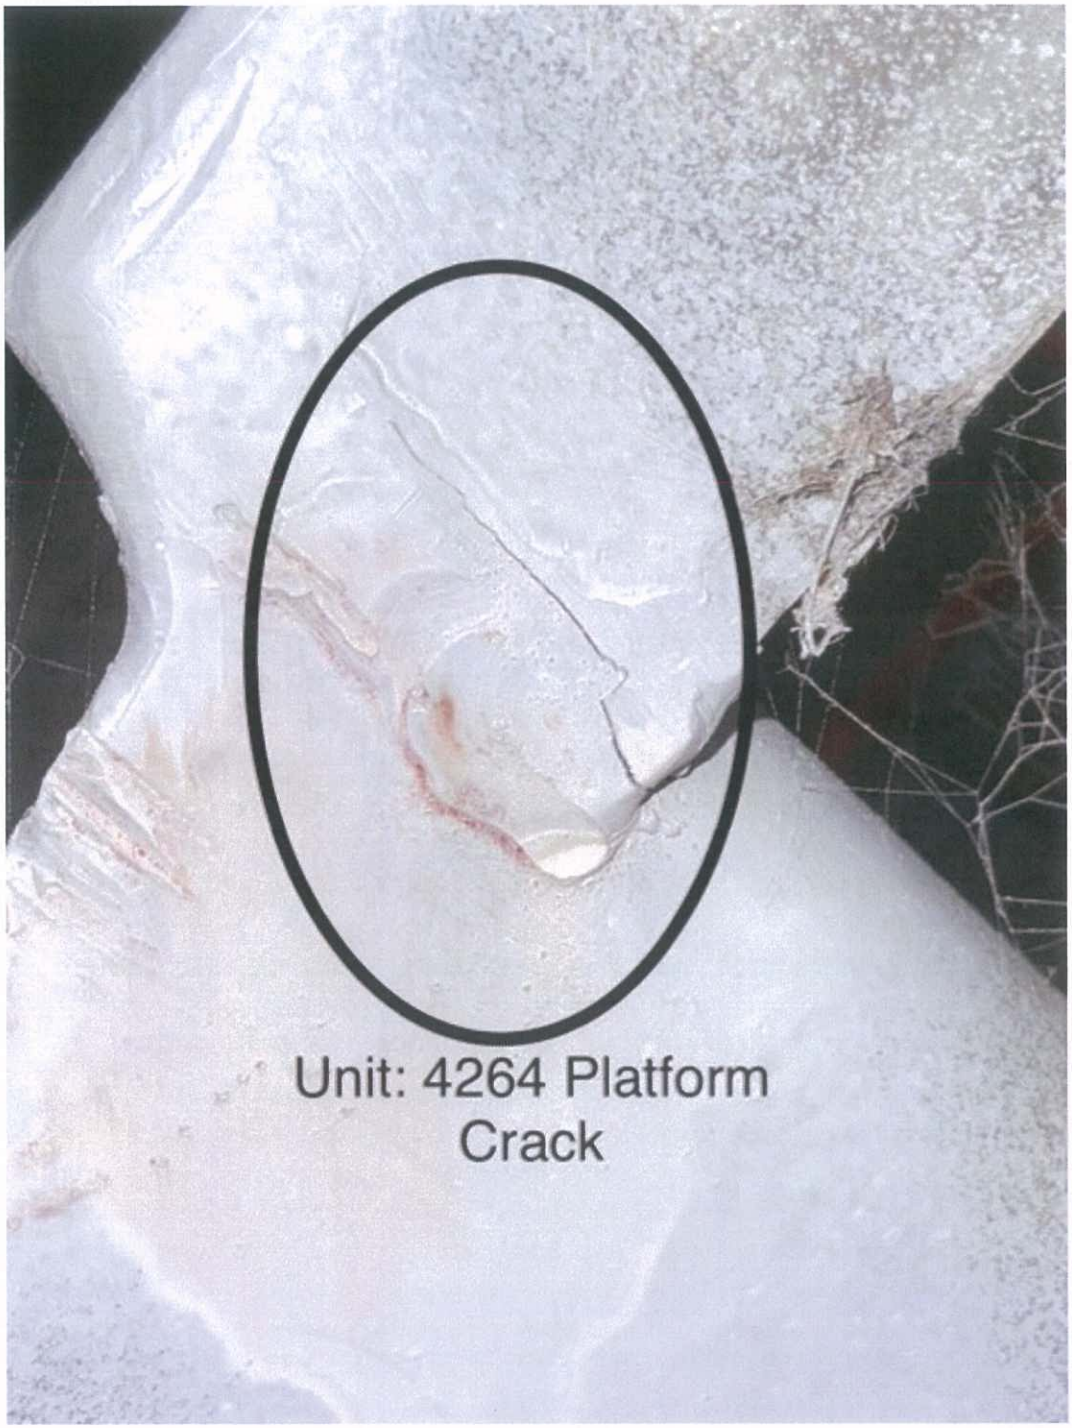
Photo 9

- 100% of Platform Structure welds ***Cracks detected in platform floor. (Refer photo 8-10)***

Description	Amount
Weld 5 off Large Aluminium Scissor Decks Labour only Purchase Order:Dave - 22/11/2021	625.00
