Car Service Salisbury

Tax Invoice

Rego: 436 ET5 **Odo:** 127721
Make/Model: GMC SIERRA 2500 HD
Year: 2018
VIN: 1GT12EY2JF261465
Next service: Premium Service
Due: 17/01/26 **Kms:** 137176

RAS 65 Point Check

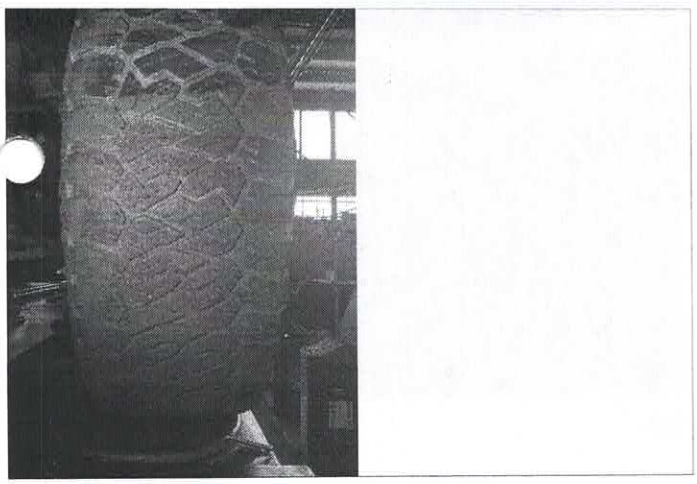
Job		Action	Ref
Wheels & Tyres			
Tread Depth LF (mm)	✗	Worn on inner edge	1.1
Tread Depth RF (mm)	✗	Worn on inner edge	1.2
Wheel / Rim Condition	✗	Rear right wheel missing 1x lug nut. Requires replacement	1.3
