# **XTREME** **EXCAVATORS**

## **CAT 6060** **Inspection Report**

**Machine Make:** CAT  
**Machine Model:** 6060  
**Serial Number:**  
**Customer:** Whitehaven Coal  
**Site:** Blackwater  
**Hours:** 58,117

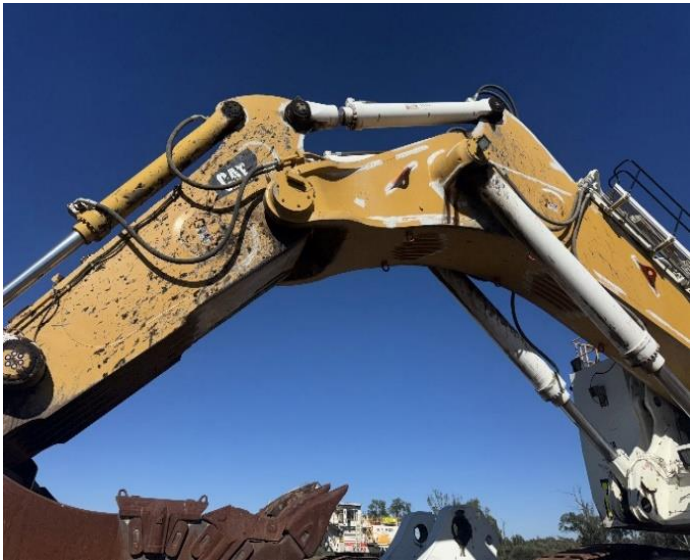
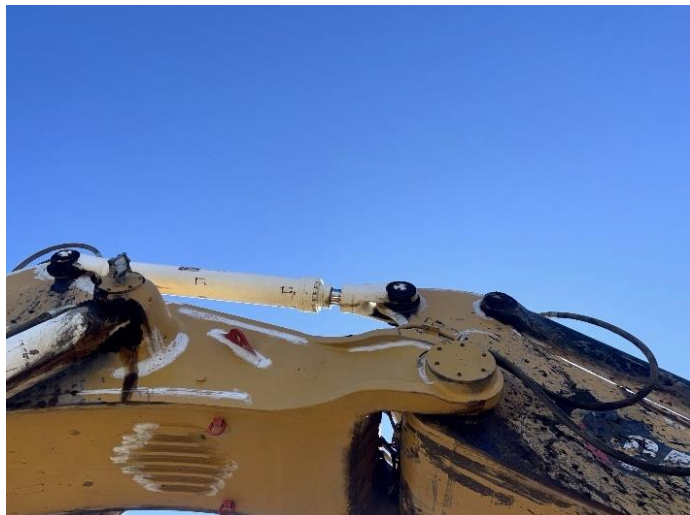
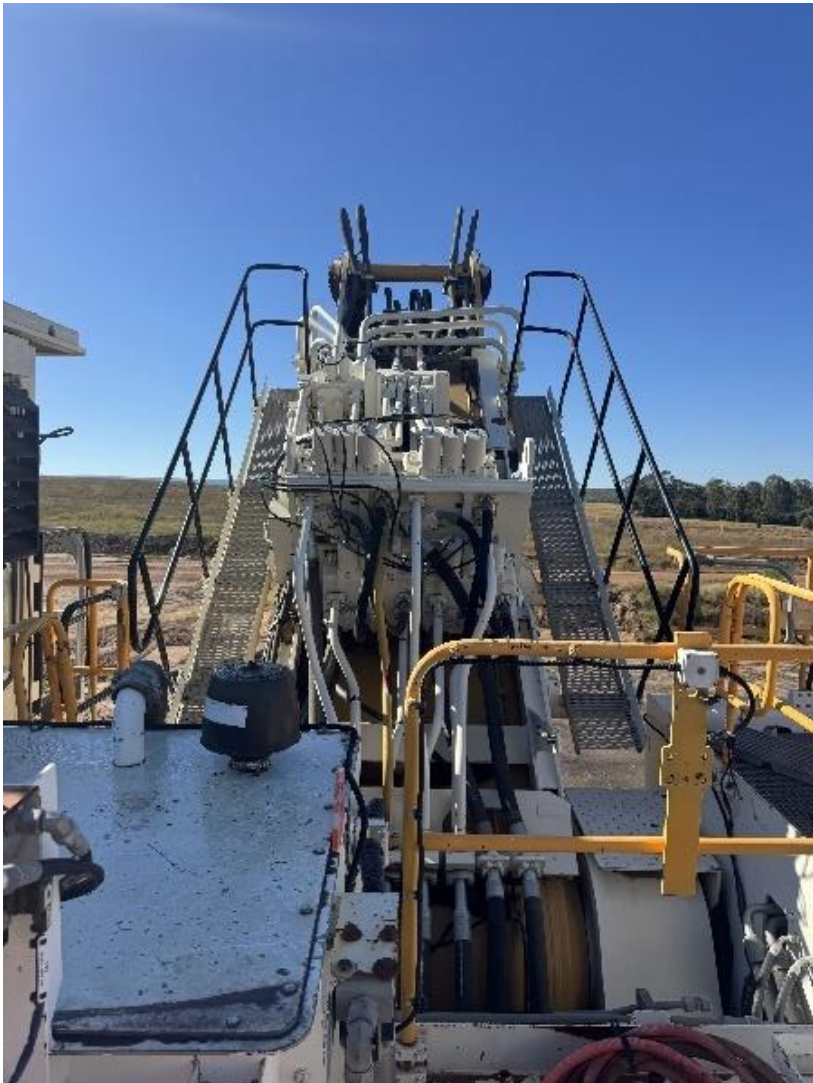
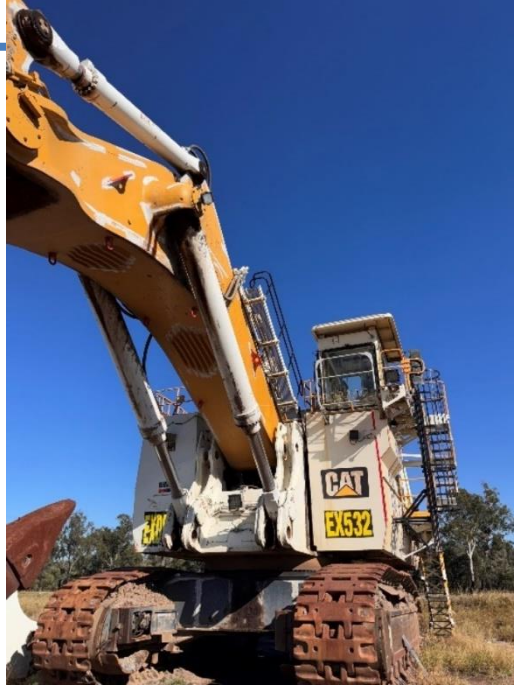
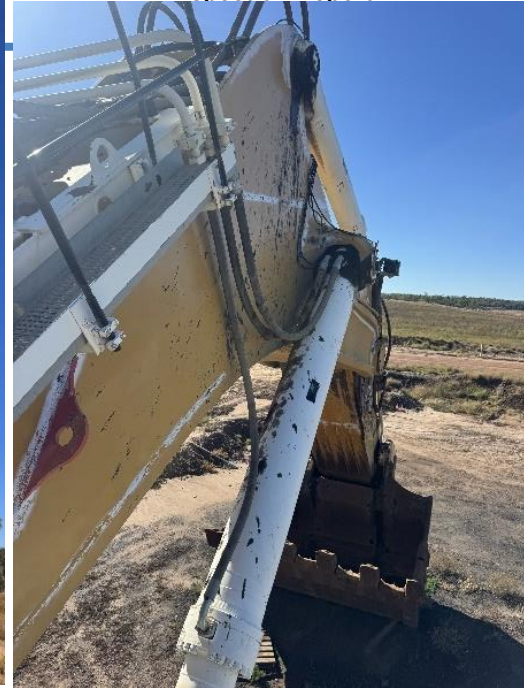
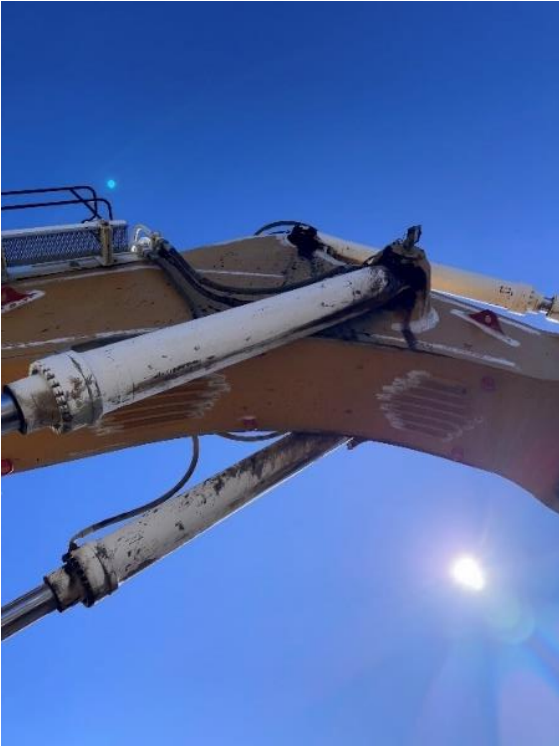
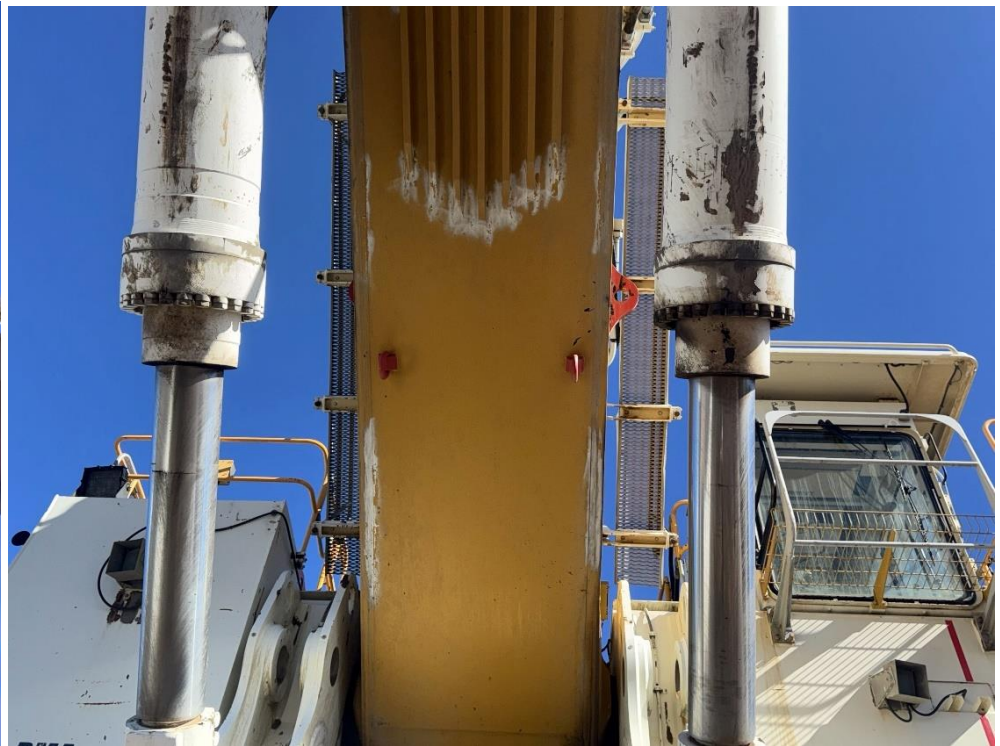
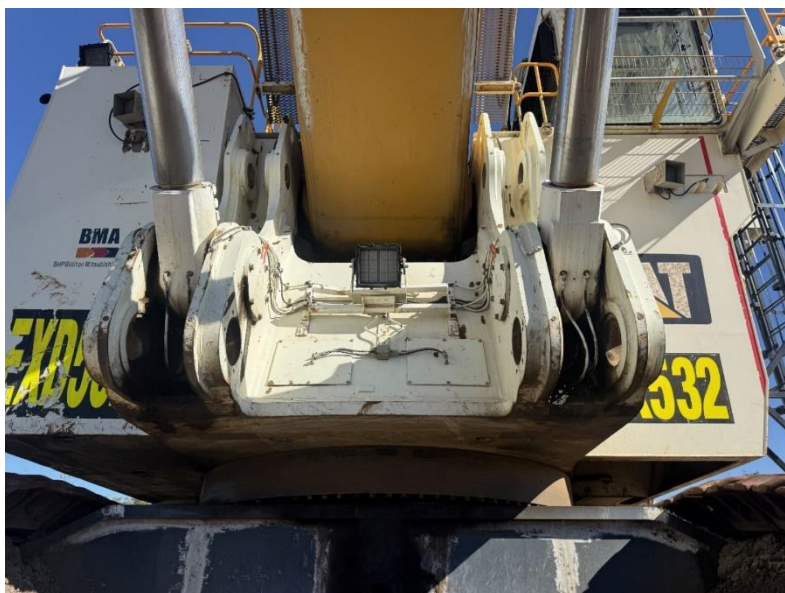
## 1.1 Boom

| Description | L/H | R/H |
|---|---|---|
| Boom Foot Pins/bushes | Ok at time of inspection. Visual Only as we could not run the machine to check movement. | Ok at time of inspection. Visual Only as we could not run the machine to check movement. |
| Boom Cylinder Hoses | Ok at time of inspection. Only inspected these from the ground and top deck. | Ok at time of inspection. Only inspected these from the ground and top deck. |
| Arch Hoses | These hoses looked in good condition at time of inspection. | These hoses looked in good condition at time of inspection. |
| Boom Cylinders | No leaks or damage visible from ground. | No leaks or damage visible from ground. |
| Stick Cylinders | No leaks or damage visible from ground. | No leaks or damage visible from ground. |
| Grease Lines | Did not get up on boom for inspection due to pass outs. Looked ok from ground and top deck. | Did not get up on boom for inspection due to pass outs. Looked ok from ground and top deck. |
| General Condition | Visually looked ok from the ground and top deck at time of inspection. Not sure when the last NDT was carried out. | Visually looked ok from the ground and top deck at time of inspection. Not sure when the last NDT was carried out. |

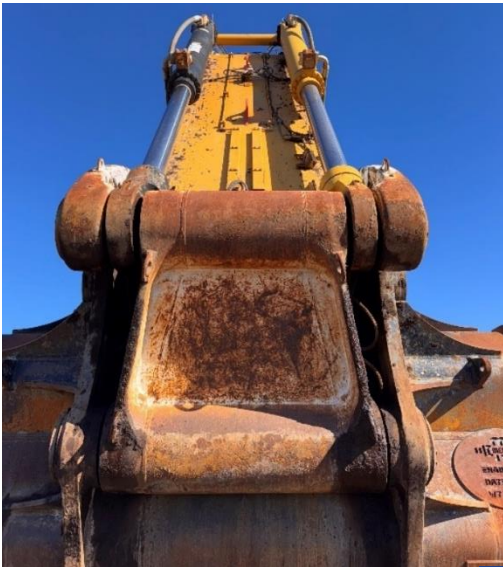
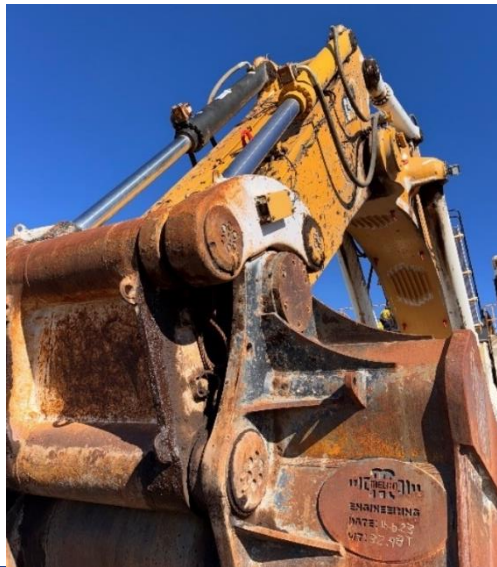
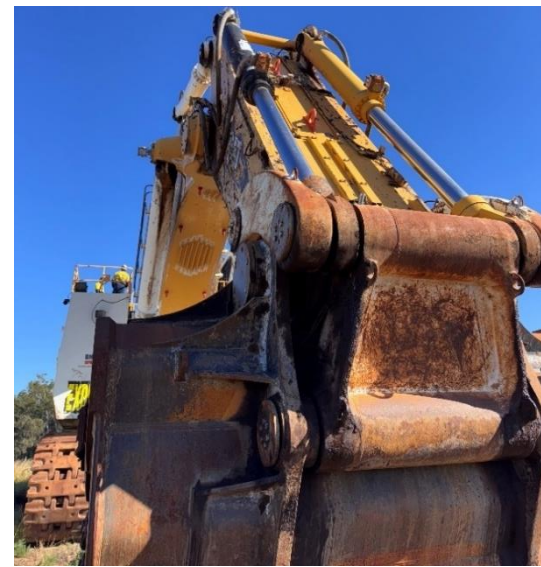
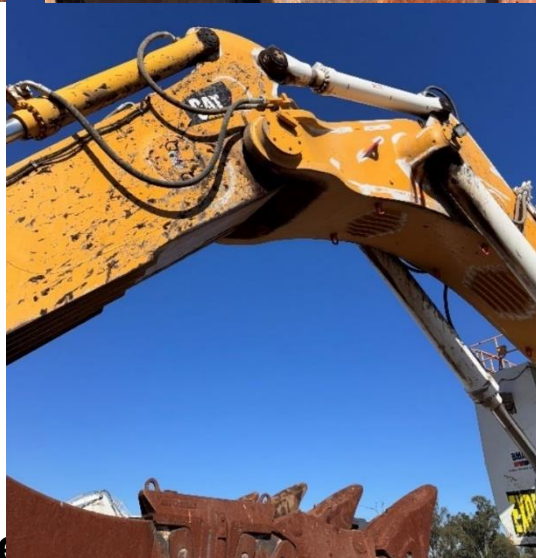
| Description | L/H | R/H |
|---|---|---|
| Boom - Stick Pins/bushes | Ok at time of inspection. Visual Only as we could not run the machine to check movement. | Ok at time of inspection. Visual Only as we could not run the machine to check movement. |
| Bucket Cylinders | No Leaks or damage visible from ground. Visually all looked ok at time of inspection. | No Leaks or damage visible from ground. Visually all looked ok at time of inspection. |
| Grease Lines | Grease lines look ok at time of inspection. Would suggest carrying out Grease audit. | Grease lines look ok at time of inspection. Would suggest carrying out Grease audit. |
| General Condition | Arm Looked to be in serviceable condition at time of inspection. Only inspected from ground. Not sure when last NDT was carried out. | Arm Looked to be in serviceable condition at time of inspection. Only inspected from ground. Not sure when last NDT was carried out. |

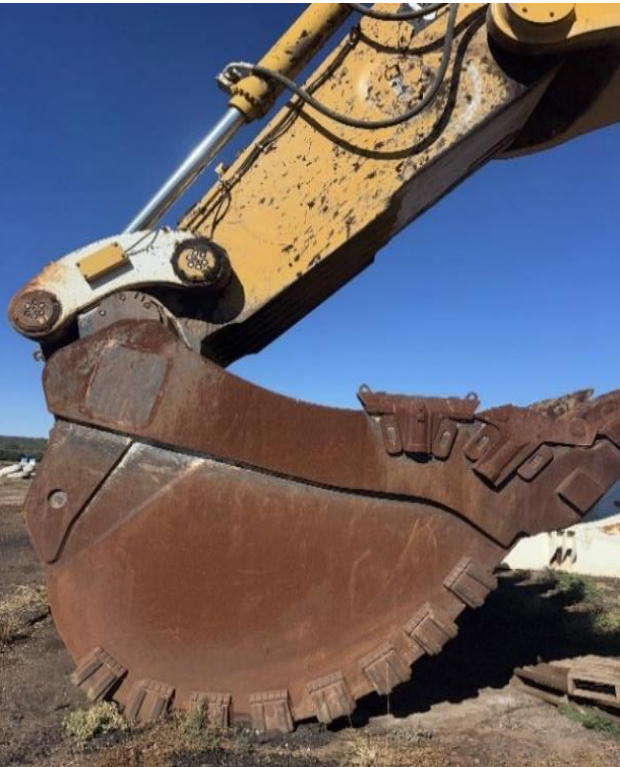
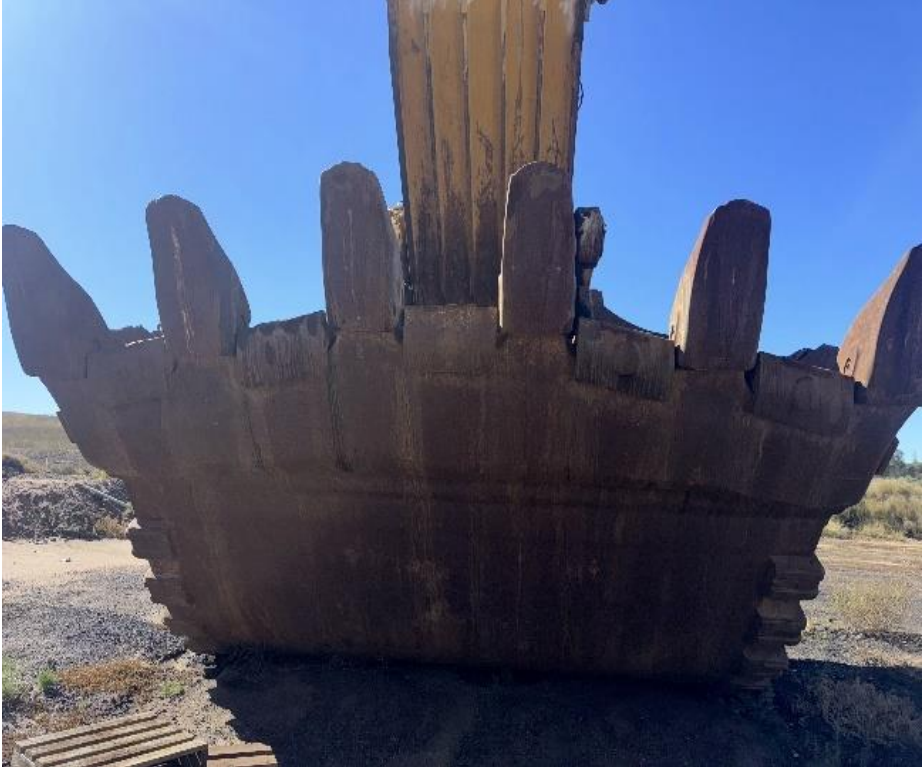
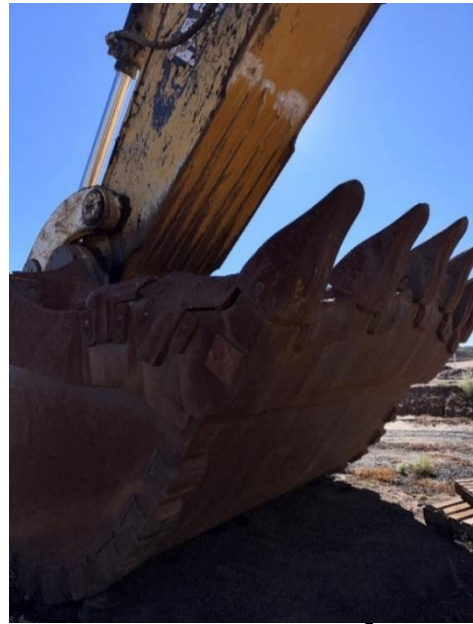
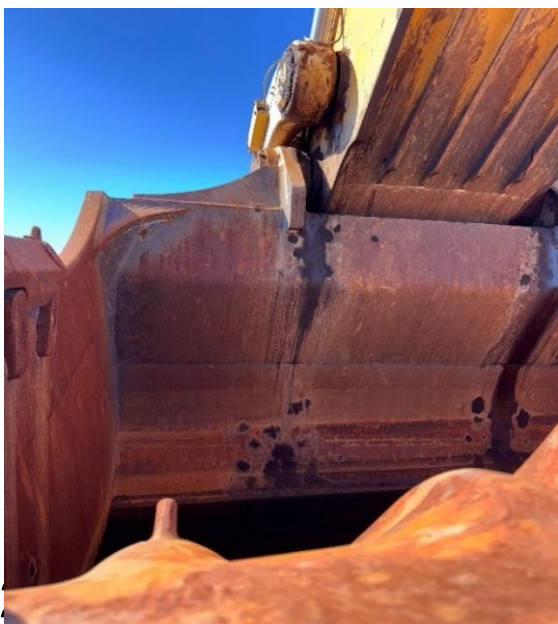
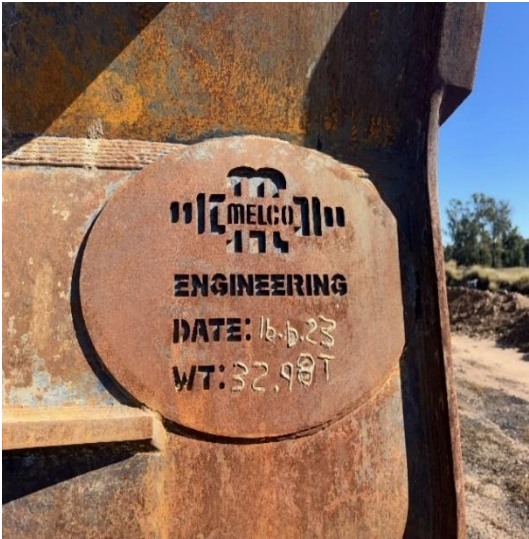
## 1.3 Buckets

| Description | L/H | R/H |
|---|---|---|
| Bucket Pins/bushes | Bucket looked to be good condition at time of inspection. Looked like it had a recent overhaul. Didn't get to look at wear package as bucket was curled and couldn't start machine. | Bucket looked to be good condition at time of inspection. Looked like it had a recent overhaul. Didn't get to look at wear package as bucket was curled and couldn't start machine. |
| GET | All GET looked in good condition at time of inspection. | All GET looked in good condition at time of inspection. |
| Cracking | Visually could not see any cracking from position that the bucket was sitting in. | Visually could not see any cracking from position that the bucket was sitting in. |
| General Condition | Good Condition all round. | |

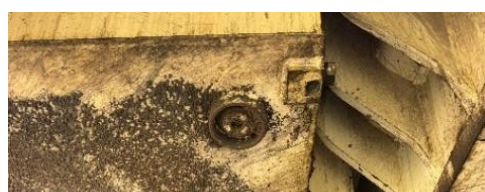
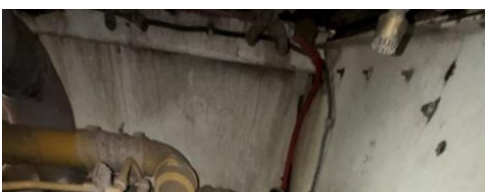
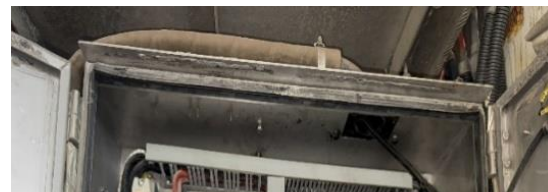
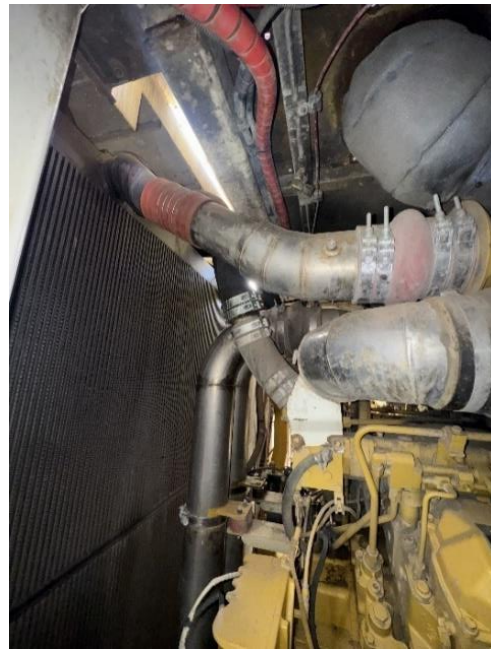
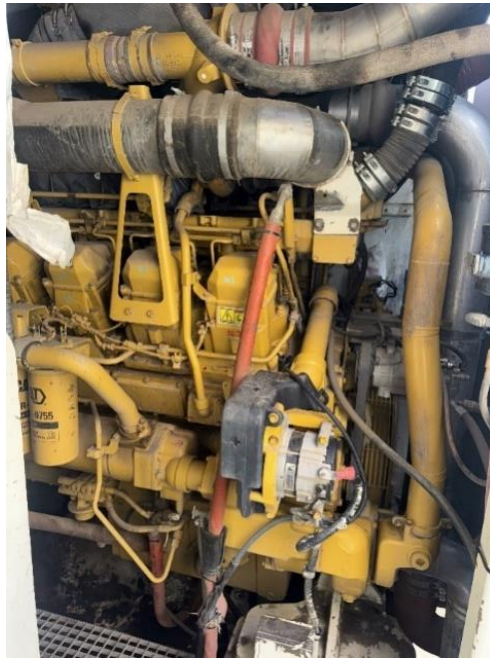
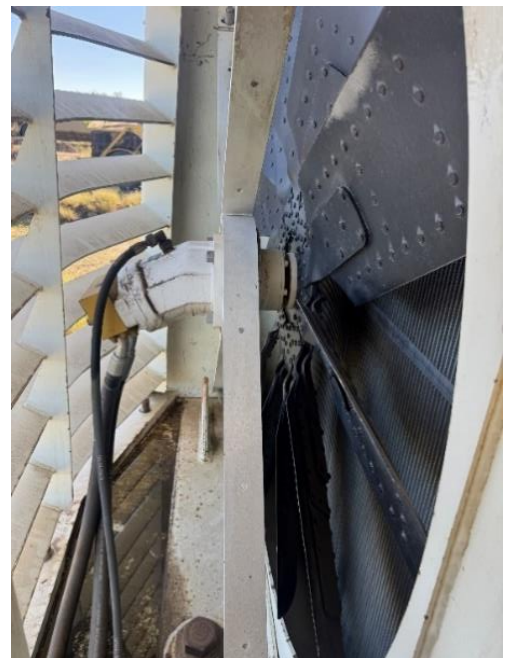
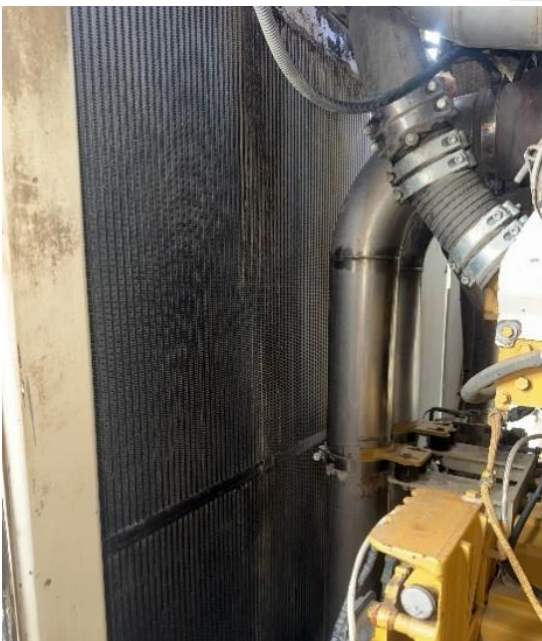
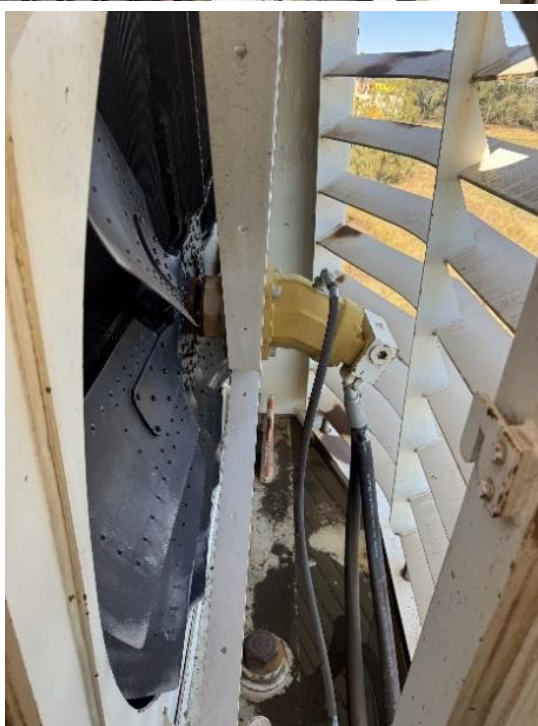
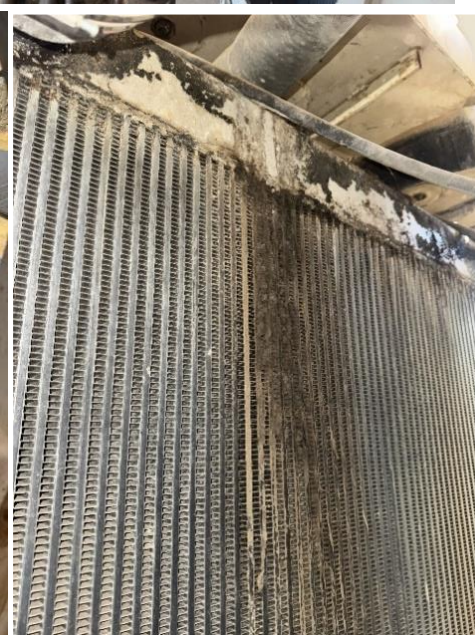
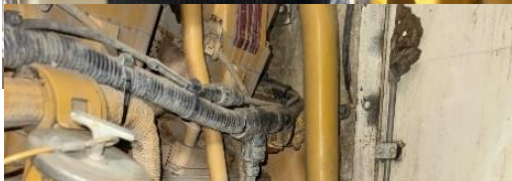
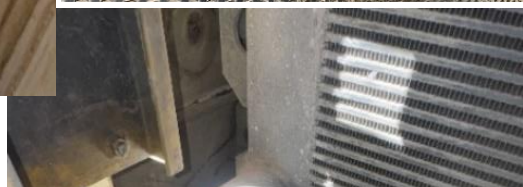
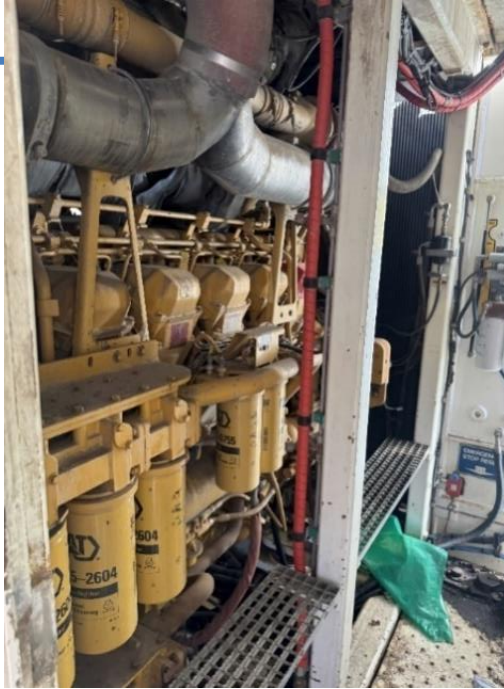
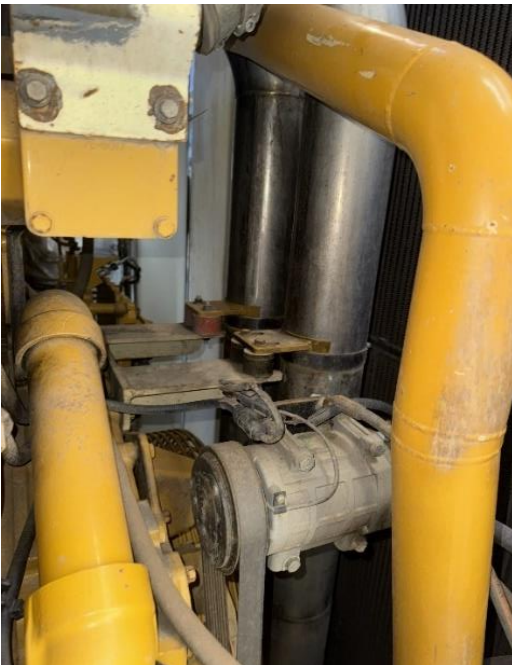
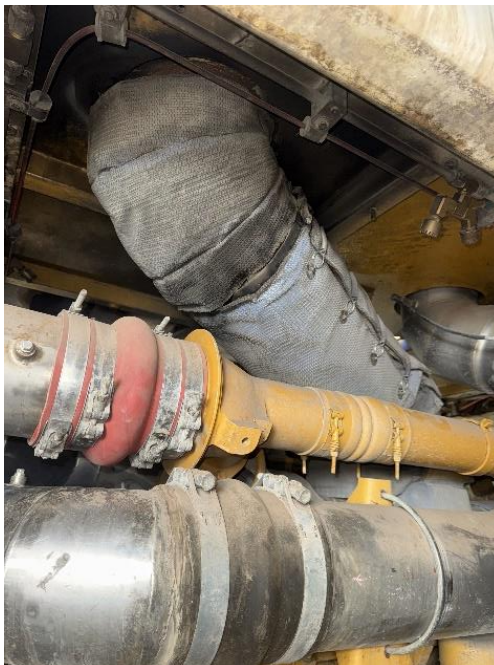
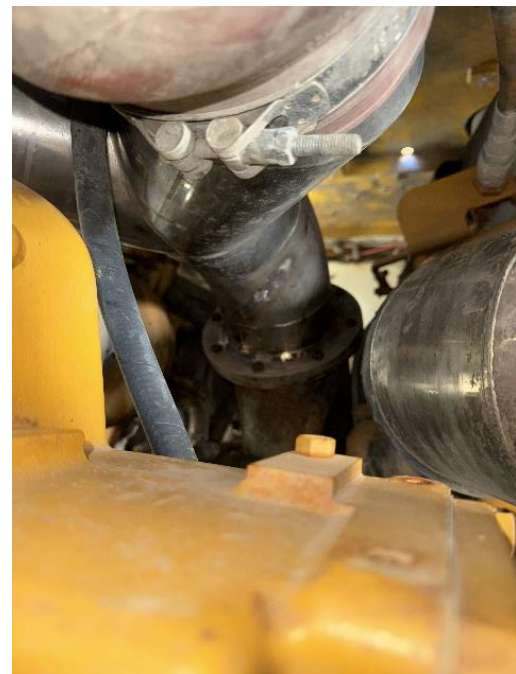
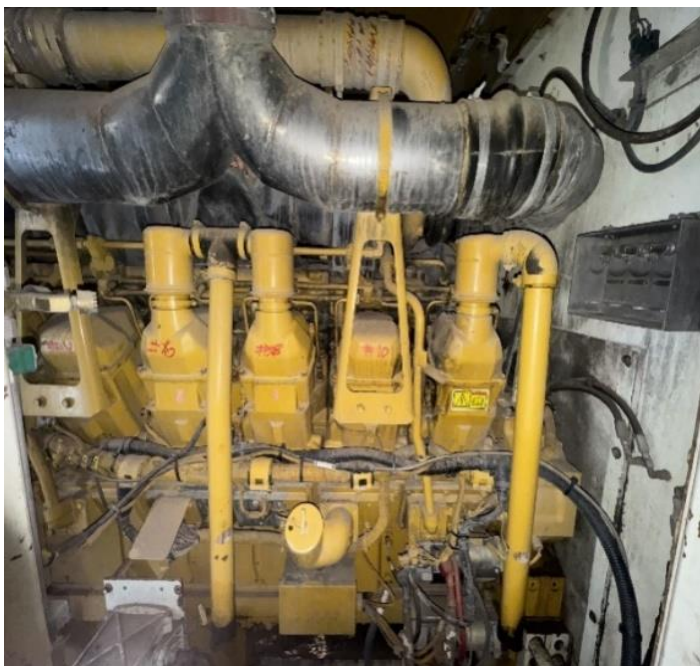
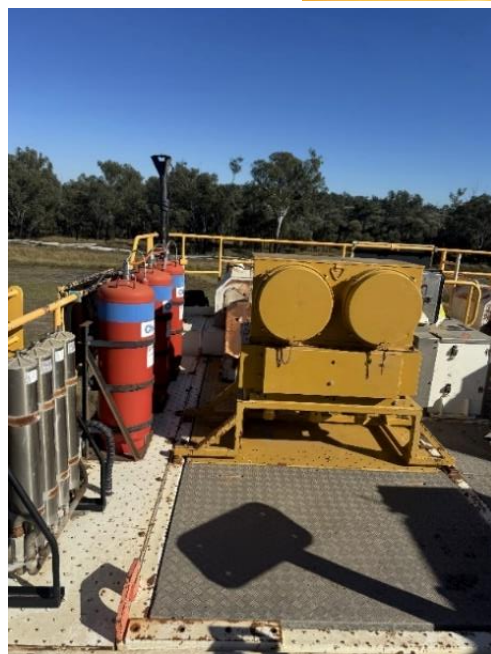
## 2.1 Engine

| Description | L/H | R/H |
|---|---|---|
| Fluid Leaks | Engine looked to be free of leaks at time of inspection. | Engine looked to be free of leaks at time of inspection. |
| Turbo Charger | Turbos had no visible signs of leaks or damage at time of inspection. | Turbos had no visible signs of leaks or damage at time of inspection. |
| Exhaust Leaks & Lagging | Exhaust lagging looked to be in ok condition at time of inspection. No Visual leaks found. | Exhaust lagging looked to be in ok condition at time of inspection. No Visual leaks found. |
| Engine and Radiator Mounts | Mounts look in serviceable condition at time of inspection. | Mounts look in serviceable condition at time of inspection. |
| Hydraulic Spider Assemblies | Assemblies look to be in ok condition at time of inspection. No visible leaks and free from movement. | Assemblies look to be in ok condition at time of inspection. No visible leaks and free from movement. |
| Intake Piping / Clamps | Intake piping and clamps in ok condition. A number of aftercooler clamps missing from hoses. Aftercooler has visible build up near cores in middle. Airboxes look to be in ok condition at time of inspection. | Intake piping and clamps in ok condition. A number of aftercooler clamps missing from hoses. Airboxes look to be in ok condition at time of inspection. |
| General Condition | LH Fuel Tank leaking, fish plated on bottom for repair. Engine missing A/C compressor guard. Electrical harnesses and sensors look ok at time of inspection. | RH Fuel Tank leaking, fish plated on bottom for repair. Electrical harnesses and sensors look ok at time of inspection. X15 box in good condition, 150amp fuse removed. |

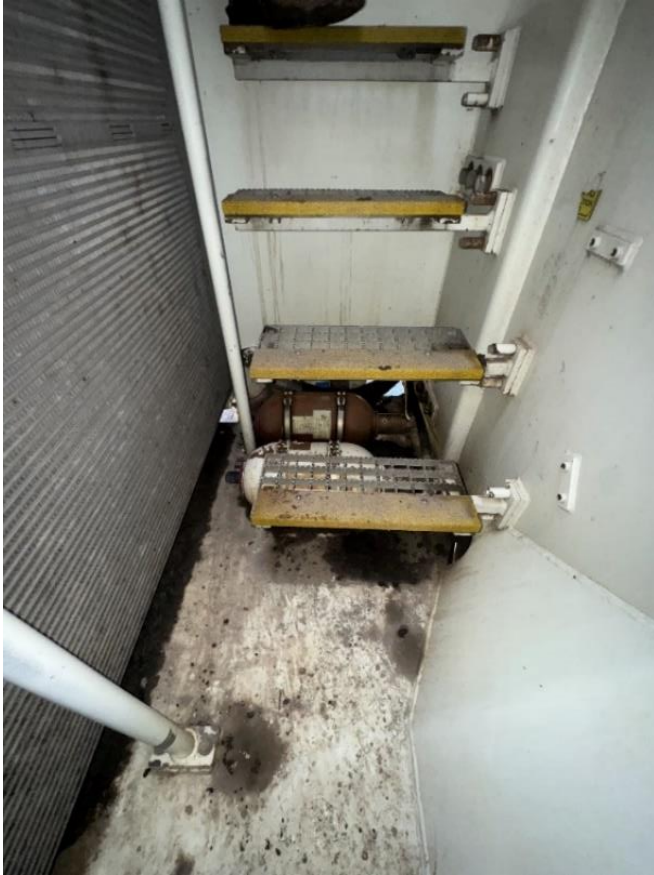
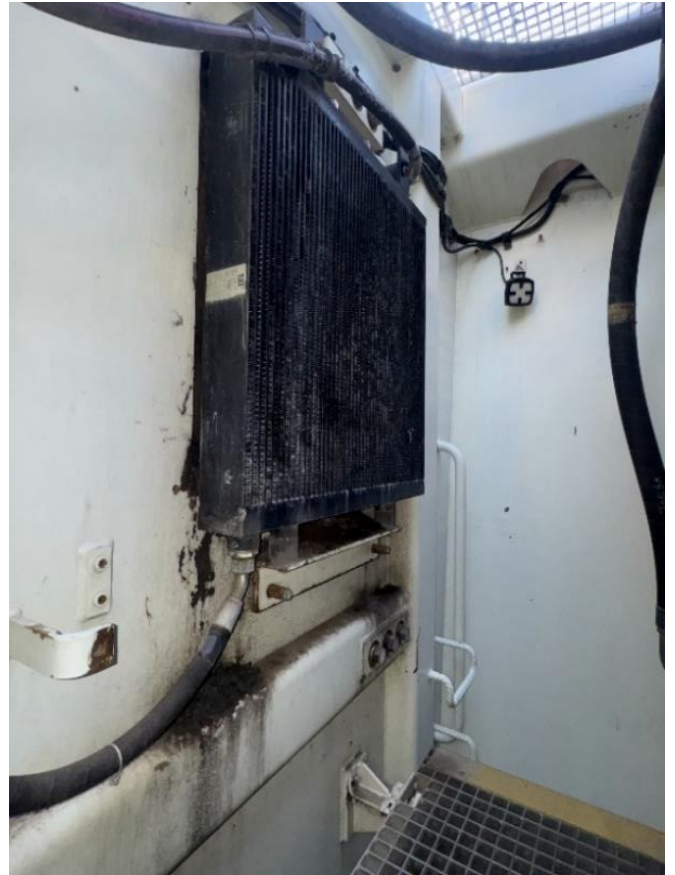
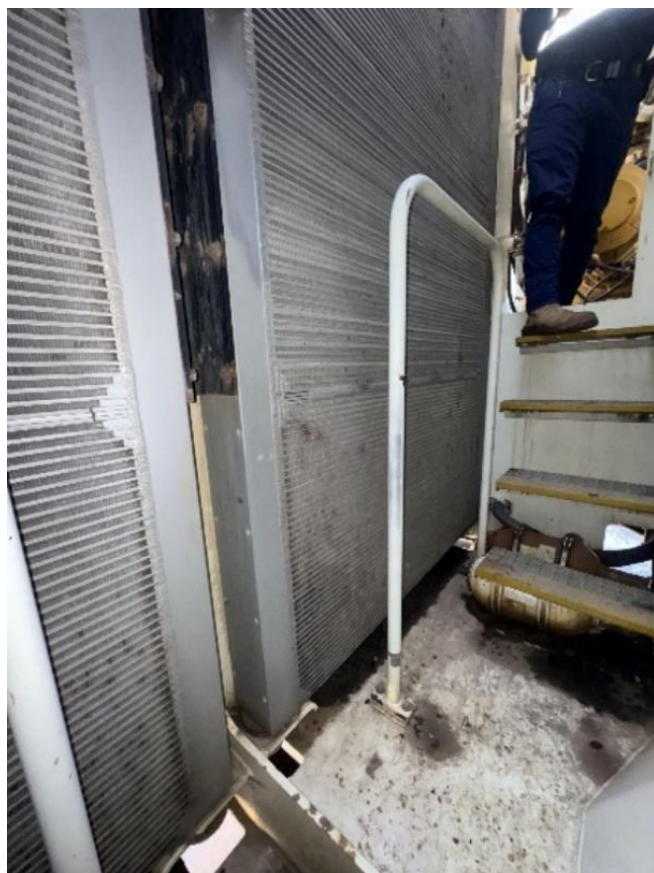
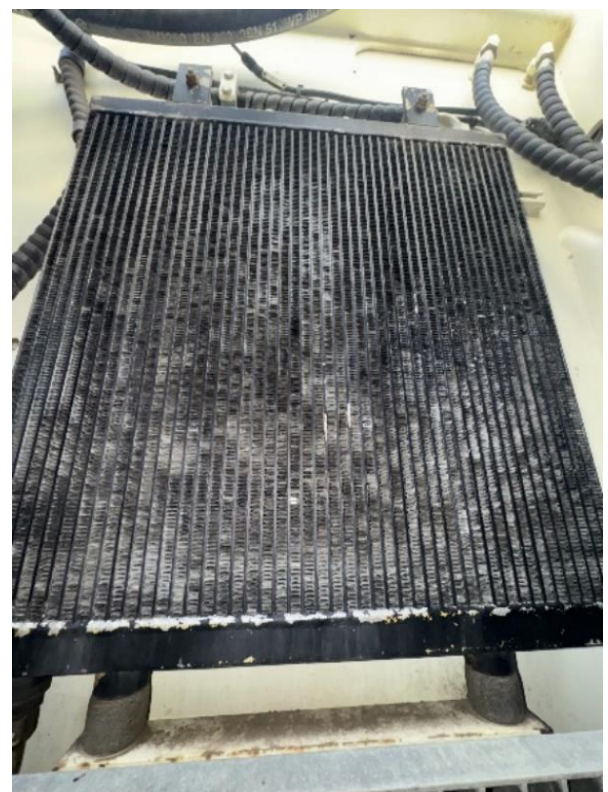
| Location | Comments |
|---|---|
| Hydraulic Oil Coolers | Coolers look in good condition at time of inspection. All mounting hardware still fitted. |
| PTO Coolers | Coolers in good condition at time of inspection. All mounting hardware still fitted. |
| Mounting Bolts | Cooler Module mounting hardware still fitted. |

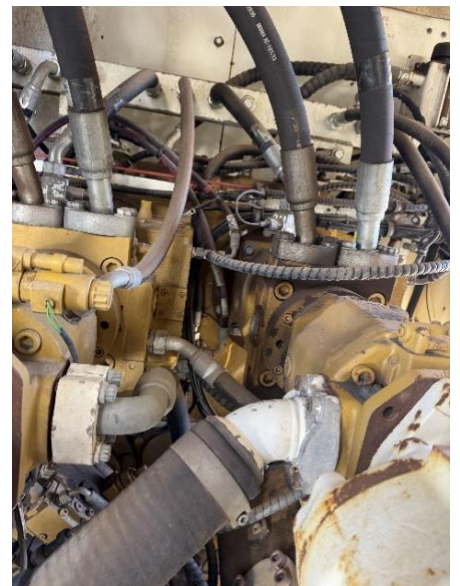
## 2.3 PTO

| Location | L/H | R/H |
|---|---|---|
| Fluid Leaks | Slight leak around lower clamps on MP3/4 suction hose. | Slight leak around slew charge pump sectioning. |
| Hoses | Hoses in pump bay looked ok at time of inspection. Was a number of stiff hoses, would suggest replacing if to go back to work. | Hoses in pump bay looked ok at time of inspection. Was a number of stiff hoses, would suggest replacing if to go back to work. |

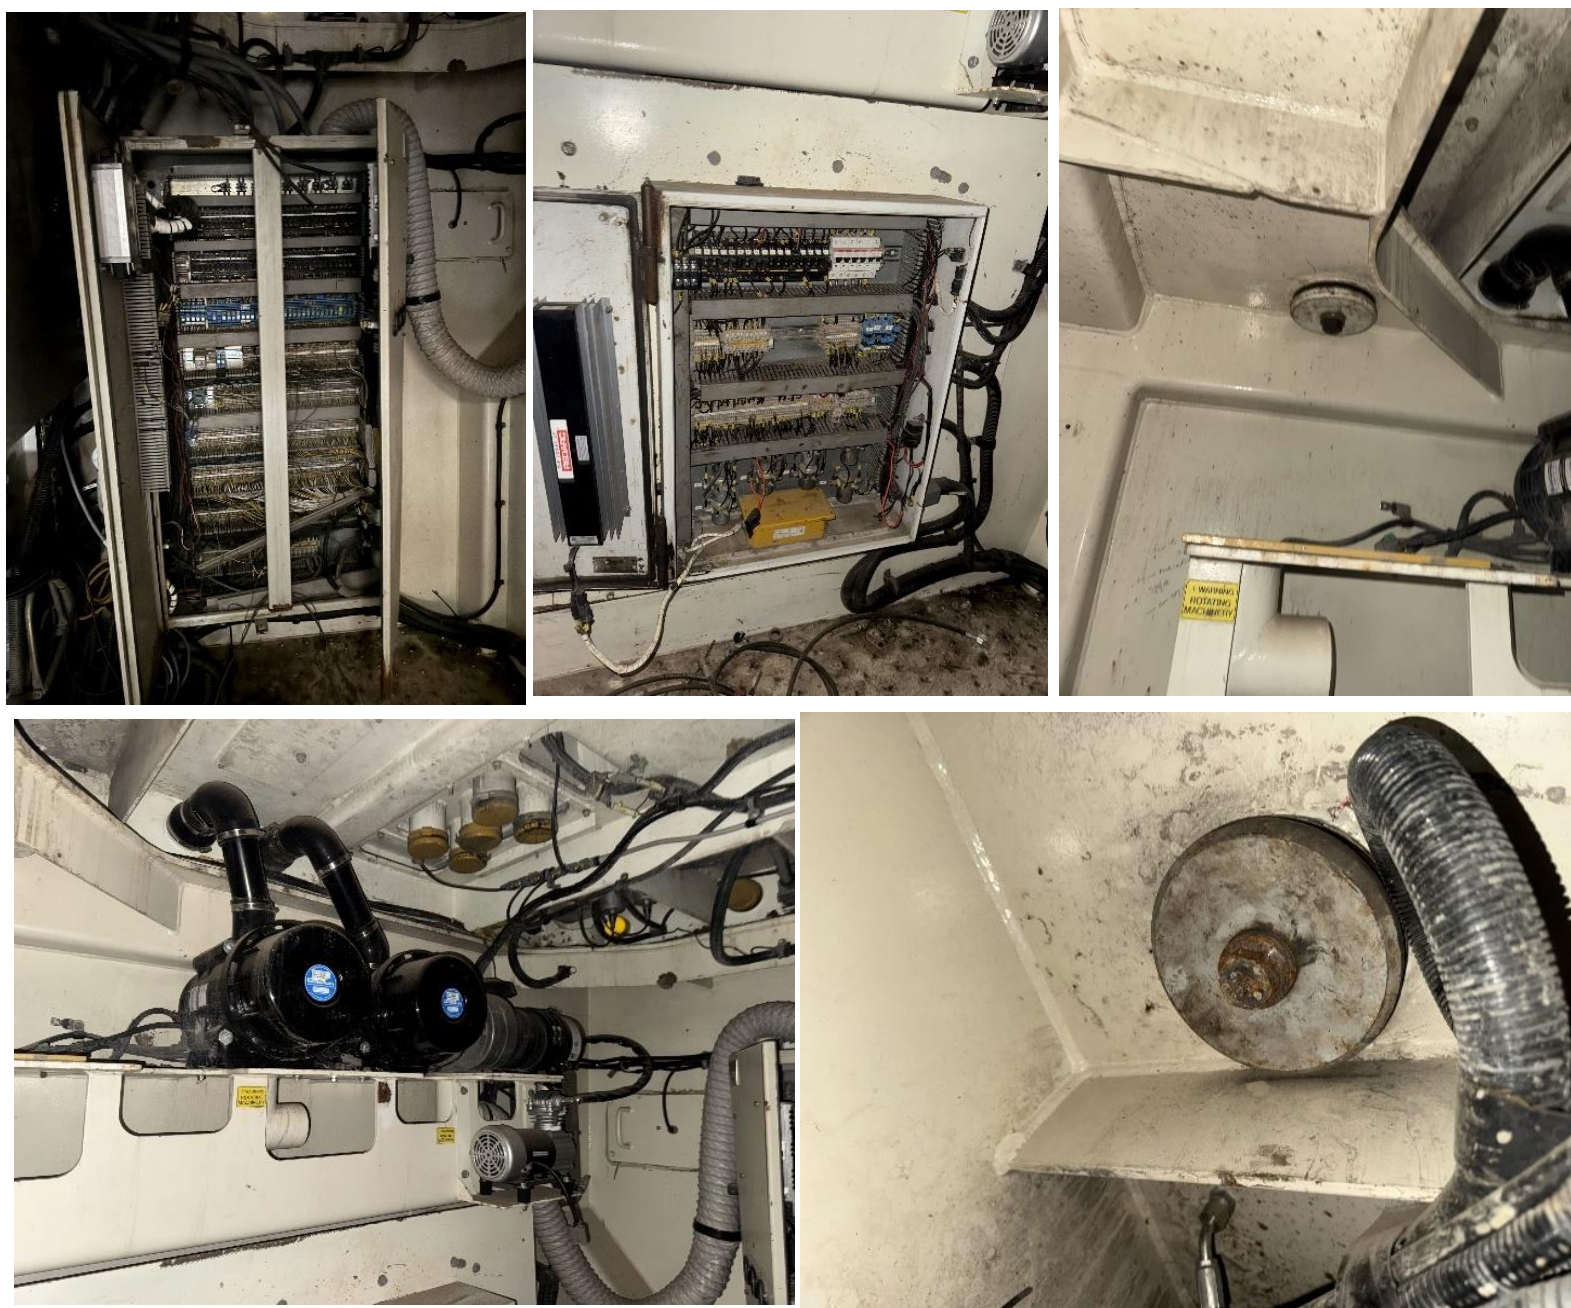
## 2.4 Cascade Room

| Location | Comment |
|---|---|
| Electrical | Electrical Cabinets look in ok condition at time of inspection. |
| Mounting Bolts and Cab Mounts | All mounting hardware fitted and looked to be in serviceable condition at time of inspection. No visible cracks found. |

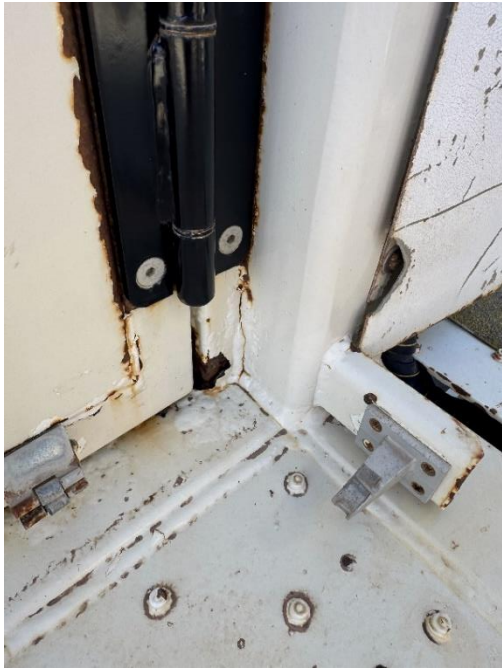
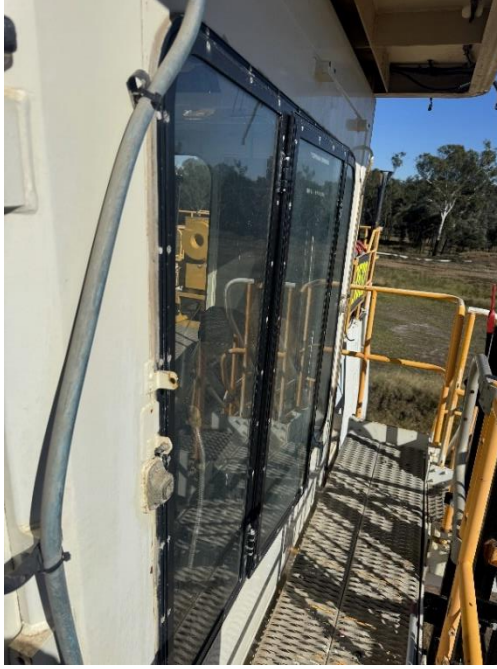
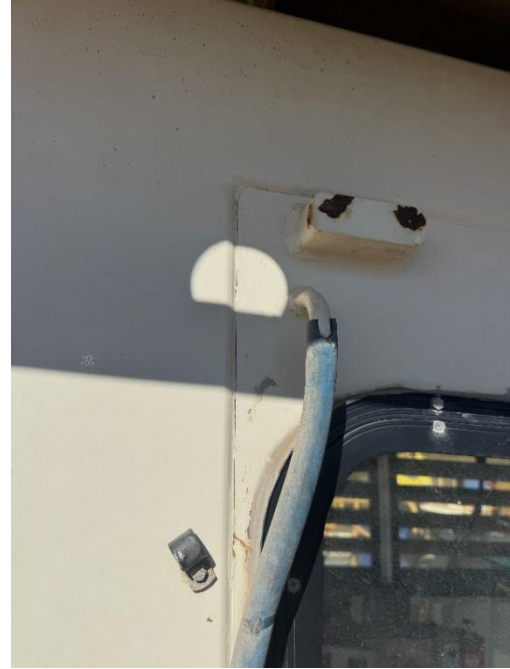
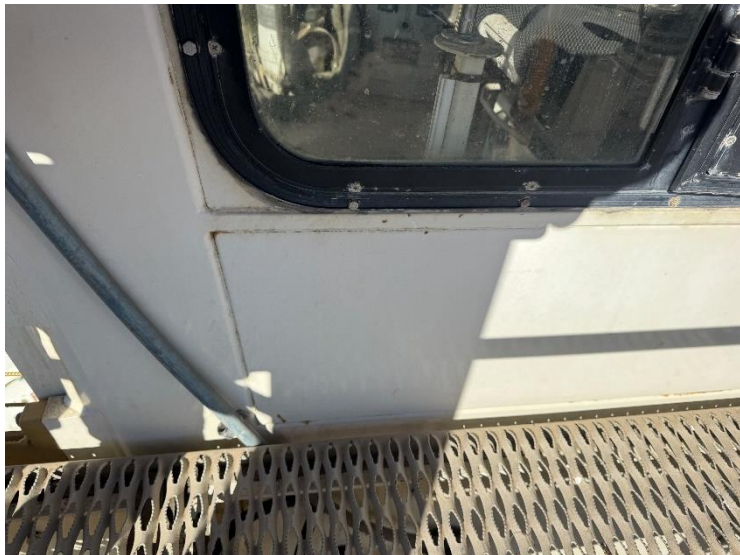
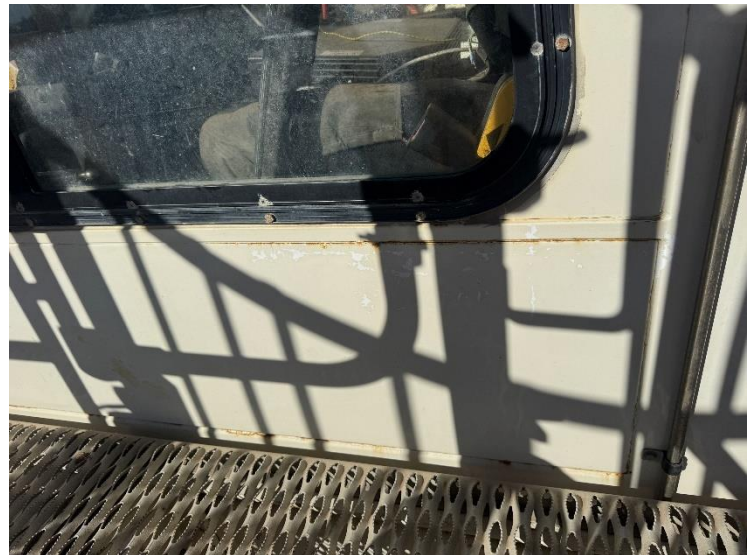
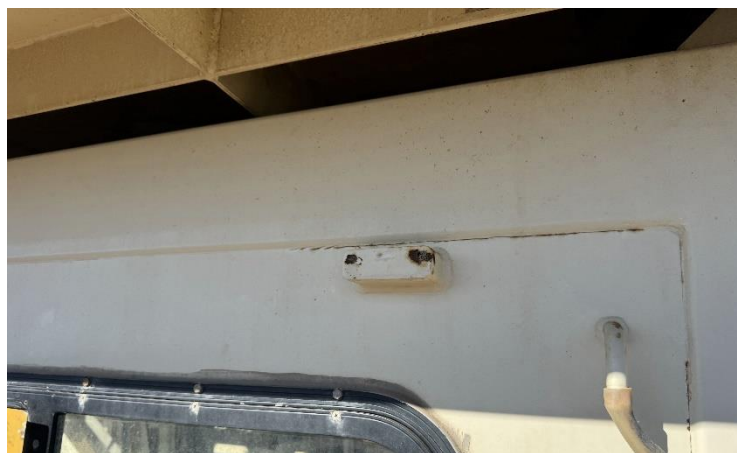
| Location | Comments |
|---|---|
| Cab seals | Cab seals worn. |
| Other | <p>Cab not very clean.</p> <p>Cracks found on LHS of cab shell.</p> <p>Cracks also found at rear RH corner behind door.</p> <p>LH cab blind removed.</p> <p>Rear evaporator unit in cab looks new, filter missing from it. Did not notice anything else removed from units at time of inspection.</p> |

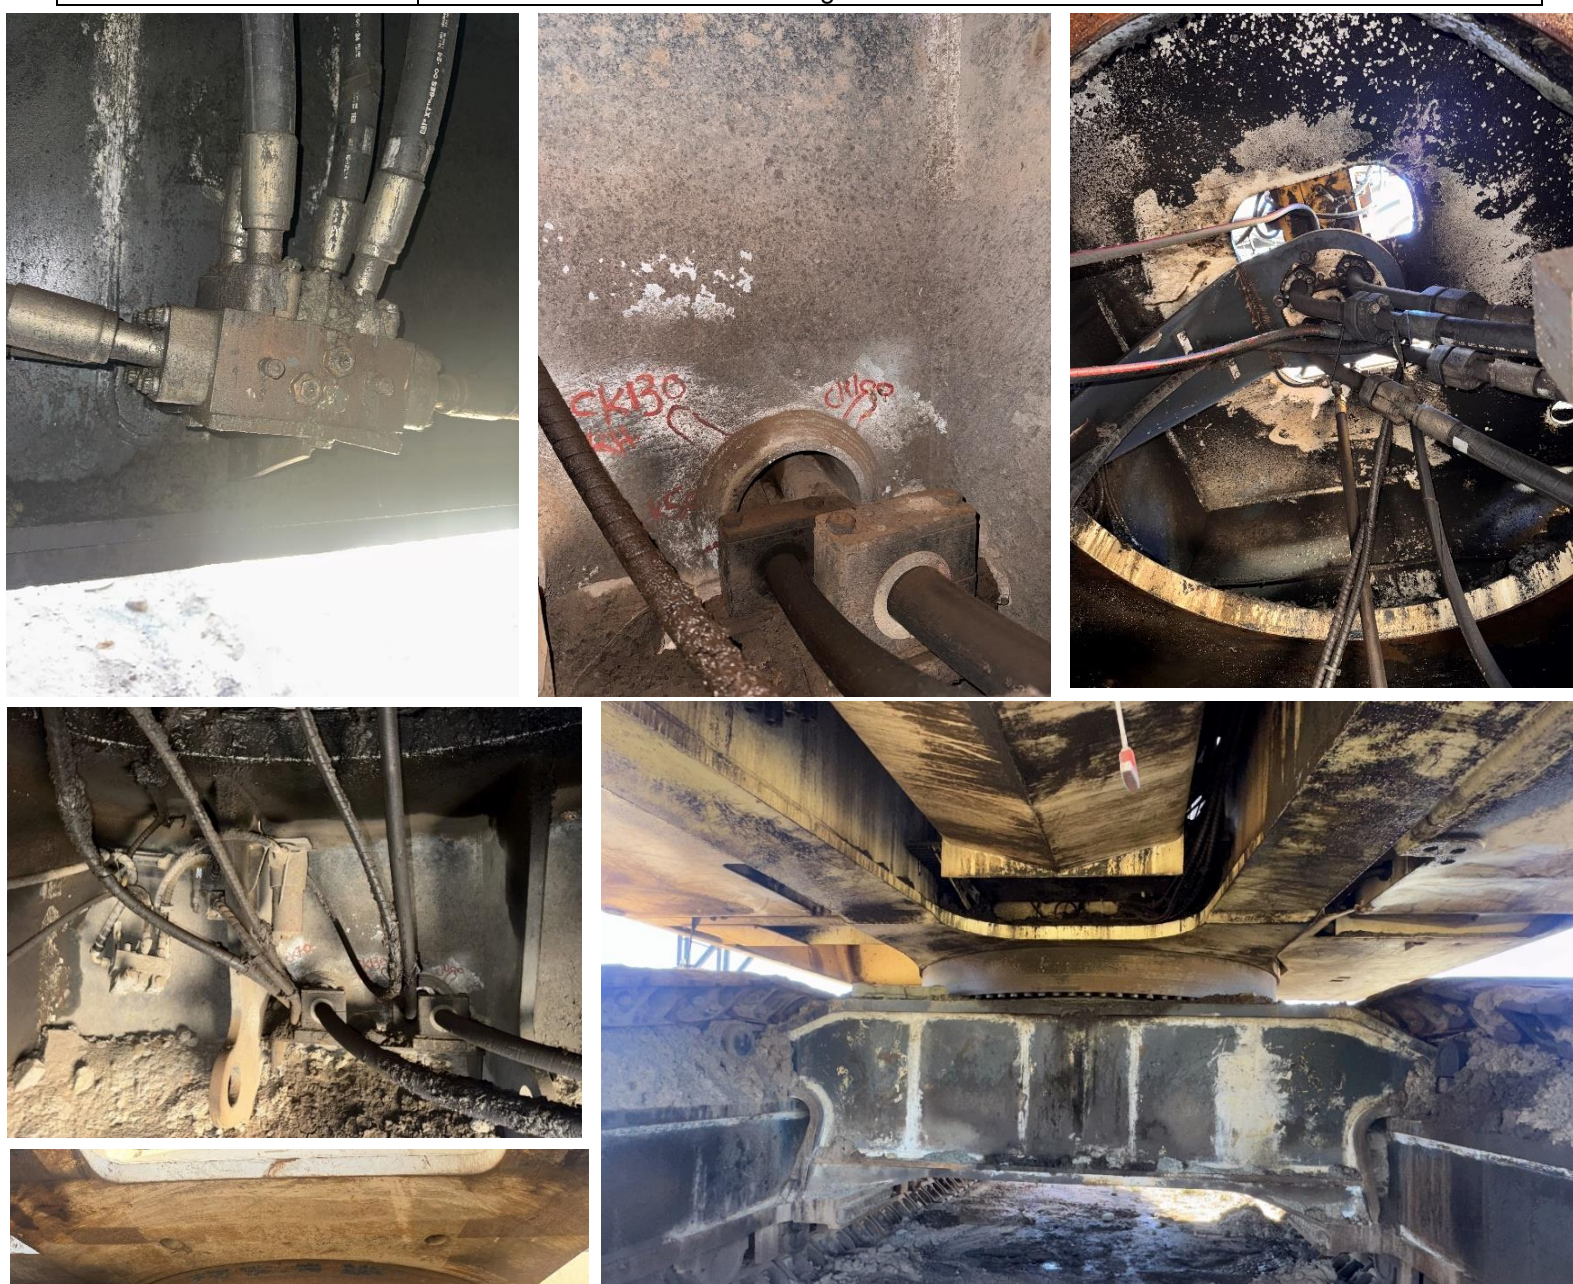
### 7.1 Centre Frame

| Location | Comments |
|---|---|
| Cracking | No major cracking found. Small cracks inside of centre frame where travel hoses go though. |
| Other | Travel relief block under centre frame bent.<br>Travel shock relief valve mountings look bent. |

| Location | Comments |
|---|---|
| Swing Bearing | Slew ring looked ok at time of inspection. Would suggest doing a slew ring deflection unless you can get last recorded measurement. |
