# **XTREME** **EXCAVATORS**

## **CAT 6060** **Inspection Report**

**Machine Make:** CAT  
**Machine Model:** 6060  
**Serial Number:**  
**Customer:** Whitehaven Coal  
**Site:** Blackwater  
**Hours:** 58,117

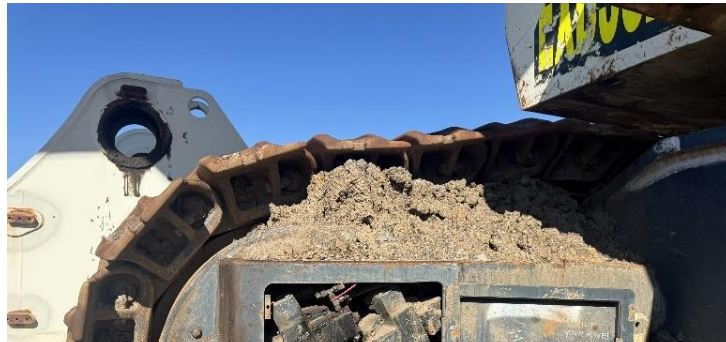
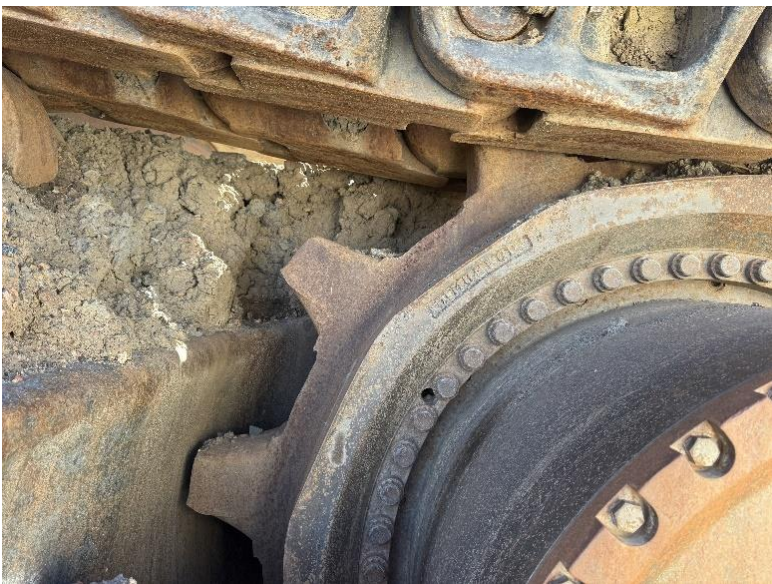
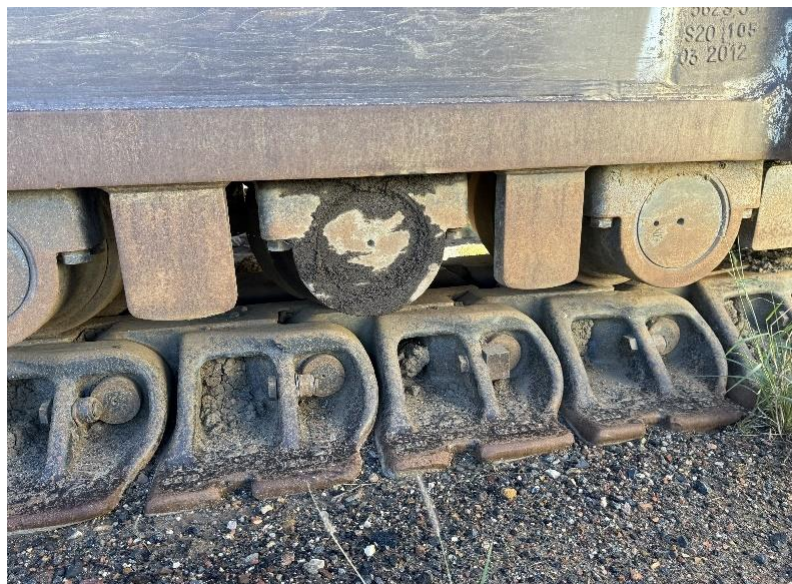
## 7.2 – L/H Track Frame

| Location | Comments |
|---|---|
| Mounting Bolts | Front Horizontal Mounting bolt is broken. |
| Lower Rollers | Pos 2 & 6 look to be leaking grease at outer cap. |
| Idler | Idler looks ok, hasn't failed/collapsed. Slides worn. |
| Sprocket | Sprocket has excessive wear. Would suggest changing out with new tracks. |
| Final Drive / Travel motors | Slight leak around rear travel motor. |
| Track | Tracks look worn. Pins also look worn. No missing retainer bolts at time of inspection. |

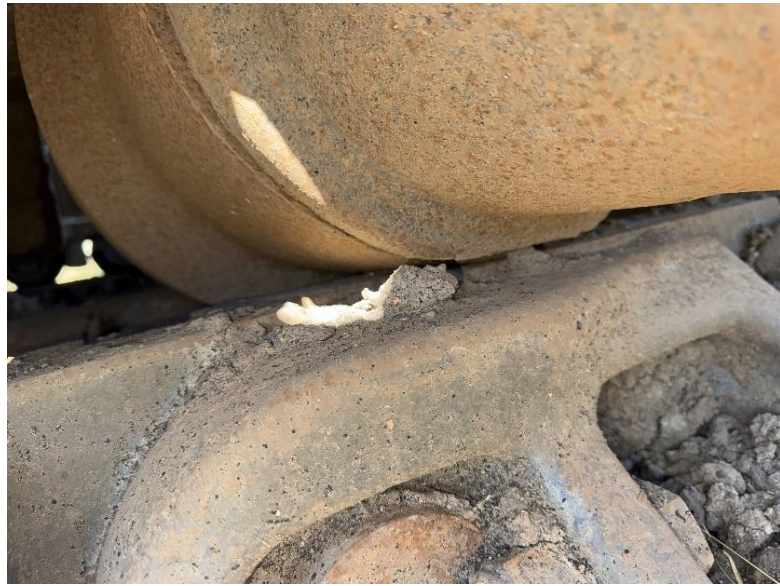
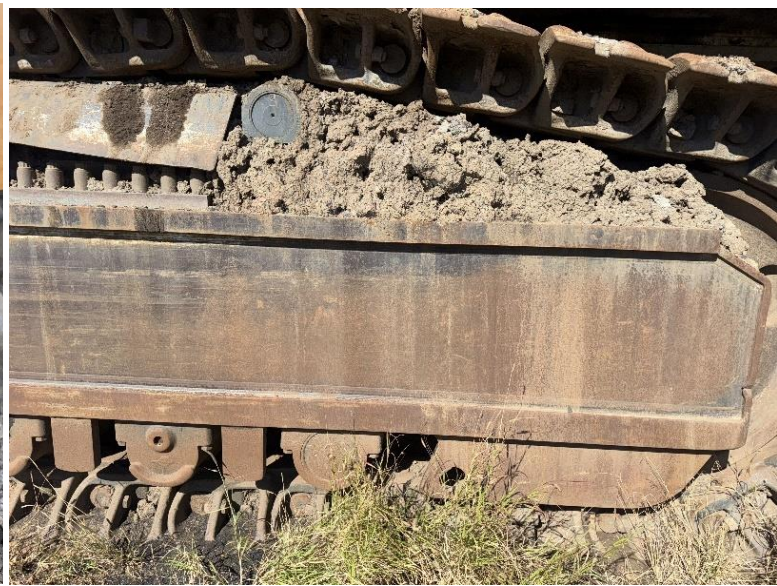
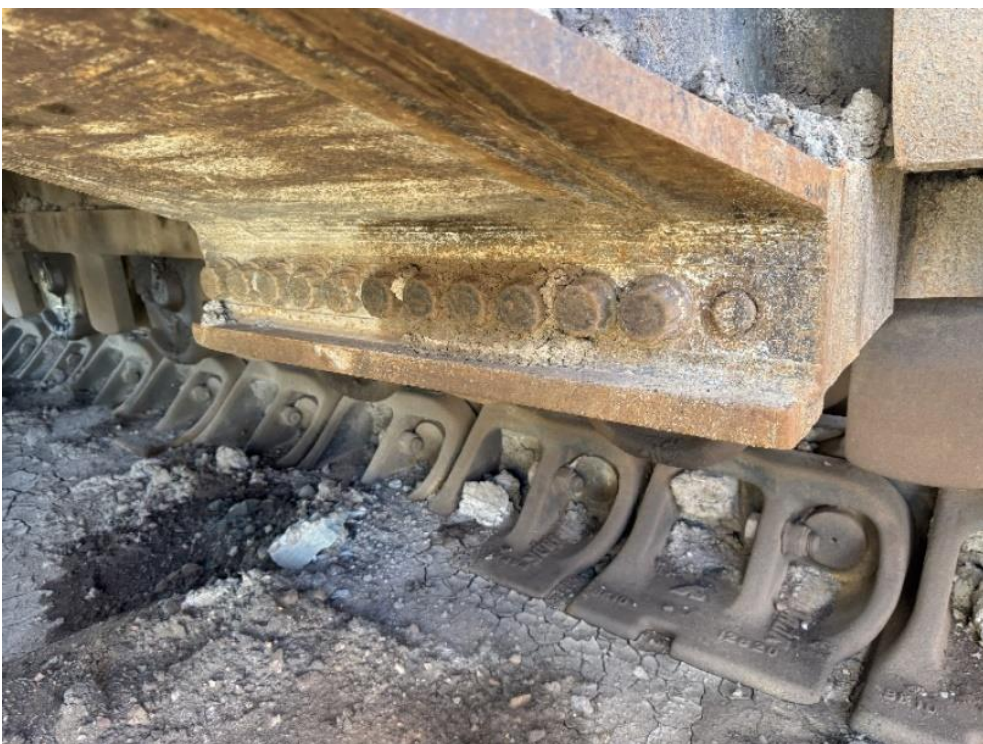
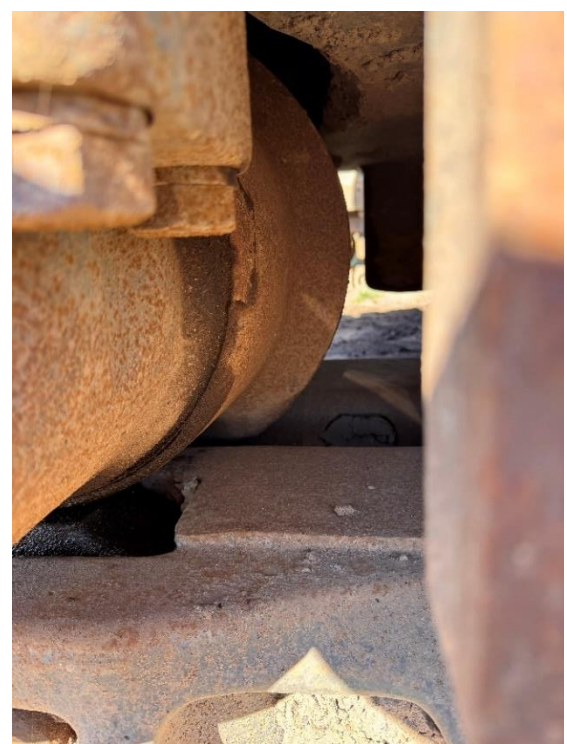
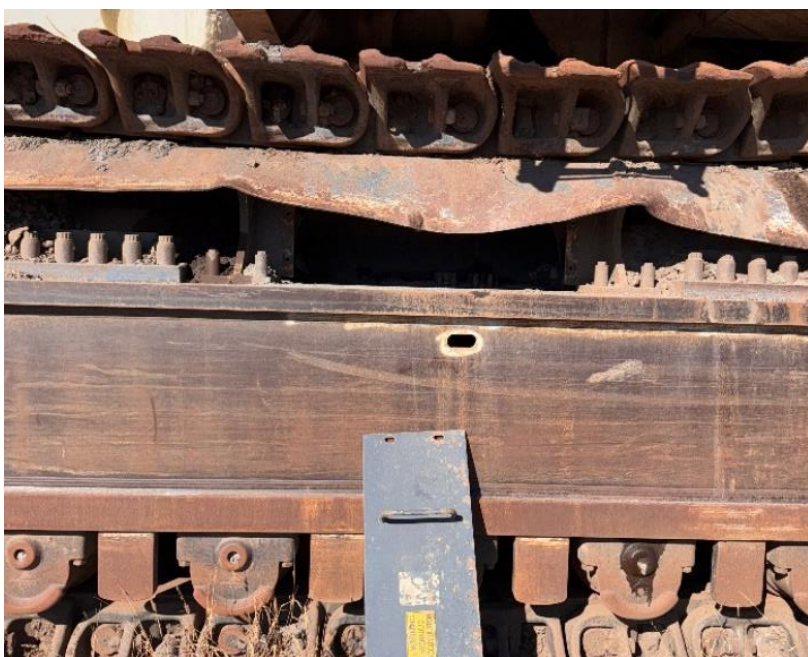
| Location | Comments |
|---|---|
| Mounting Bolts | Rear Horizontal Mounting bolt is broken. |
| Lower Rollers | Pos 1 looks to have collapsed and is leaking. |
| Idler | Idler looks ok, hasn't failed/collapsed. Slides worn. |
| Sprocket | Sprocket has excessive wear. Would suggest changing out with new tracks. |
| Track | Tracks look worn. Pins also worn. No missing retainer bolts at time of inspection. |
