CEA Service Job Sheet - QLD

No.
00251

Complaint 1 Fault
Inspection on JCB 540-70

Carried out pre-purchase inspection as per JCB sheet

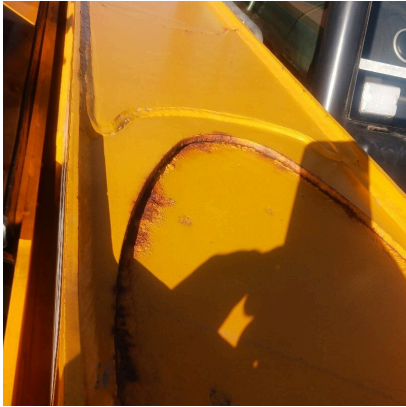
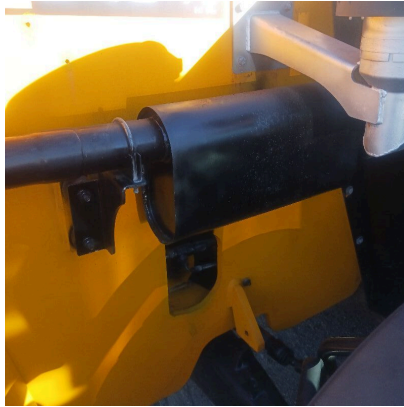
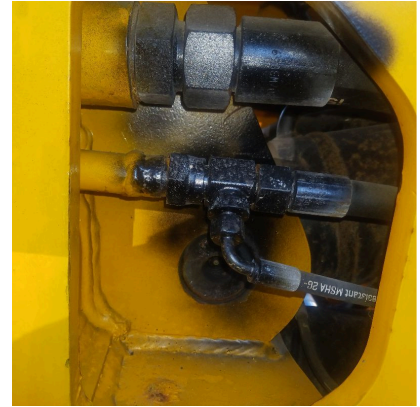
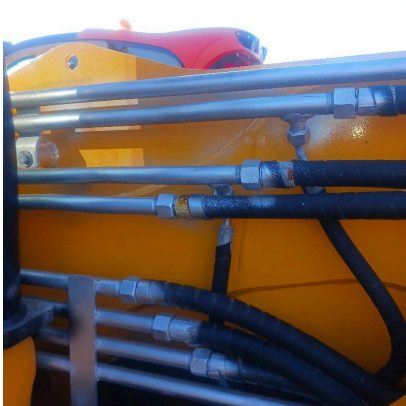
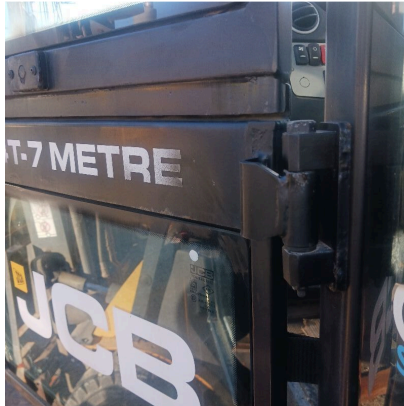
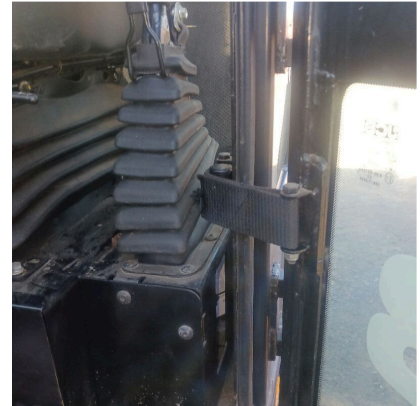
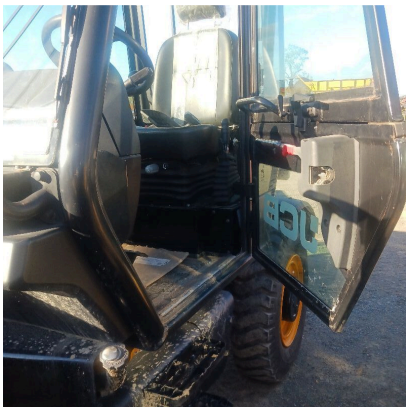
Faults found on inspection:

Rust on the whole machine

Boom has a lot off Rust on welds

LH top mirror and bracket have broken off

Rear working lights are missing

Rear window latch is broken

Bottom engine cover is missing

Tilt cylinder has rust on rod

Load charts are damaged and missing

Front wiper blade needs replacement

Hazard lights are not working

Rear door hinges are rusted, door is not moving

Boom lift cylinder has rust on rod
Transmission has been over filled
Error code for live link
Error codes for engine EGR unit and can error
Took hydraulic pressure all in specifications
Engine runs good
Transmission works ok
Brake and park brake works
