Condition and Valuation Survey Report

Raman I Ramp Barge

Accurate Appraisals & Marine Surveys Ltd.
735 Cherry Point Road
Cobble Hill, BC
V0R 1L3

February 25, 2021

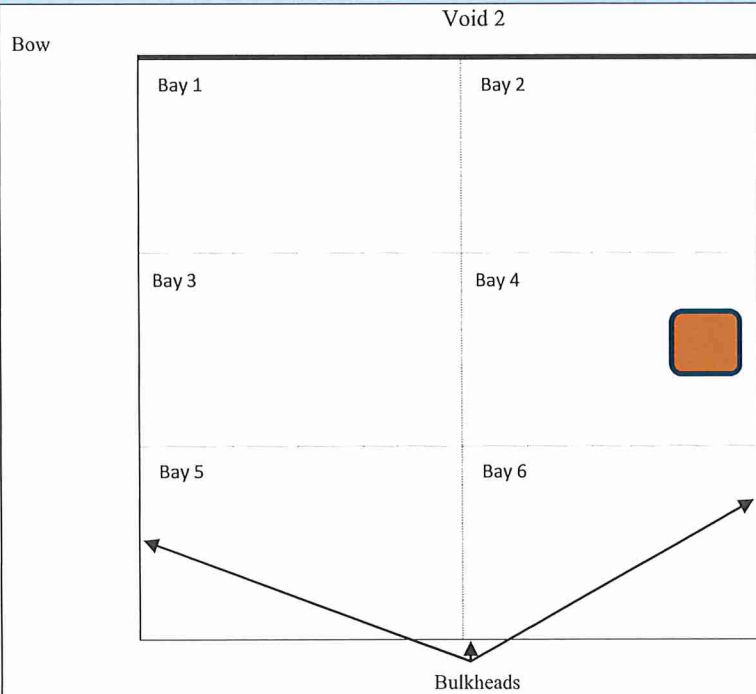
- 2021 repair to side shell corner; welded at bow rake with all new material
- 1/2" steel

- Good condition
- 4" hole between Void 1 and 5 is capped at 2' mark on hull

- Repair to hull and side shell at bow rake with 1/2" steel plate

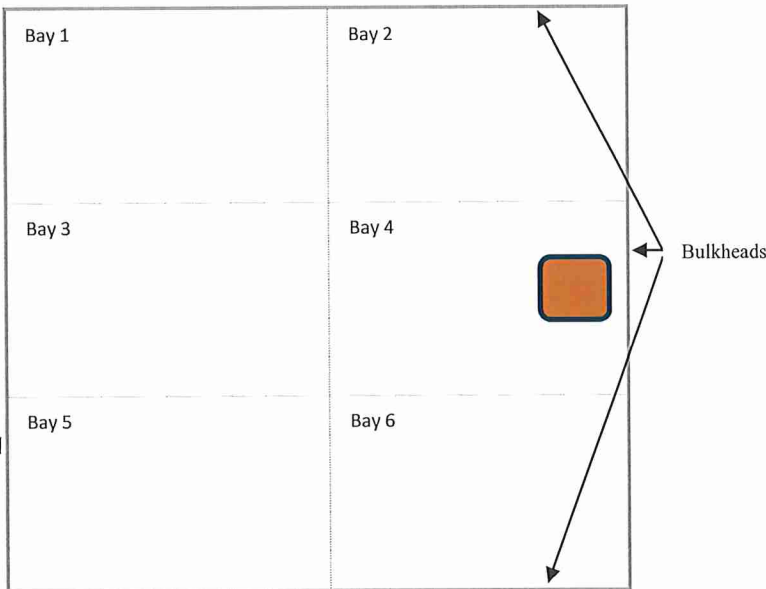
Void 14

- Good condition
- **1" mud on hull plating

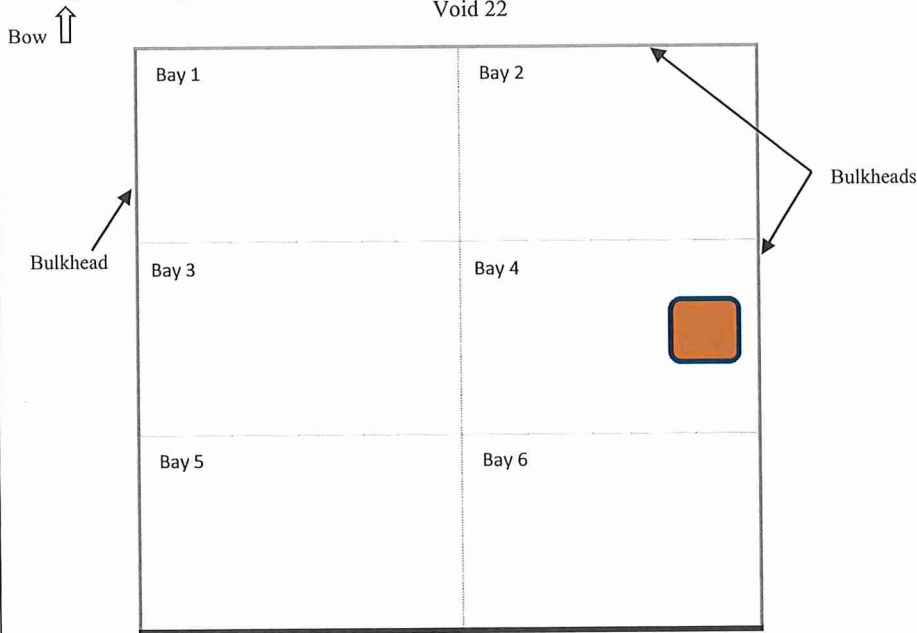
- Repair to side shell corner welded at bow rake with all new 1/2" steel plate

- Repair to hull and side shell at bow rake with 1/2" steel plate
