## MEMORANDUM

To: Gord Closson, South Coast Standing Stem  
From: Iain Mill, Senior Naval Architect  
Prepared By: Shaun Wallis, Junior Marine Systems Engineer  
Date: 2019-04-08  
RE: **JB McCarron Barge Stabilization Refit Review**

J.B. MCCARRON BARGE  
STABILITY ASSESSMENT

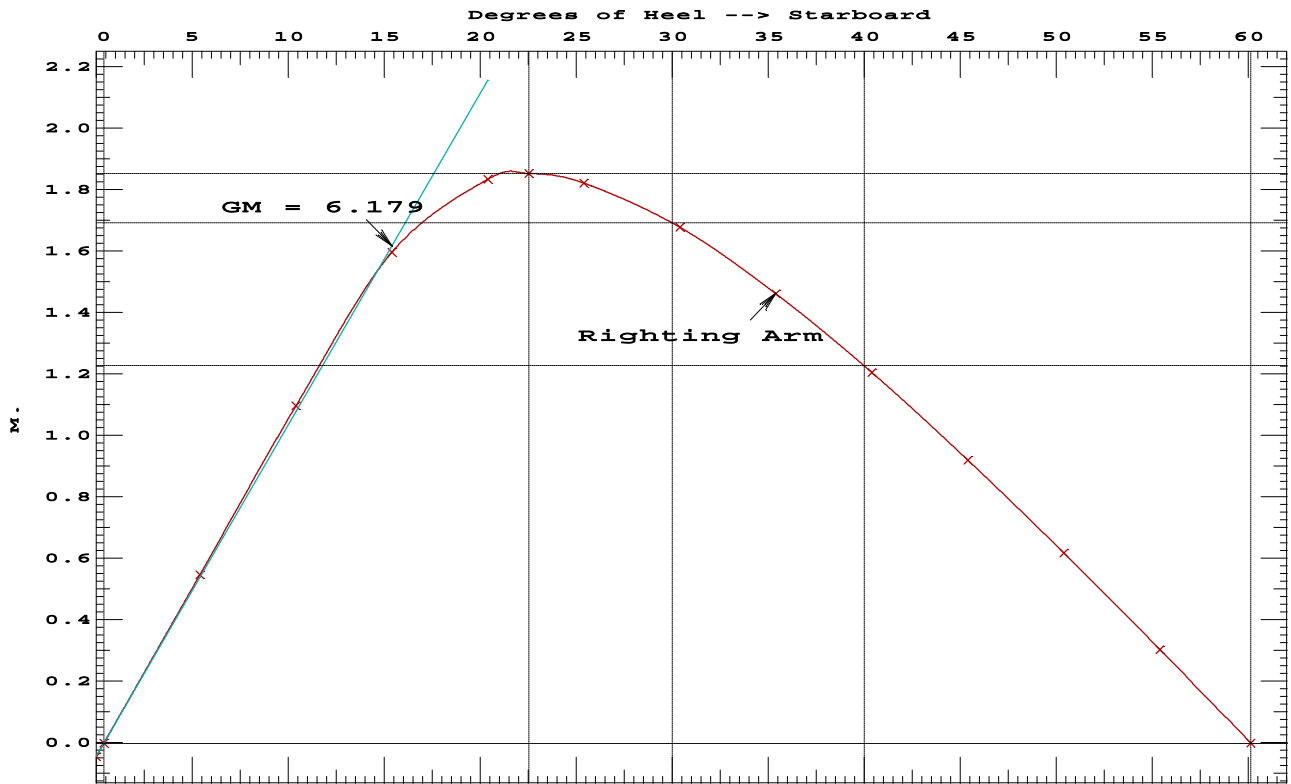
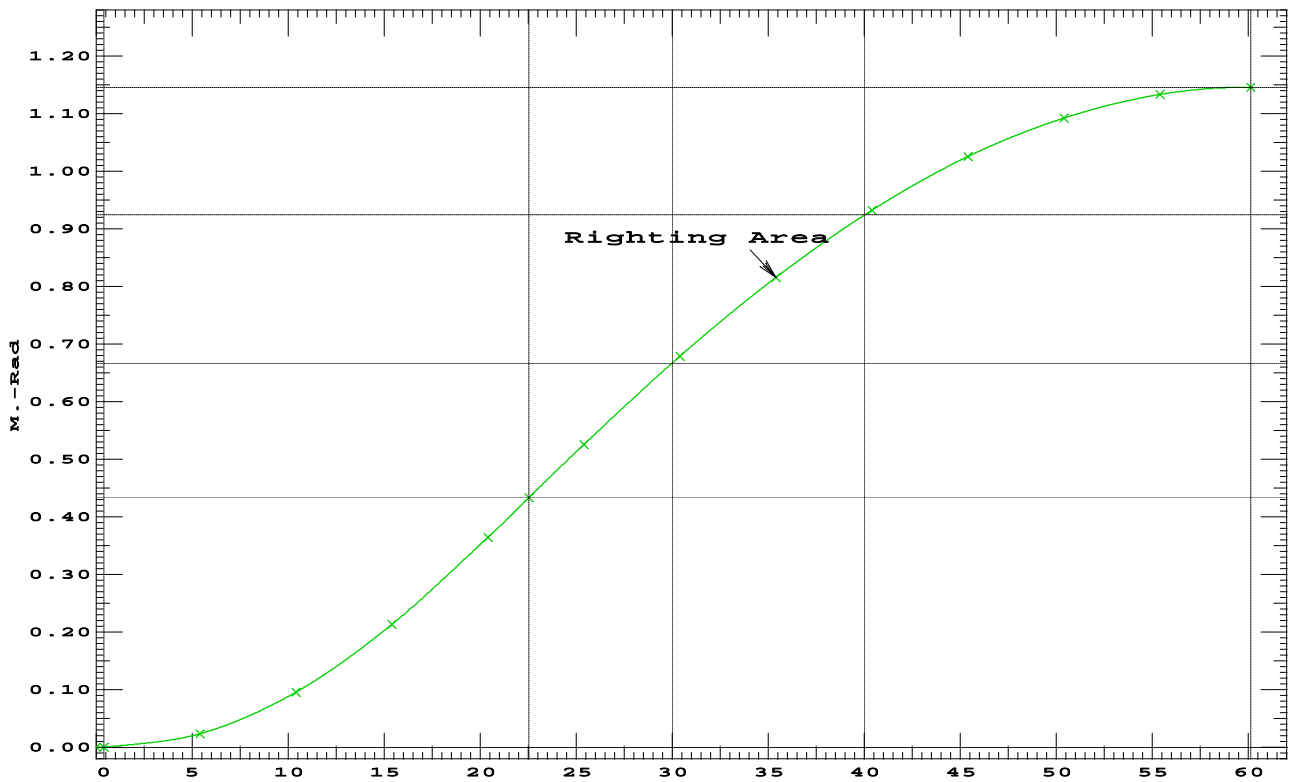
3GA Marine Limited  
18-107 JB McCarron Barge  
AS SURVEYED

The vessel was assessed against the Transport Canada stability criteria of TP 7301 Stab 5 – Standard for the intact stability of passenger vessels carrying more than 12 passengers. The vessel passes all the criteria in this standard in its current condition. The analysis of this condition is provided in Appendix A.

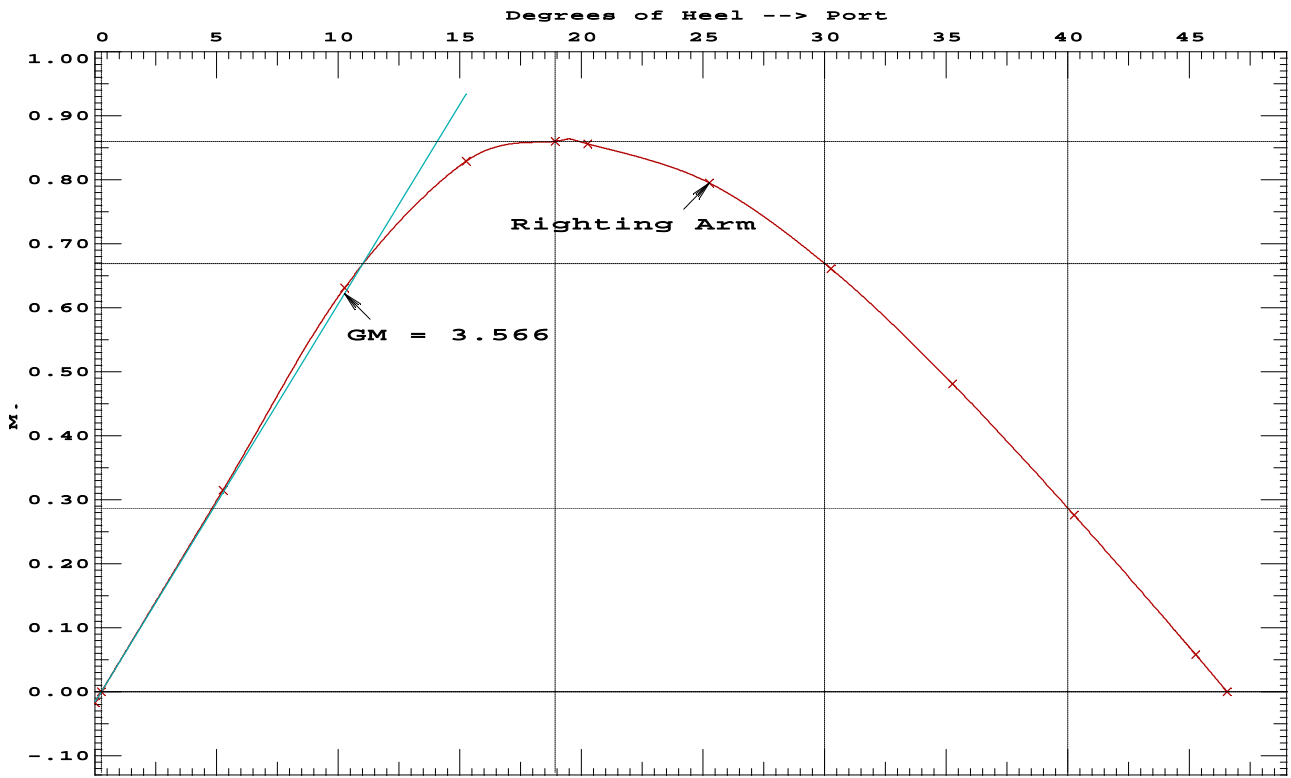
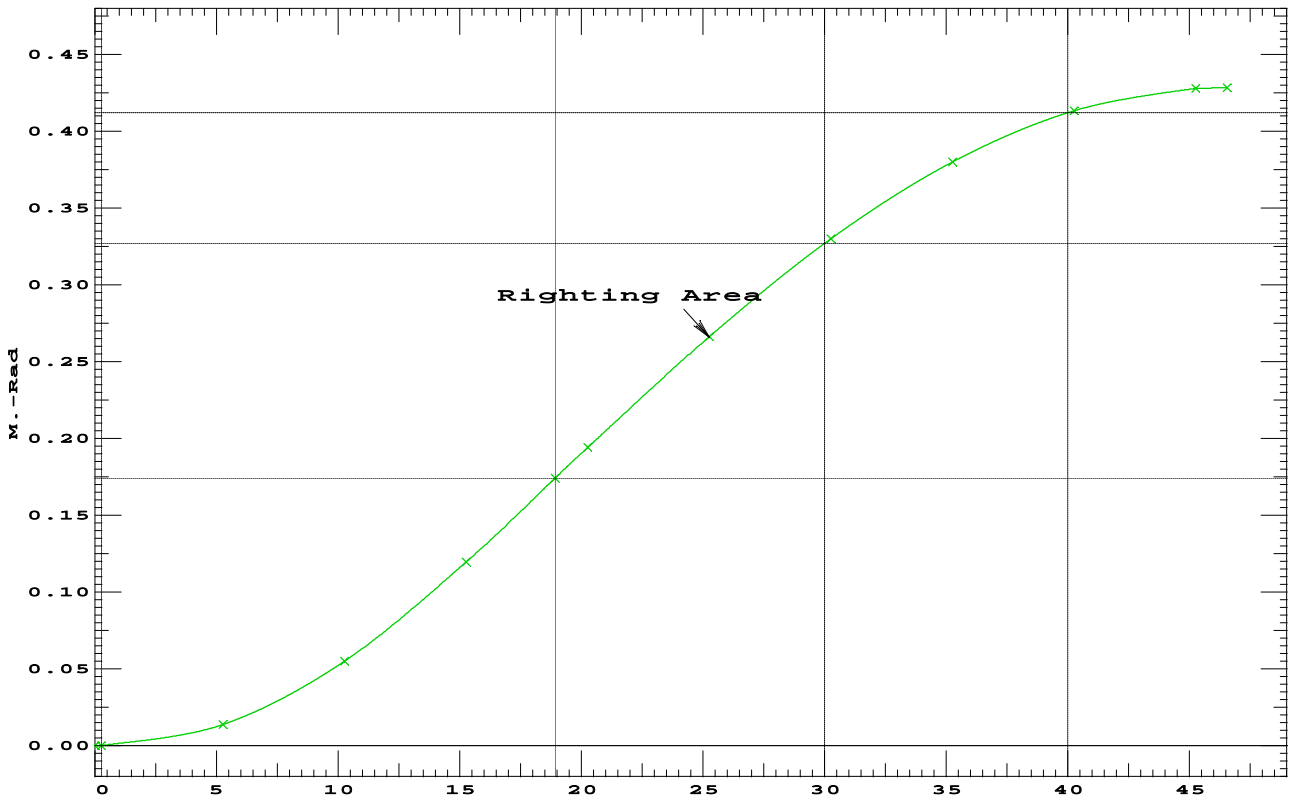
3GA Marine Limited  
18-107 JB McCarron Barge  
FOAMED & FLOODED

The vessel was again assessed against TP 7301 Stab 5. The vessel passes all the criteria in this condition. The analysis of this condition is provided in Appendix B.

Foam installed in voids B, C, G, and H, and these spaces flooded.
