REPAIR REPORT

AT744 – CAT 740 – B1P01666 – 18058 Hours

The following is a report on the damage and repairs to Articulated Dump Truck 744 for Garraway Group, Douglas Mine Site, VIC

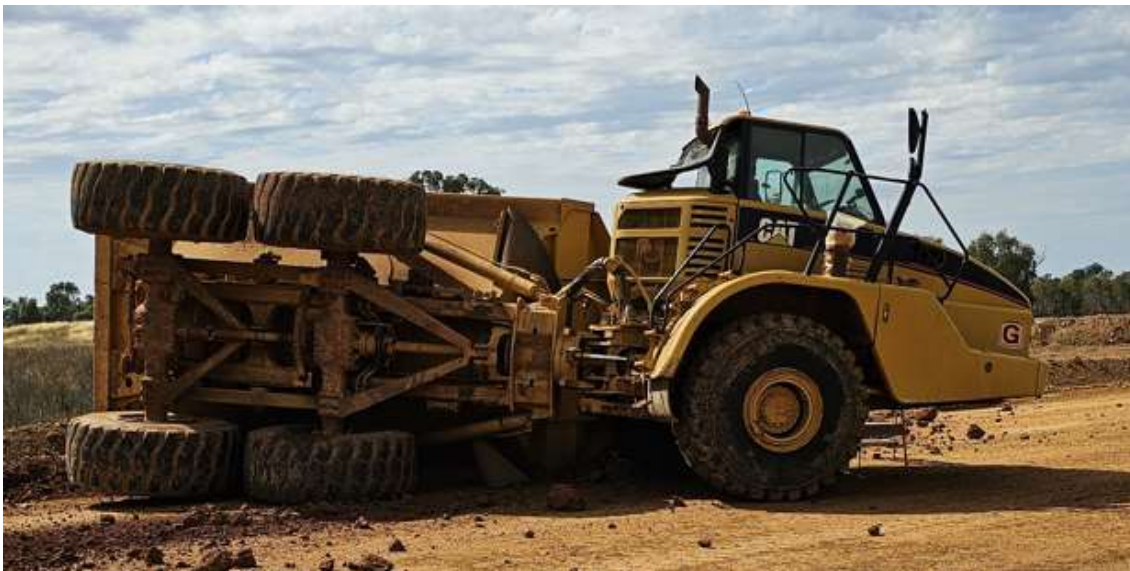
The machine was inspected on site and the following damages were observed:

- Oil pooling in P3 wheel due leaking centre axle output yoke. Upon further inspection the centre axle track rod had contacted the drive shaft/yoke – damage to the seal.
- LH hose guide bracket has been bent.
- P3 had dirt pushed between the tyre bead and the rim bead ring, damaged the lock ring protector on the bead seat.
- Damage to the LH front of the tipping body.
- P1 guard had been pushed towards the wheel by the spilling load.

- Centre axle output yoke has had the bearings and seals replaced.
- Uni-joints were replaced on the driveshaft.

- LH hose guide bracket was repaired.
- Damage to the LH front of the tipping body was not structural as per below, exterior scratches only.
- P1 guard has been repaired.
