# Lubricant Analysis Report

Account Information		Component Information		Sample Information	
Account Number: LUB307-0037-0000 Company Name: PIDHERNEY'S Contact: CARLA MERKLIN Address: RANGE RD 70 PO BOX 940 ROCKY MOUNTAIN HOUSE, AB T4T 1A7 CA Phone Number: 403-845-3072		Component ID: 6555 H Secondary ID: 1DW524PAPMLZ12577 Component Type: HYDRAULIC Manufacturer: JOHN DEERE Model: 524P Application: CONSTRUCTION Sump Capacity: 83 L		Tracking Number: 25168S93751 Lab Number: E-030192 Lab Location: Edmonton Data Analyst: ENC Sampled: 28-Aug-2025 Submitted: 17-Sep-2025 Received: <b>19-Sep-2025</b> Completed: 23-Sep-2025	
Filter Information		Miscellaneous Information		Product Information	
Filter Type: <b>Information Requested</b> Micron Rating: 0		Wildcard 1: Your Rep.: Cary Maxwell Wildcard 2: Ph:(403) 861-9957		Product Manufacturer: JOHN DEERE Product Name: HYDRAU XR Viscosity Grade: ISO 46	
Comments	Flagged data does not indicate an immediate need for maintenance action. Continue to observe the trend and monitor equipment and fluid conditions. Flagged additives do not match current baseline reference for the specified product (this does not imply the lubricant does not meet proper API,

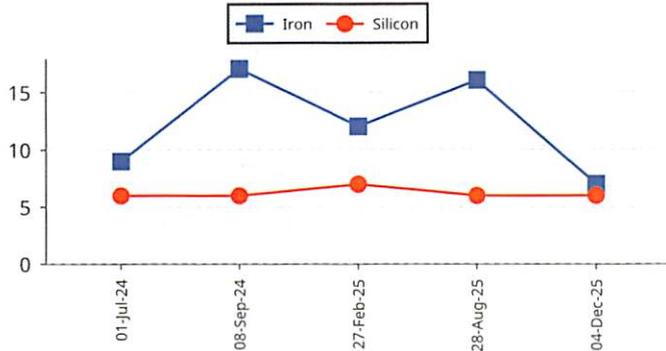
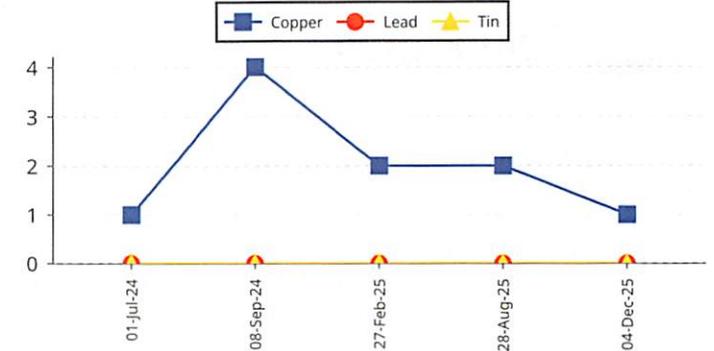
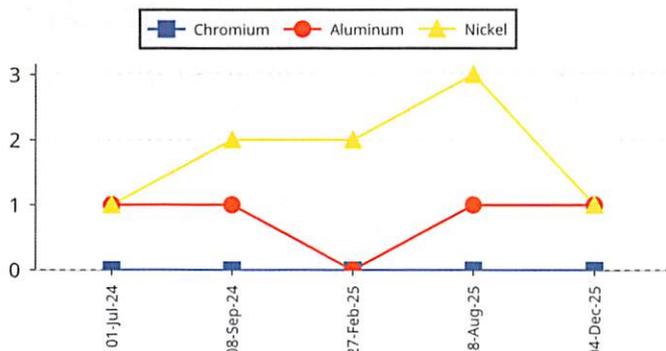
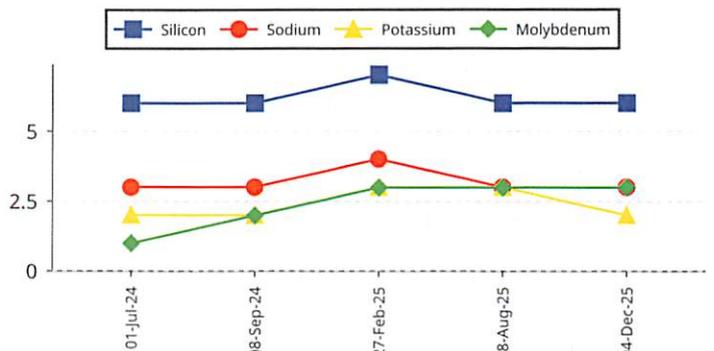
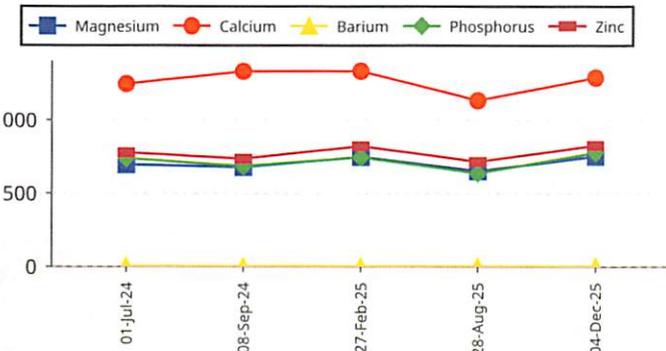
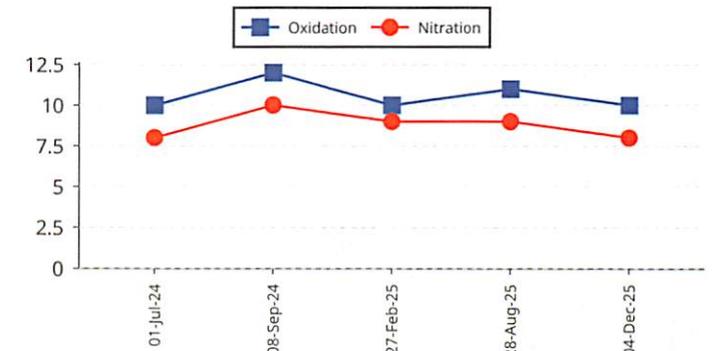
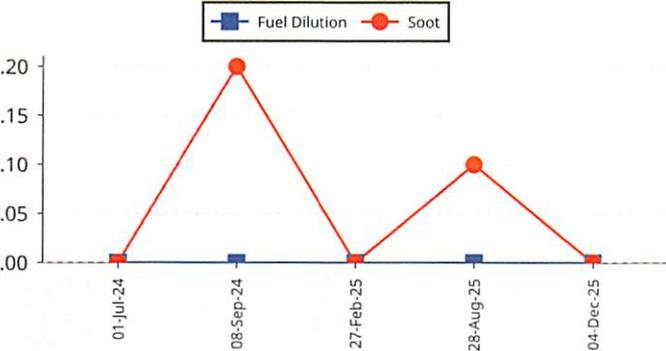
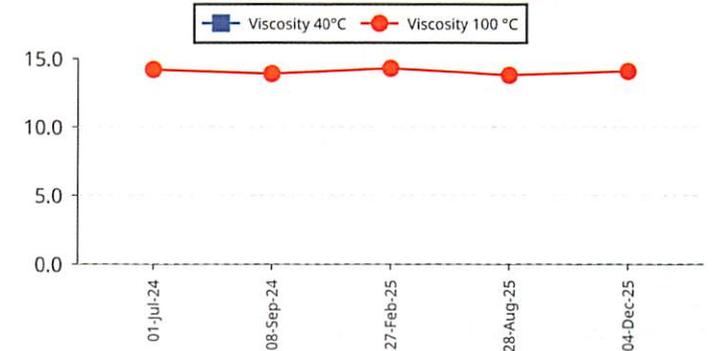
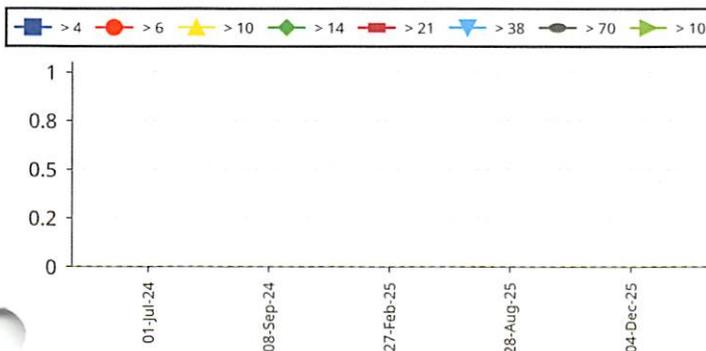
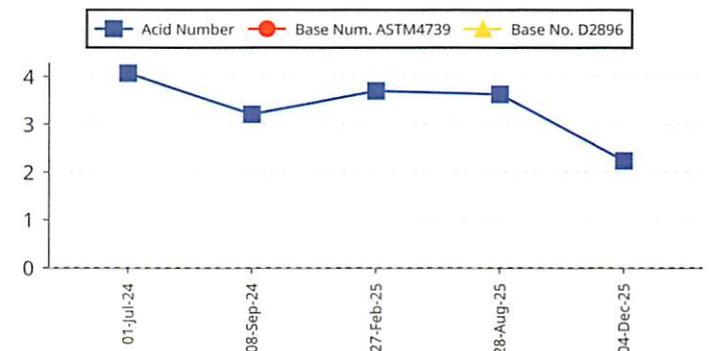
Historical Comments	11	Data indicates no abnormal findings. Resample at normal interval. LUBRICANT TIME was not provided for this sample.
	12	Flagged data does not indicate an immediate need for maintenance action. Continue to observe the trend and monitor equipment and fluid conditions. Cylinder region metals (pistons, rings, liners etc.) are at a MINOR LEVEL;
	13	Flagged data does not indicate an immediate need for maintenance action. Continue to observe the trend and monitor equipment and fluid conditions. Nickel is at a MINOR LEVEL; Possible valve train (valves, stems, guides etc.) metal;
	14	Flagged data does not indicate an immediate need for maintenance action. Continue to observe the trend and monitor equipment and fluid conditions. Nickel is at a MODERATE LEVEL; Possible valve train (valves, stems, guides etc.) metal; Lubricant and filter change acknowledged.

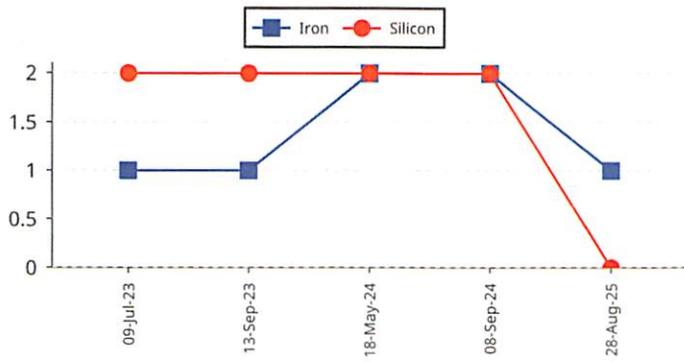
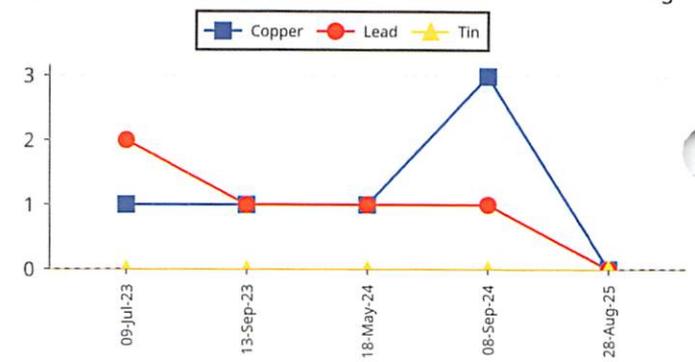
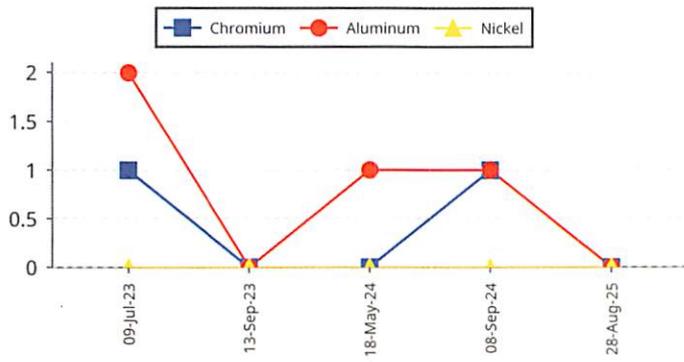
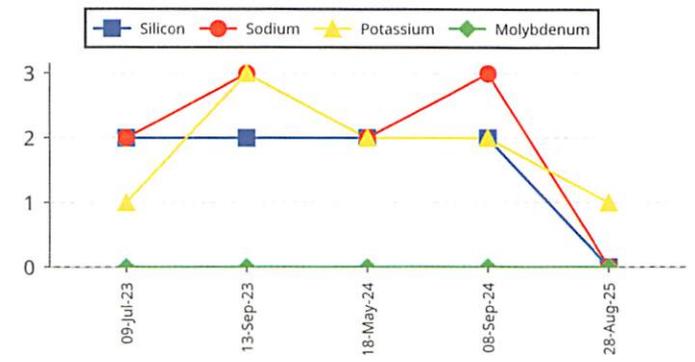
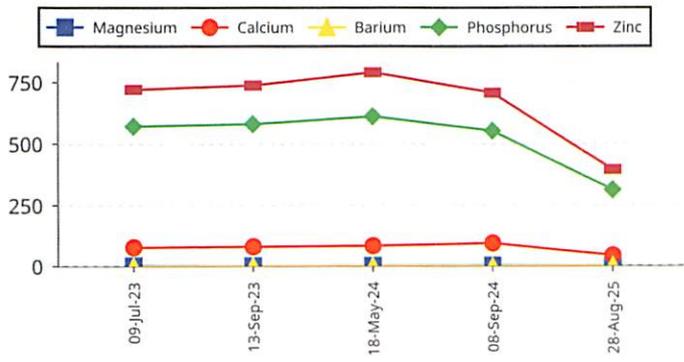
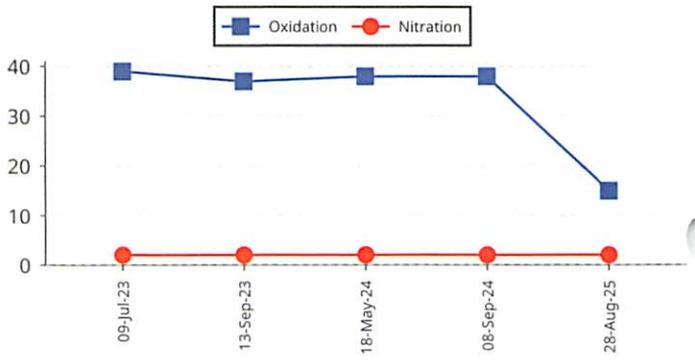
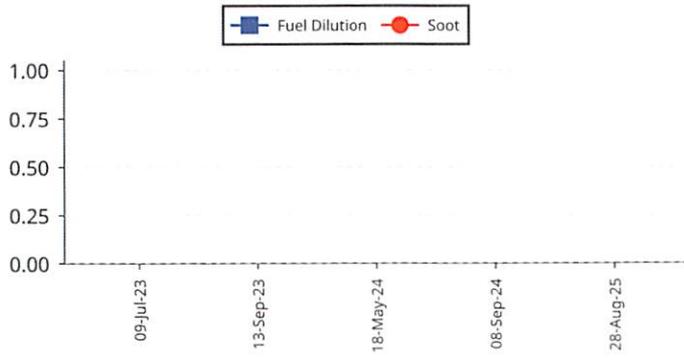
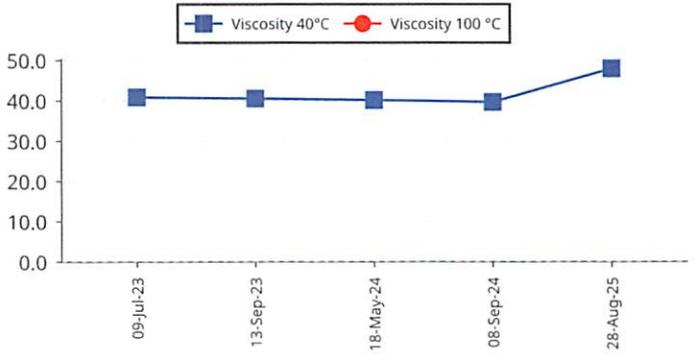
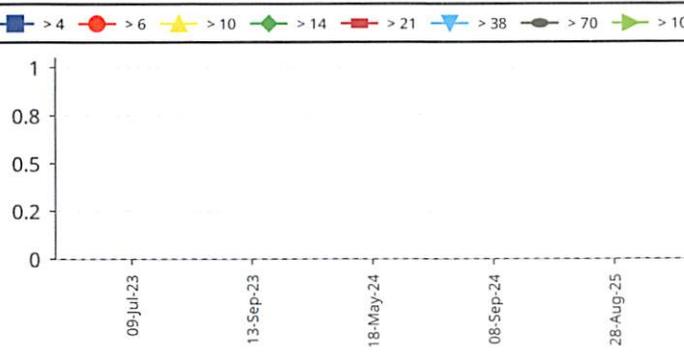
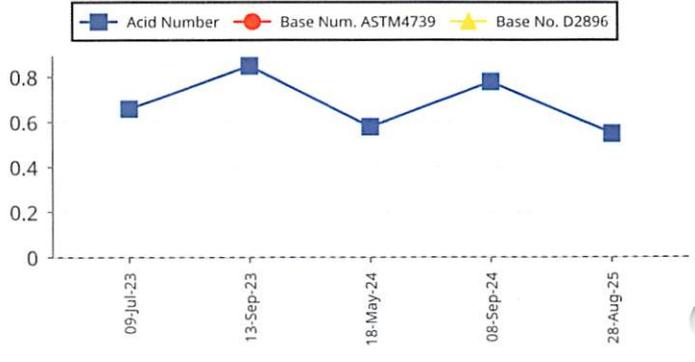
Historical Comments	3	LUBRICANT CHANGE is suggested if not done at sampling time. Infrared results indicate OXIDATION is SEVERELY HIGH; Acid Number is SLIGHTLY HIGH, which may be due to oxidation, contamination with an acidic product, extended drain interval, or lubricant mixing. Bearing metal is at a MINOR LEVEL; Viscosity is SLIGHTLY LOW. Causes include contamination, incorrectly identified viscosity grade, or adding a different viscosity grade to the component. Flagged additives do not match current baseline reference for the specified product (this does not imply the lubricant does not meet proper API, SAE, or ISO classifications). LUBRICANT TIME was not provided for this sample.
	4	LUBRICANT and FILTER CHANGE is suggested if not done at sampling time. Infrared results indicate OXIDATION is SEVERELY HIGH; Acid Number is SLIGHTLY HIGH, which may be due to oxidation, contamination with an acidic product, extended drain interval, or lubricant mixing. Viscosity is SLIGHTLY LOW. Causes include contamination, incorrectly identified viscosity grade, or adding a different viscosity grade to the component. Flagged additives do not match current baseline reference for the specified product (this does not imply the lubricant does not meet proper API, SAE, or ISO classifications). LUBRICANT TIME was not provided for this sample.

5	LUBRICANT CHANGE is suggested if not done at sampling time. Infrared results indicate OXIDATION is SEVERELY HIGH; Viscosity is SLIGHTLY LOW. Causes include contamination, incorrectly identified viscosity grade, or adding a different viscosity grade to the component. LUBRICANT TIME was not provided for this sample. Filter change acknowledged.
	6	Flagged data does not indicate an immediate need for maintenance action. Continue to observe the trend and monitor equipment and fluid conditions. Viscosity is SLIGHTLY LOW. Causes include contamination, incorrectly identified viscosity grade, or adding a different viscosity grade to the component. LUBRICANT TIME was not provided for this sample.

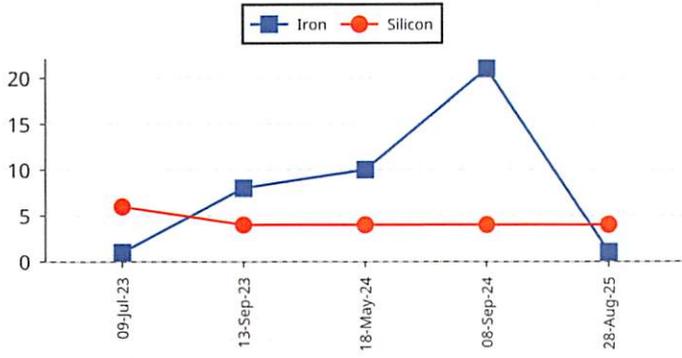
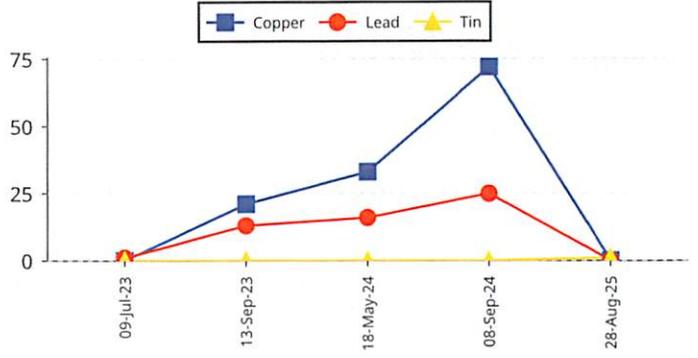
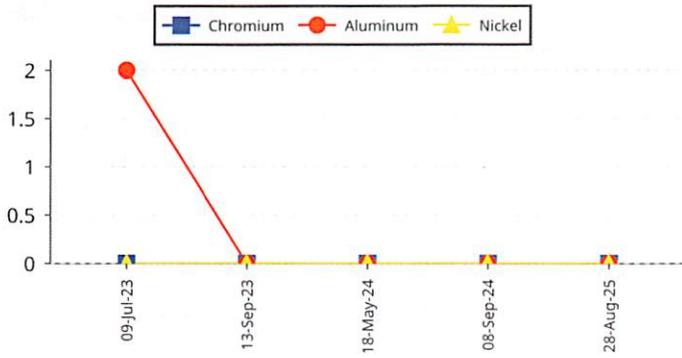
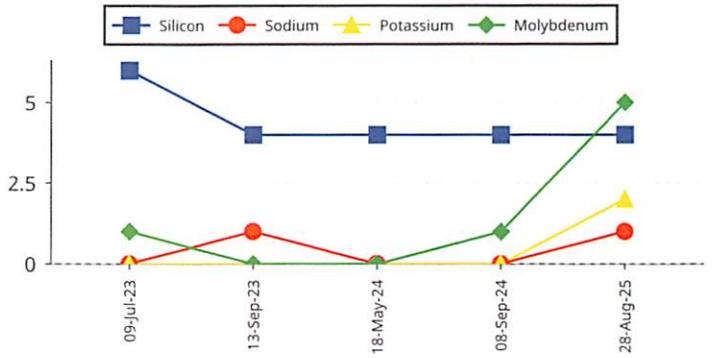
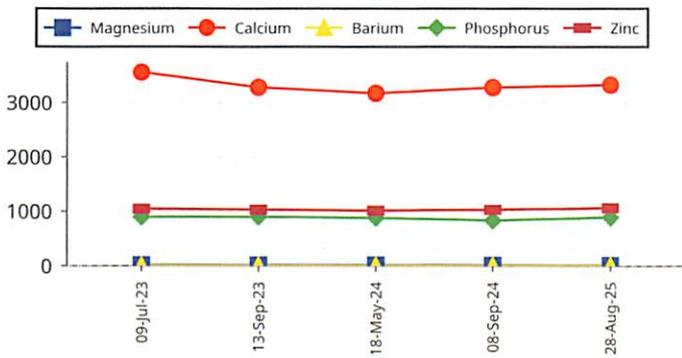
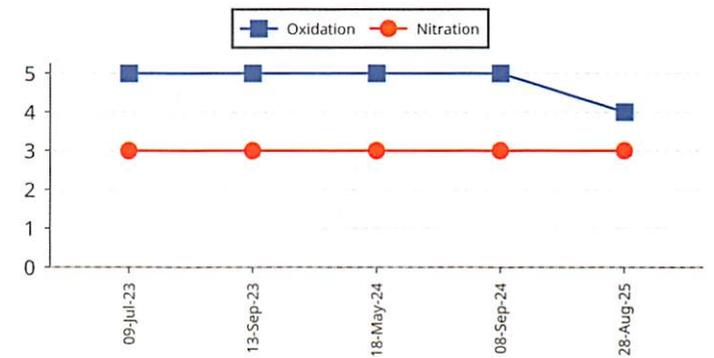
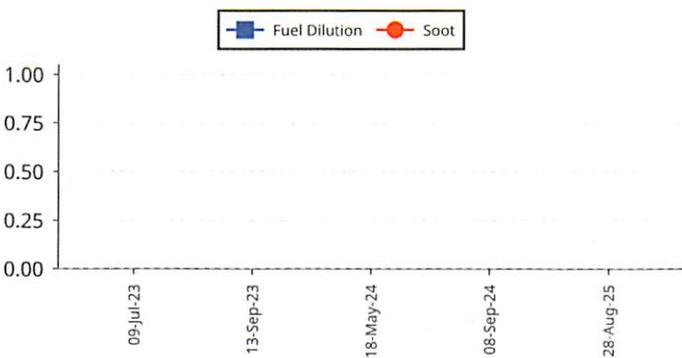
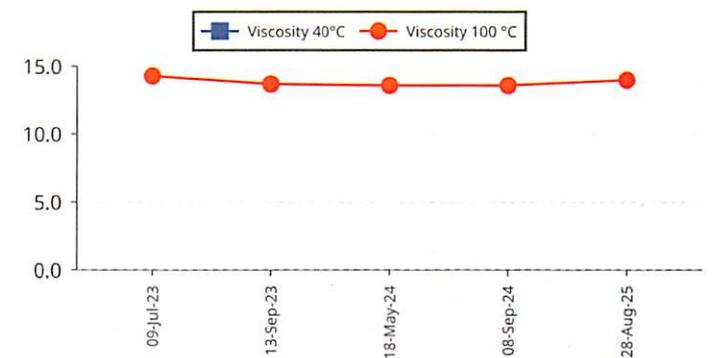
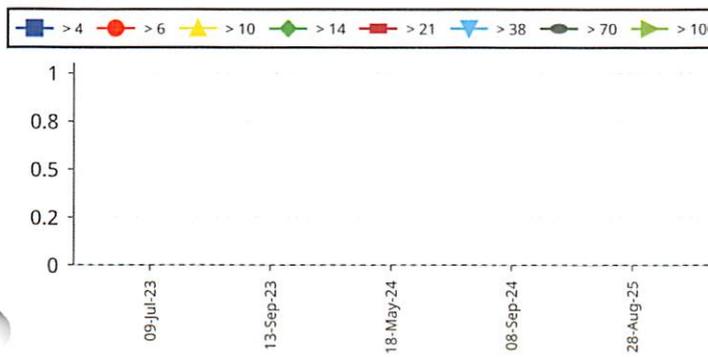
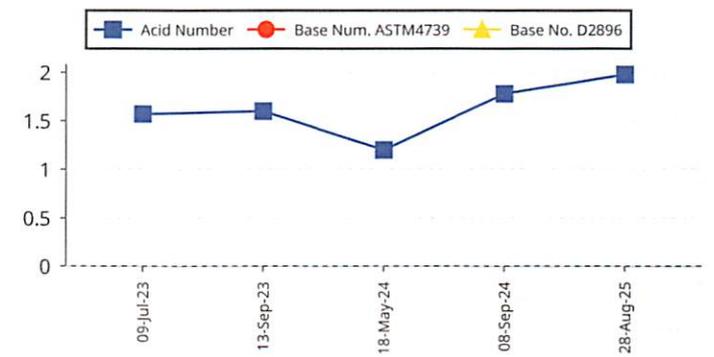
Historical Comments	3	Data indicates no abnormal findings. Resample at normal interval. LUBRICANT TIME was not provided for this sample. Lubricant change acknowledged.
	4	Flagged data does not indicate an immediate need for maintenance action. Continue to observe the trend and monitor equipment and fluid conditions. Bushing/Thrust metal is at a MINOR LEVEL; Gear and/or bearing metal is at a MINOR LEVEL;
	5	Data indicates no abnormal findings. Resample at normal interval.
	6	Flagged data does not indicate an immediate need for maintenance action. Continue to observe the trend and monitor equipment and fluid conditions. Bushing/Thrust metal is at a MINOR LEVEL; Gear and/or bearing metal is at a MINOR LEVEL;

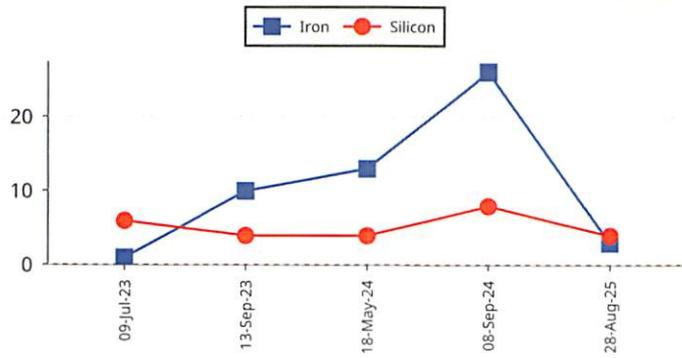
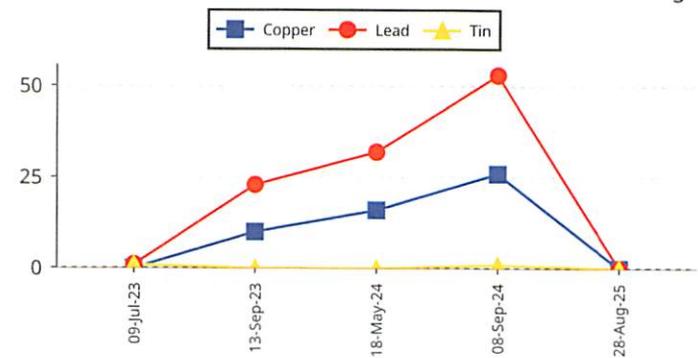
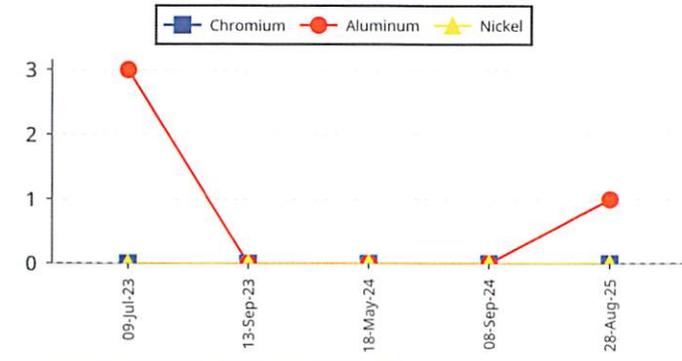
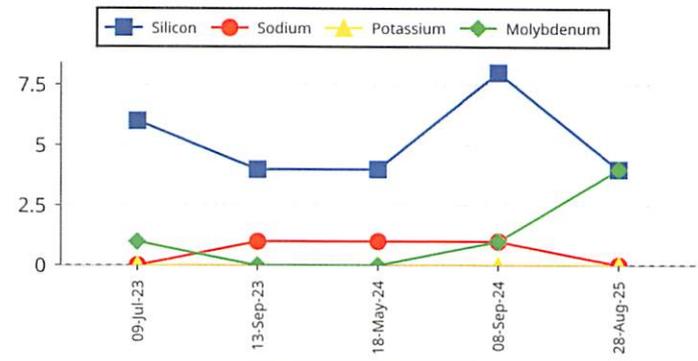
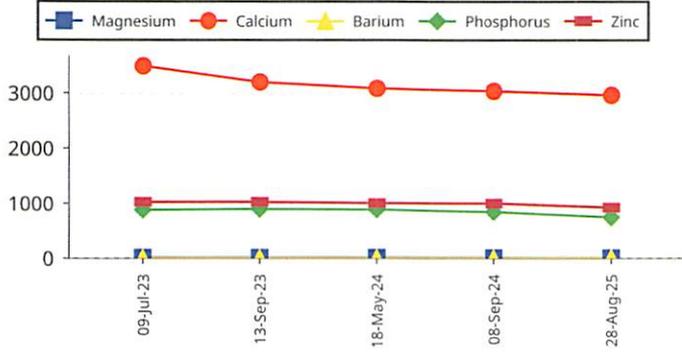
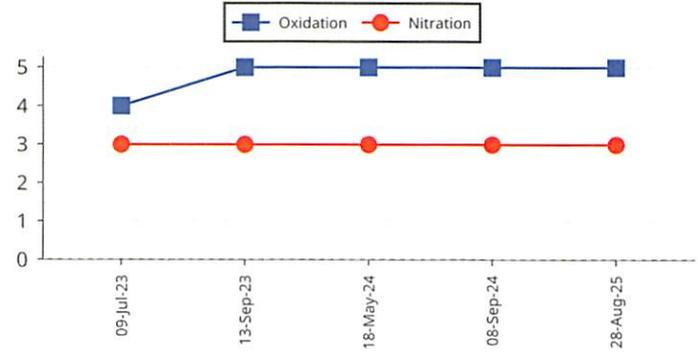
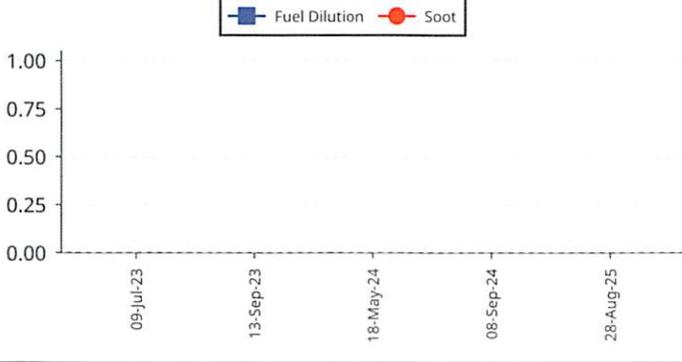
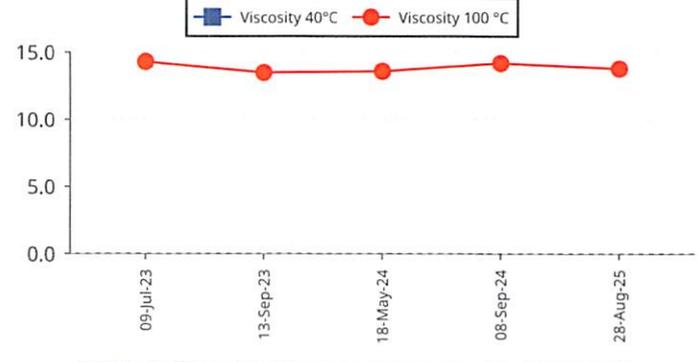
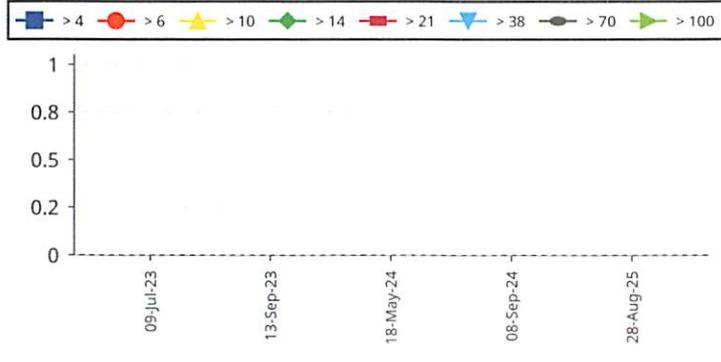
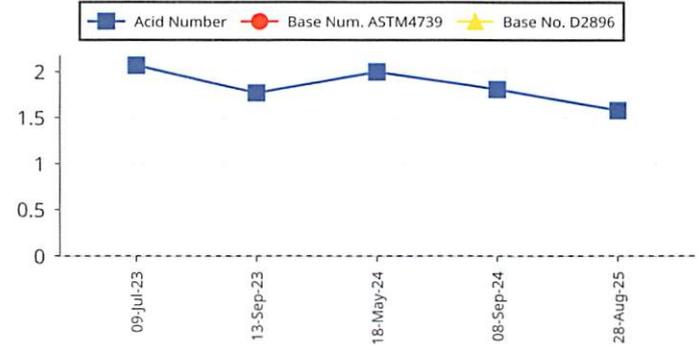
Historical Comments	3	Data indicates no abnormal findings. Resample at normal interval. LUBRICANT TIME was not provided for this sample. Lubricant change acknowledged.
	4	Flagged data does not indicate an immediate need for maintenance action. Continue to observe the trend and monitor equipment and fluid conditions. Bushing/Thrust metal is at a MINOR LEVEL; Gear and/or bearing metal is at a MINOR LEVEL;
	5	Data indicates no abnormal findings. Resample at normal interval.
	6	Flagged data does not indicate an immediate need for maintenance action. Continue to observe the trend and monitor equipment and fluid conditions. Lead is at a MINOR LEVEL; LEAD source in GEAR SYSTEMS may be from BUSHING/THRUST overlay, LEAD SOLDER, Coating surface, or contamination from GREASE;
