SERVICE ORDER: RA855000883

VIN: 1FDYS96B1WVA15494 Fleet Unit #: 7040
Year/Make/Model: 1998 STERLING LOUISVILLE
Engine Model / Serial#: SERIES 60 / 06R0356724
Engine Hours: 0
Trans Model / Serial#:
Front Axle Model / Serial#:
Rear FWD Axle Model / Serial#:
Rear Rear Axle Model / Serial#:

JOB #1 05-CVIP-3AXLE SR CVIP Periodic Inspection 3AXLE

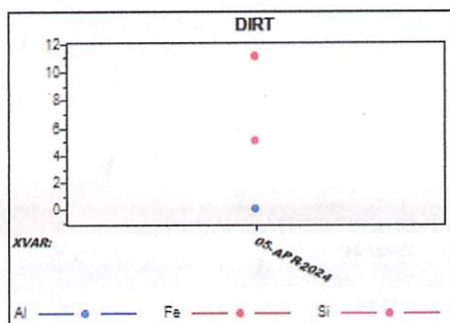
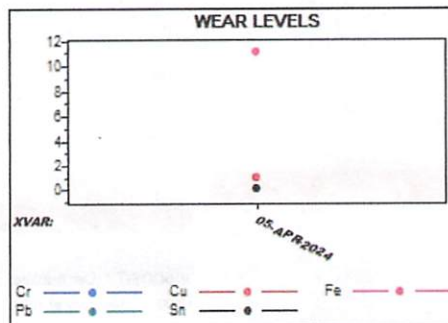
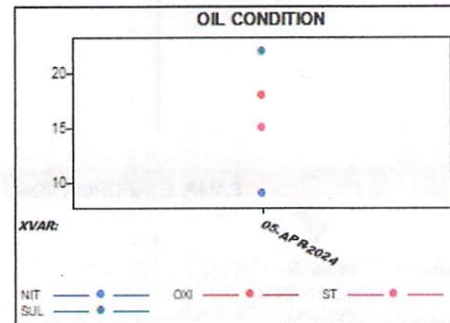
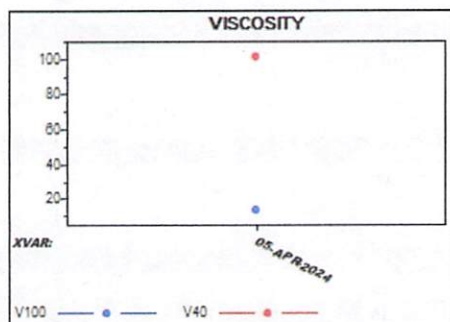
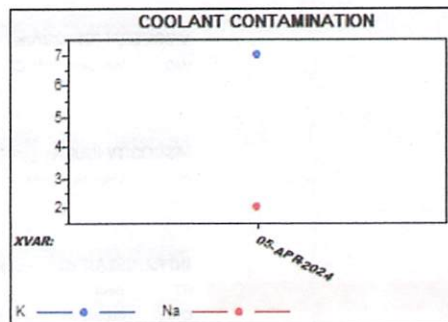
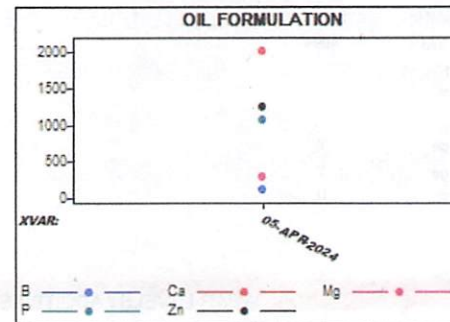
WEAR LEVELS / ADDITIVES

No Action Required

TRACE/LOW LEVELS OF WATER DETECTED (0.1%) MAY BE CONDENSATION. DIRT AND WEAR METALS APPEAR TO BE AT ACCEPTABLE LEVELS. OTHER READINGS APPEAR TO BE NORMAL. RESAMPLE AT THE NEXT SERVICE INTERVAL.
