## 282 - 2020 Kenworth t800

Parent: T436 - 2015 Peerless

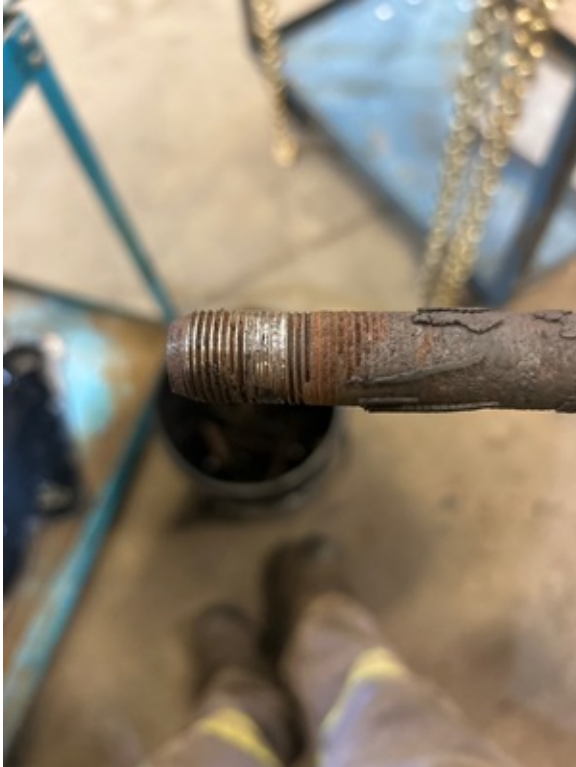
Coolant leaking externally from head gasket #6 exhaust side corner, upon removal of back head bolt found threads to be pulled, tried to clean threads and measure tried to torque but would not hold, used thread salvage kit with Cummins insert and followed procedure, measured protrusion at 11 thou on all cylinders, noted that cylinder liners may be loose at top of deck but not disassembling further to verify
