Exhibit 1. Date November 3, 2021. Rev 0
Inspection and Test Report in accordance with CSA B620 7.2. Page 1 of 6

Name and address of Inspection and Test Facility: Rogue Pressure Testing 32126 RR 5.5 Sundre AB T0M 1X0 TC-1273		Name Owner/Carrier: Neway Oilfield Services		
		Address Rocky Mountain House Alberta		
		Telephone No: 403-844-2700		
Tank Spec DOT 407	Mfr. Certification Date Month/Year 10/2012	Assembler Certification Date Month/Year 10/2012	Last M5: 06/2022	
TC 331 51, MC 330 QT <input type="checkbox"/> NQT <input type="checkbox"/> PWHT After Mfr <input type="checkbox"/>				
Special Service Corrosive <input type="checkbox"/> LPG <input type="checkbox"/> NH3 <input type="checkbox"/> Gasoline <input type="checkbox"/> Diesel <input type="checkbox"/> Other _____				
Lined <input type="checkbox"/> Insulated and Jacketed <input type="checkbox"/> Lining Type _____				
Owner Unit No 316	Tank Mfr Serial No. VIN 5HTDL4236D5J25094	Tank Mfr Date Month/Year 10/2012	Tank Manufacturer Heil	Assembler Heil
Tank Design Pressure kPa <input type="checkbox"/> PSI <input type="checkbox"/>	Original Tank Test Pressure kPa <input type="checkbox"/> PSI <input checked="" type="checkbox"/>		MDIN

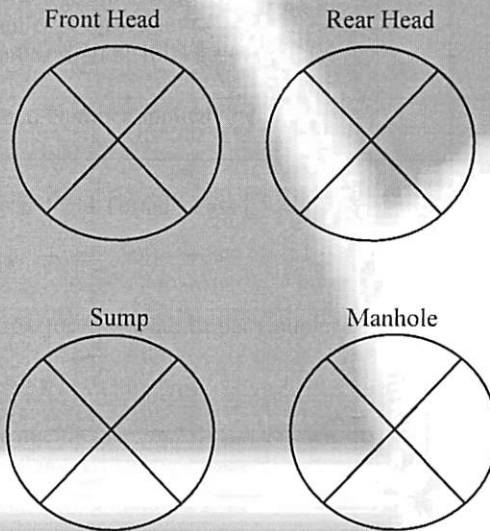
12:00	3:00	6:00	9:00	
					HEAD
1					1
2					2
3					3
4					4
5					5
6					6
7					7
8					8
9					9
10					10
11					11
					HEAD
	12:00	3:00	6:00	9:00
