Dale Croswell Construction

Vehicle/Equipment Maintenance Log

Date: April / 30 / 2025 Unit #: 21-42

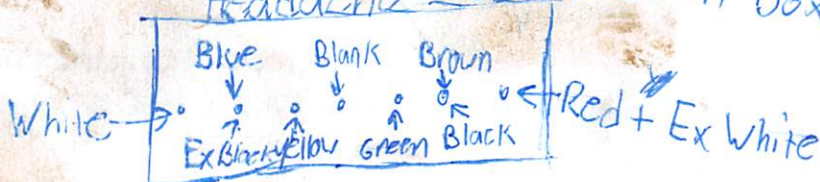
Headache rack Junction Box @ Back of truck

- White = "GRD"
- Ex Black/Blue = "clear"
- Yellow = "TURN"
- Empty = "Stop/Red"
- Green = "turn"
- Brown + Black = "tail"
- Red = "AUX"

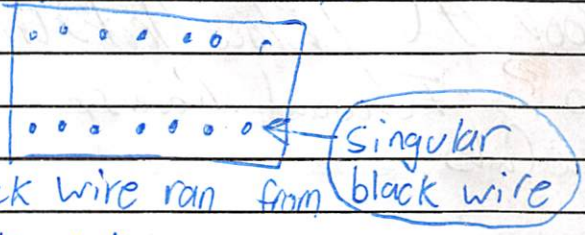
Step Junction box

1 black wire ran from singular black wire headache rack
