**2019 Ford F-550 Super Duty XL (#CN1025)**

VIN: 1FD0W5HY9KEF06739

**Acden Mechanical Repair & Maintenance**  
220 TaigaNova Crescent  
Fort McMurray, AB T9K 0T4  
(780) 714-5447  
Service@acden.com  
www.acden.com/acdenmechanical

**Invoice #73118**

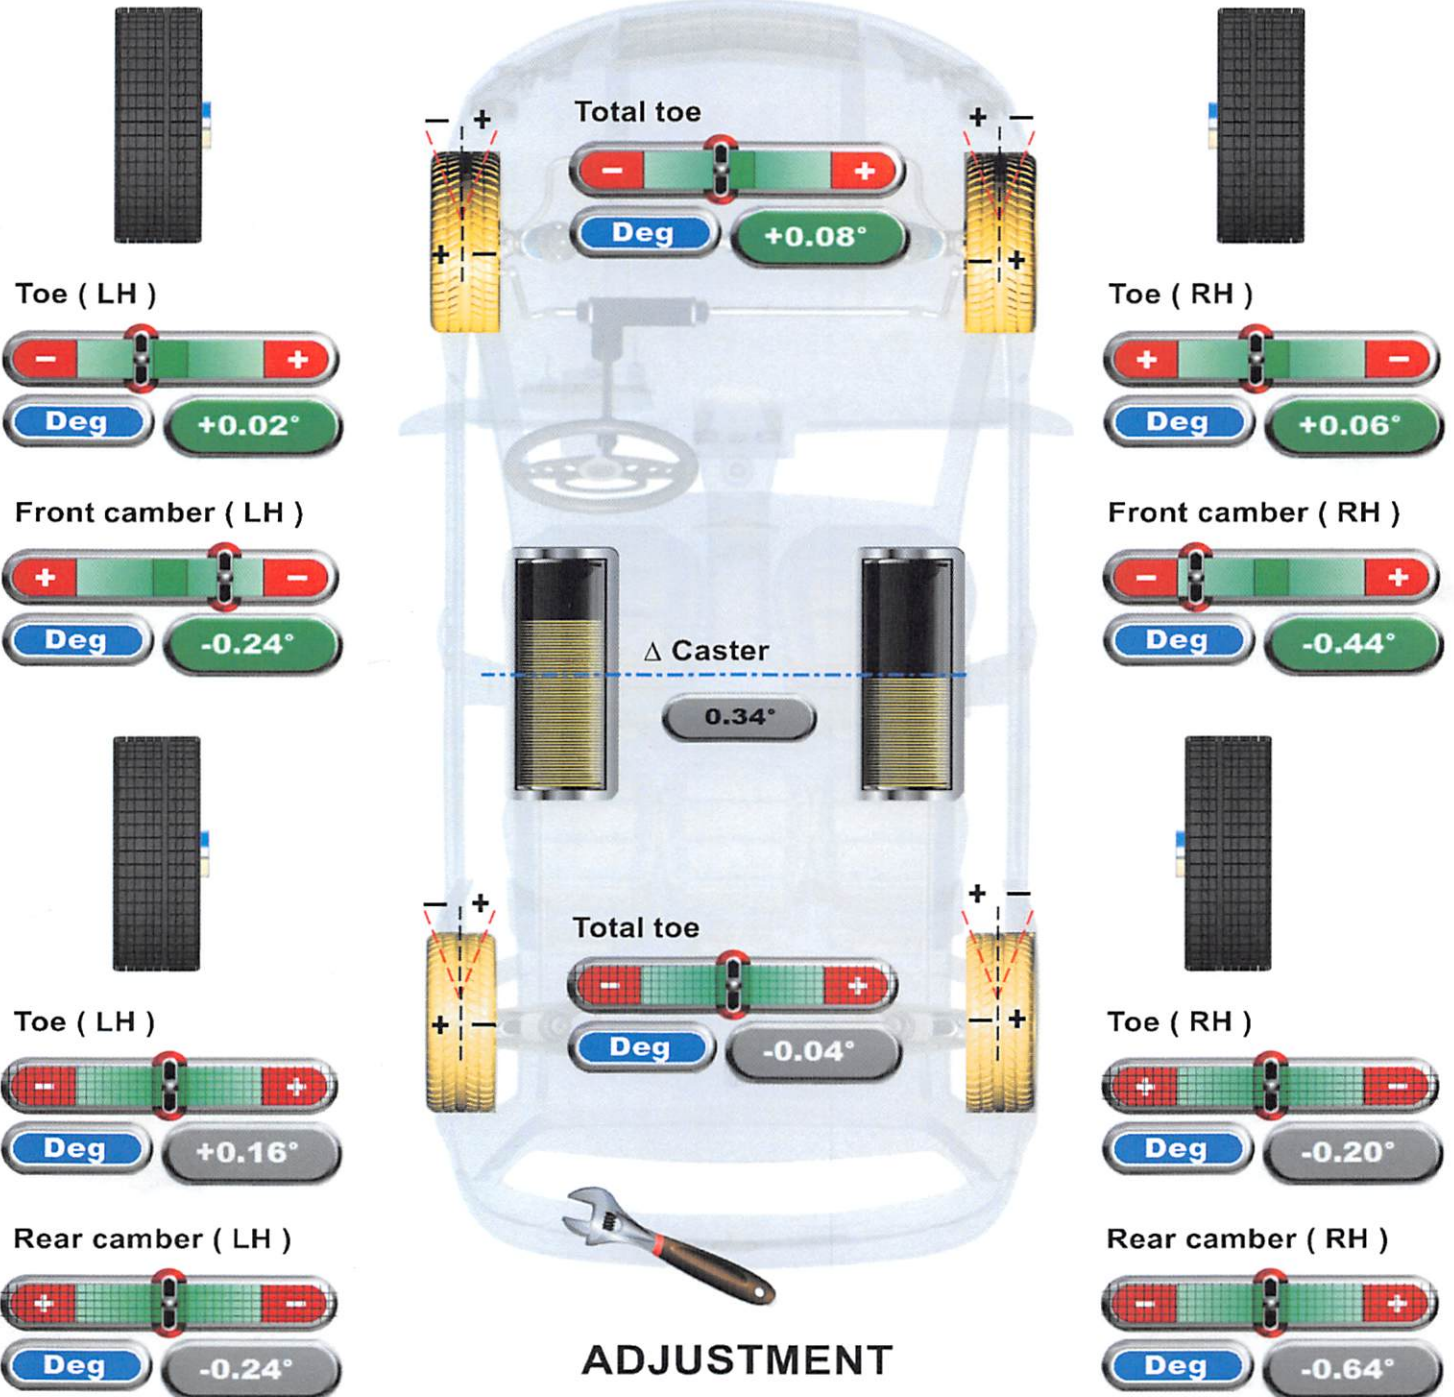
ACDEN MRM  
220 TAIGANOVA CRES  
FT. MCMURRAY

Vehicle make: FORD TRUCKS USA

Vehicle model: F550 PICKUP 4WD STD. SUSPENSION (2017-2019)

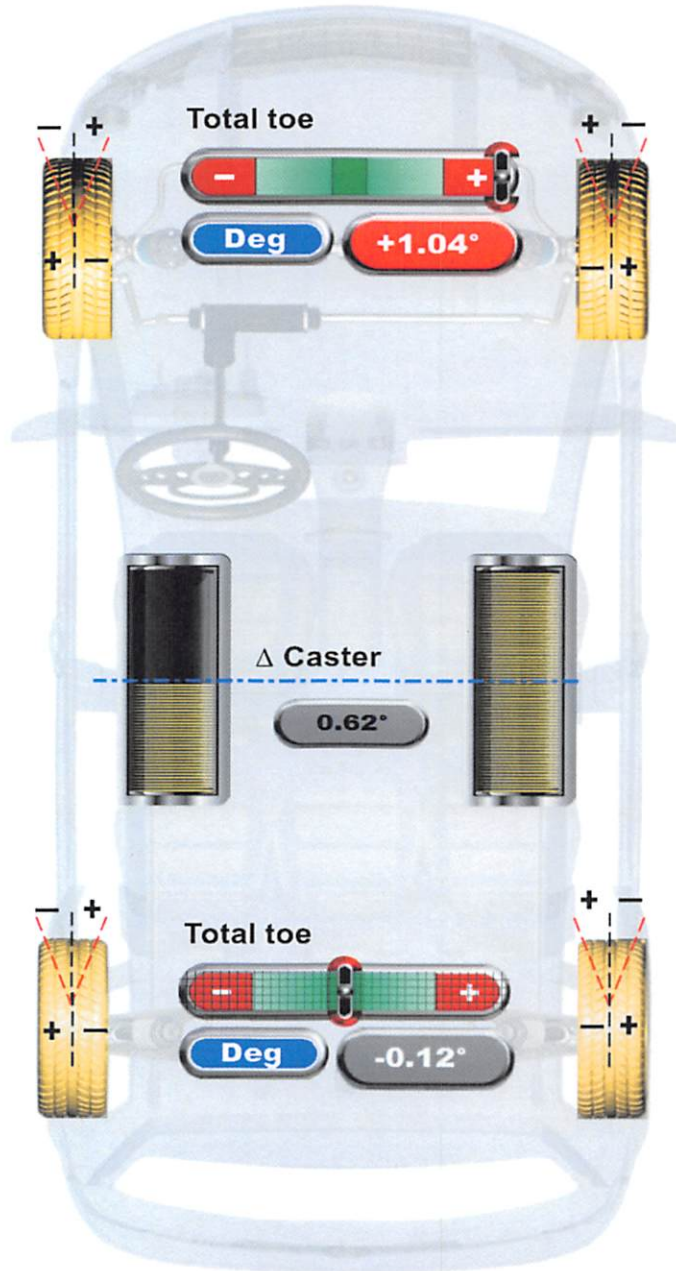
Toe ( LH )

Front camber ( LH )

Rear camber ( LH )

Toe ( RH )

Front camber ( RH )

Rear camber ( RH )
