Condition & Valuation Survey Report

Alaska Plaza – Deck Barge

Renamed and registered
as Ramrap (April 2024)

Re: Survey of Alaska Plaza

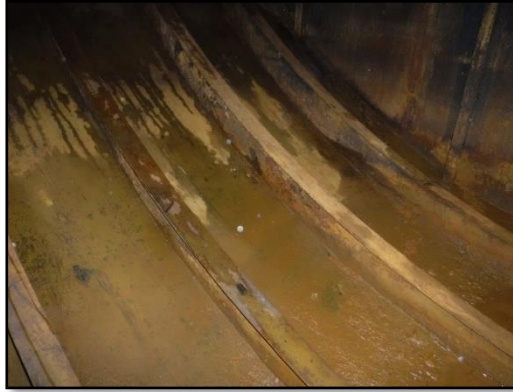
Port Bow Rake

- Good condition

- Frames in good condition

- Work done - good condition

- 2" water

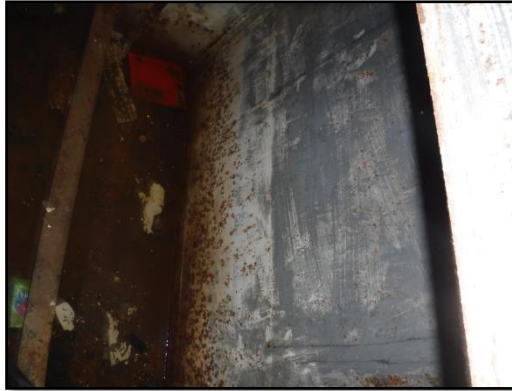
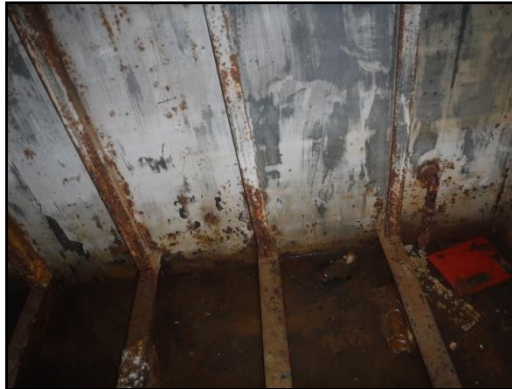
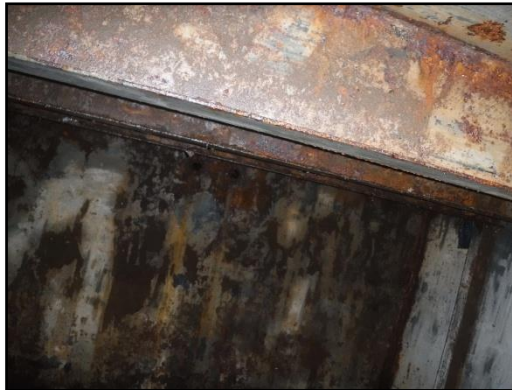
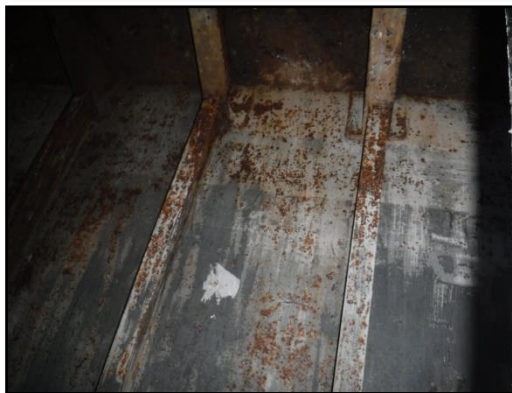
Centre Bow Rake

- Fair condition
- Moderate rust

- Fair condition

- 1" water

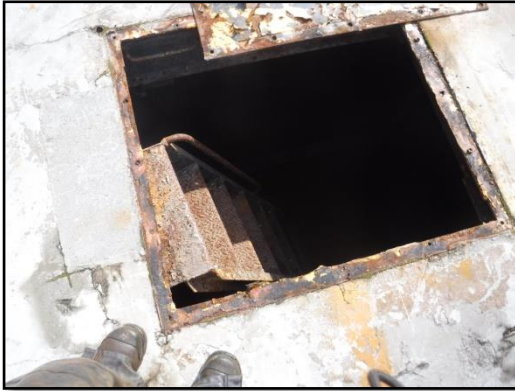
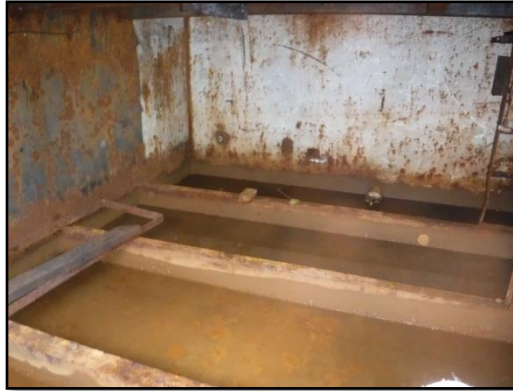
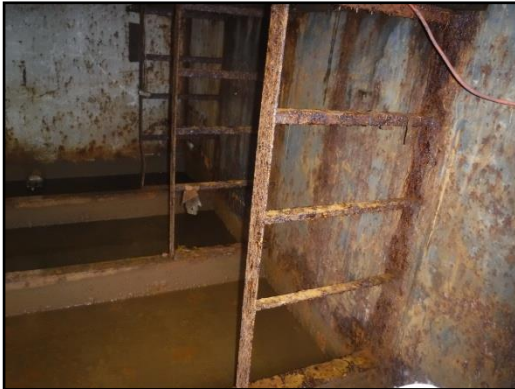
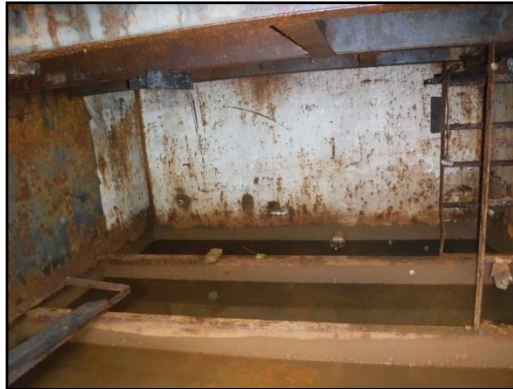
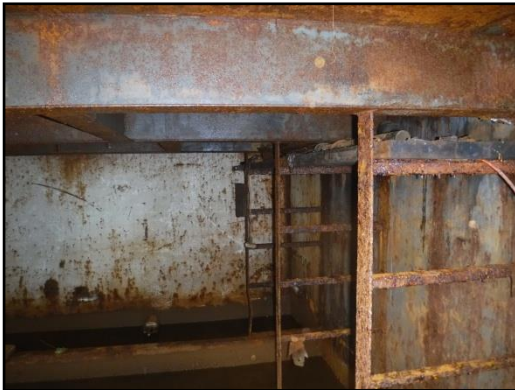
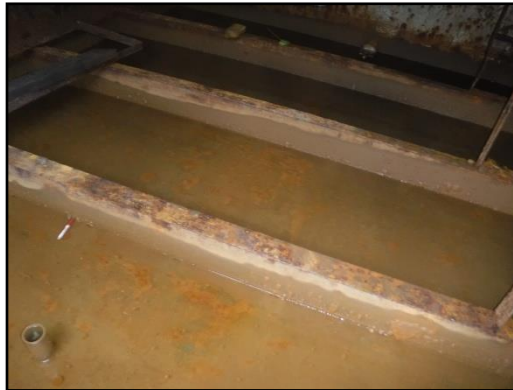
Centre 1

- Fair condition

- 1.5" water

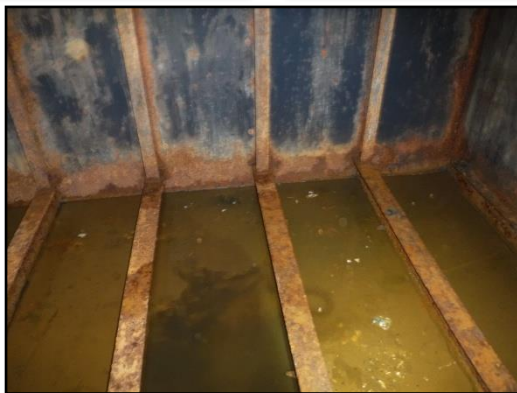
Starboard 1

- Fair condition

- ~1" water

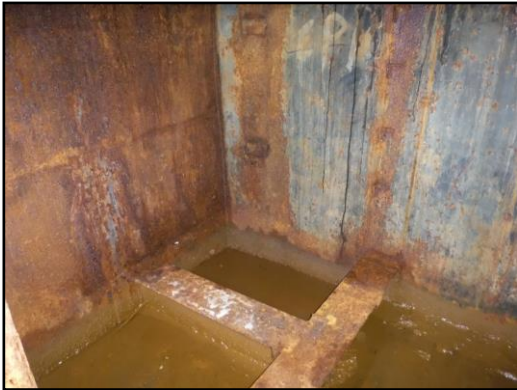
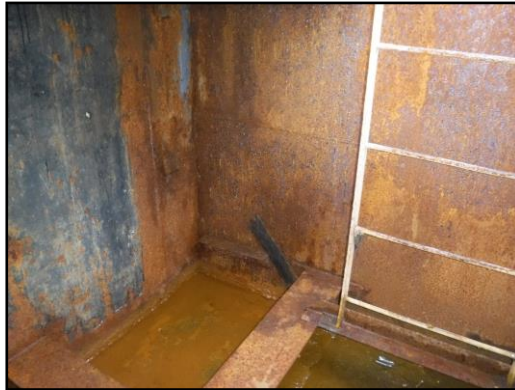
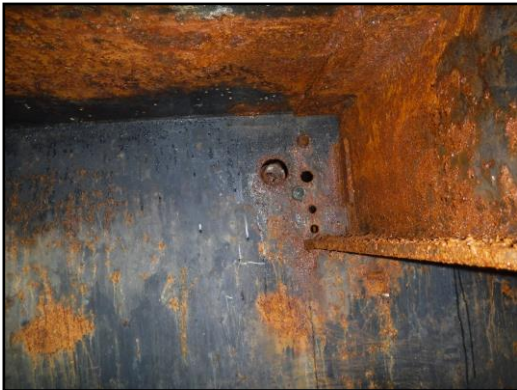
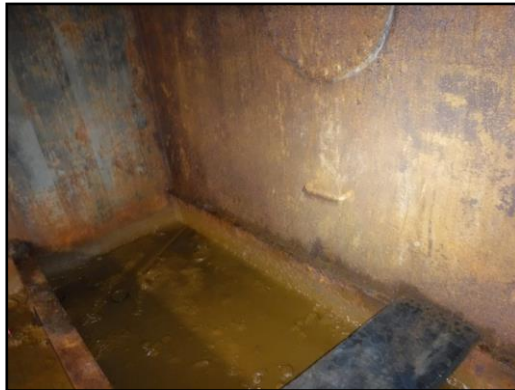
Port 2

- Fair condition

- Wood ladder missing all rungs - **poor condition

- 3" water
- Not entered – ladder in poor condition

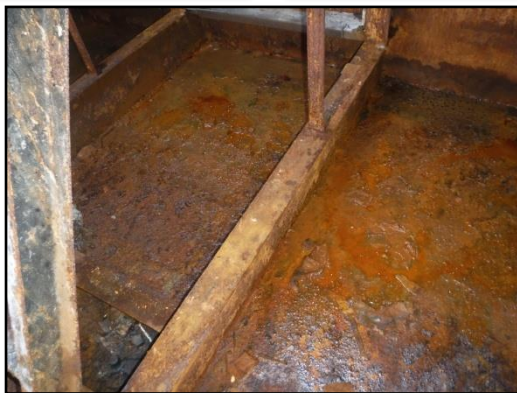
Starboard 2

- Old shelving in void

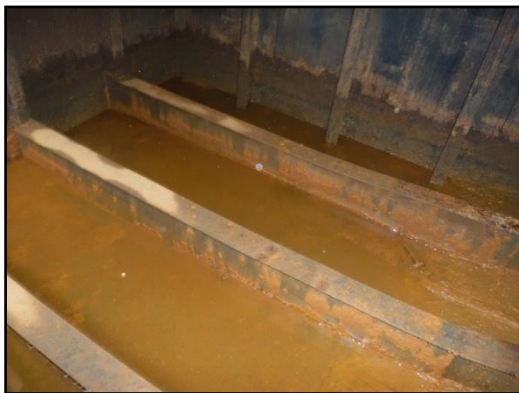
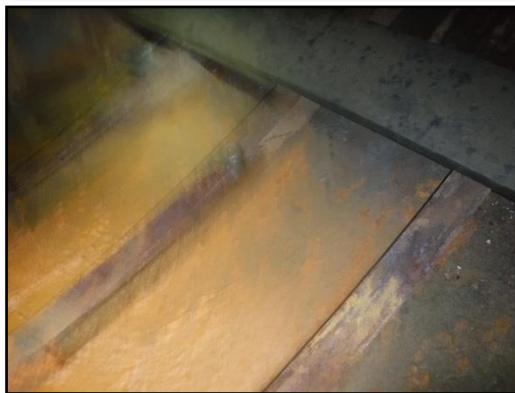
Port Stern

- Fair condition
- ~10% wasted

- ~2" water

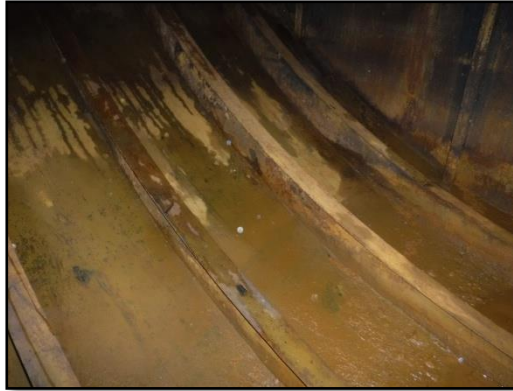
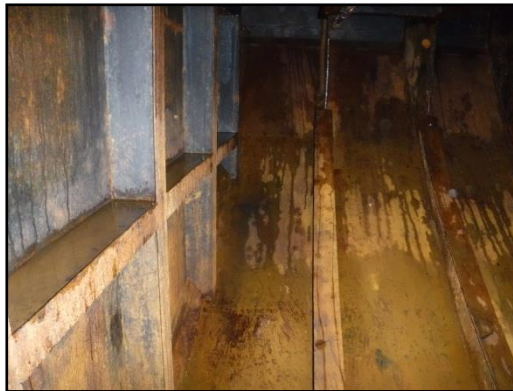
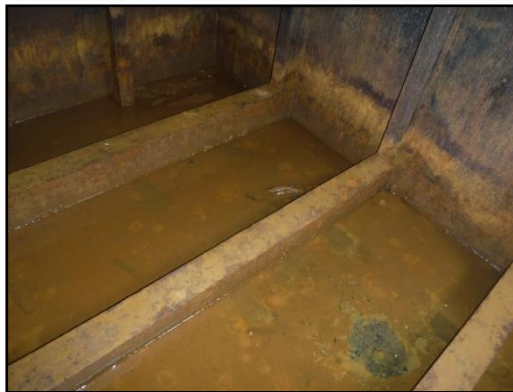
Starboard Stern

- Fair condition

- ~2" water
