# On-Hire & Insurance Survey Report

## *Pacific III*

*Re: On-Hire Survey of Pacific III*

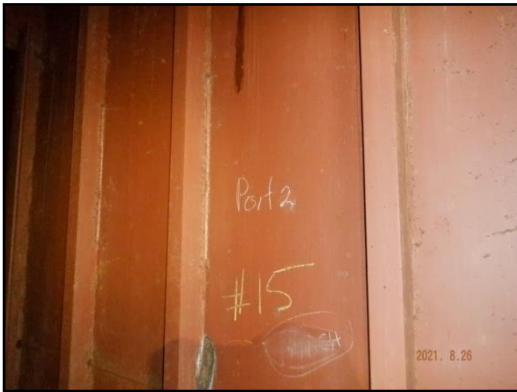
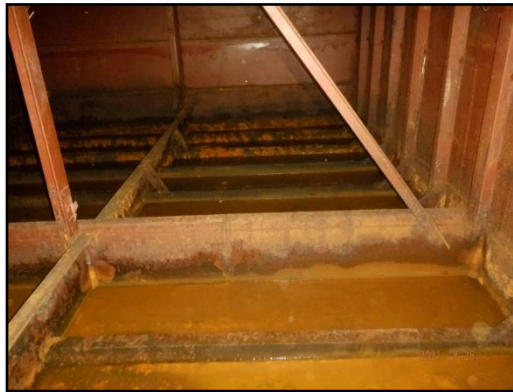
### Deck Beams:

- Bay 3 D-TF light set down
- D-P light set-down

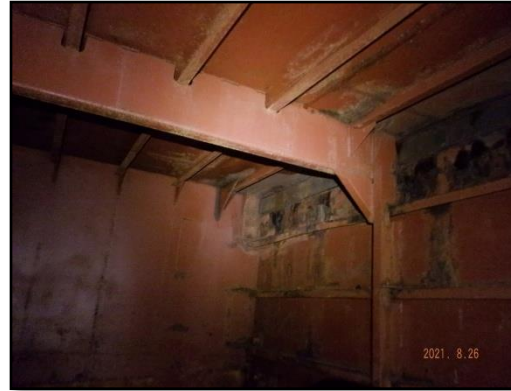
Void S4

- 14" x 21" with 3" coaming
- 8 bronze bolts & nuts
- Gasket in good condition
- Cover in good condition

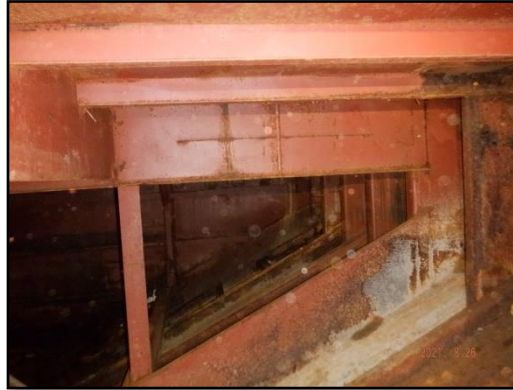
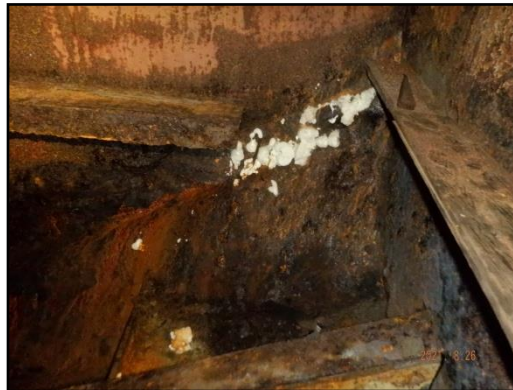
### Void S6

- 14" x 21" with 3" coaming
- 8 bronze bolts & nuts – \*\*\*1 bolt is broken
- Gasket in good condition
- Cover in good condition
